Evidence of an emerging levee failure mechanism causing disastrous floods in Italy

Stefano Orlandini¹, Giovanni Moretti¹, and John D. Albertson²

Orlandini, S., G. Moretti, and J. D. Albertson (2015), Evidence of an emerging levee failure mechanism causing disastrous floods in Italy, *Water Resour. Res.*, 51, 7995–8011, doi:10.1002/2015WR017426.

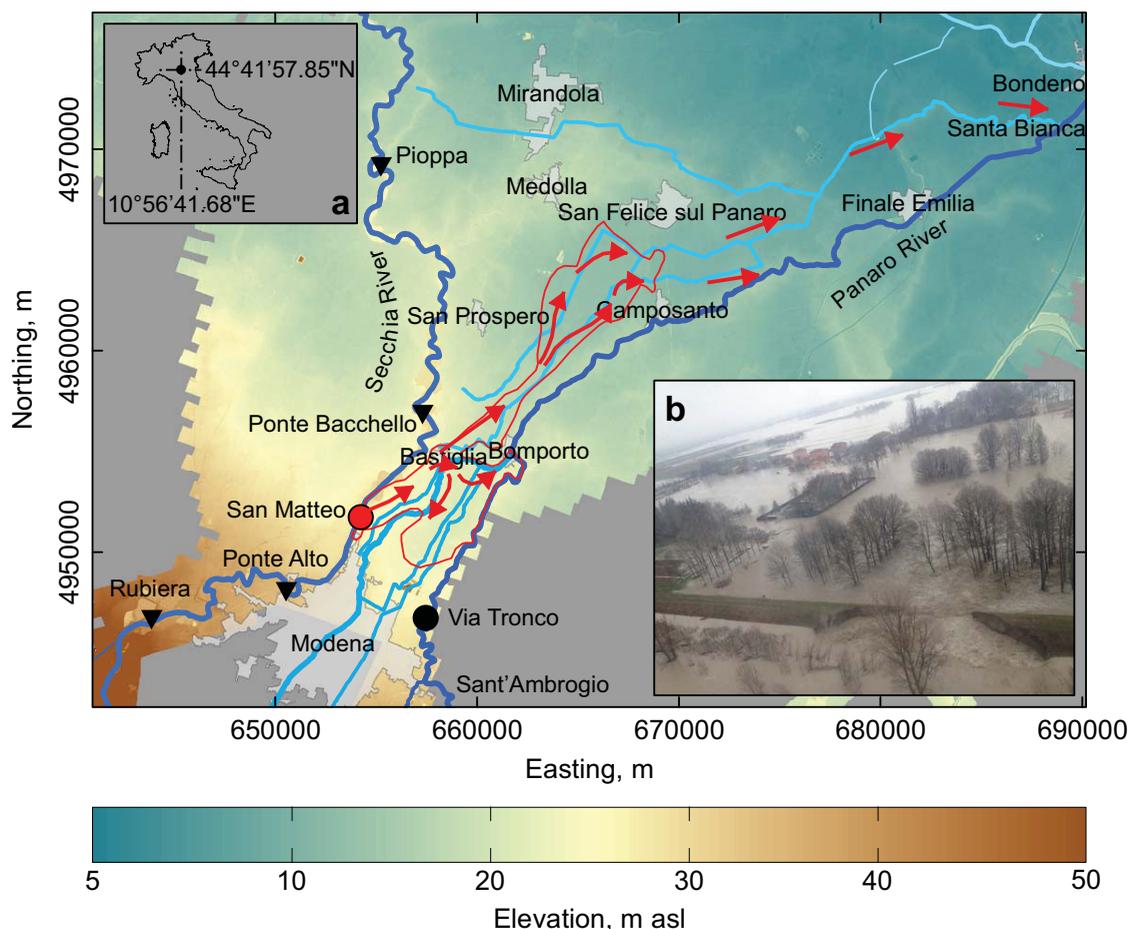
On 19 January 2014, a levee failure occurred along the Secchia River at San Matteo, Northern Italy ($44^{\circ}41'57.85''\text{N}$, $10^{\circ}56'41.68''\text{E}$, Figure 1a). The breach formed on the right side of the river system (from the perspective of looking downstream) was first observed in the morning around 6:30. Since a rapid repair was impracticable at that time, the breach developed by releasing to the surrounding plain a water volume of about $36 \times 10^6 \text{ m}^3$ with a peak flow discharge of about $434 \text{ m}^3 \text{ s}^{-1}$ (section A1). The ultimate extent of the flooded area was about 52 km^2 and the estimated flooding damage was in excess of \$500 million (Figure 1). The levees of the Secchia River are, at least in the perspective of the present investigation, representative of the levee systems developed in the Po Valley from the sixteenth century and now extending for about 2300 km (levees on both sides of the river) along the Po River and its tributaries. The Po Valley is the most densely populated and economically developed area in Italy.

Figure 1. (a) Map of the land flooded after the levee failure occurred along the Secchia River at San Matteo (Northern Italy) on 19 January 2014. (b) The delineation of the flooded areas is based on aerial surveys carried out by the Civil Protection as part of the emergency response plan for the occurred disaster. A volume of water of about $36 \times 10^6 \text{ m}^3$ (Figure 3a, area under the breach loss hydrograph) left the Secchia River by flooding (red arrows) an area of about 52 km^2 . Topographic gradients and barriers are shown by the 1 m resolution digital elevation model reported in the background.

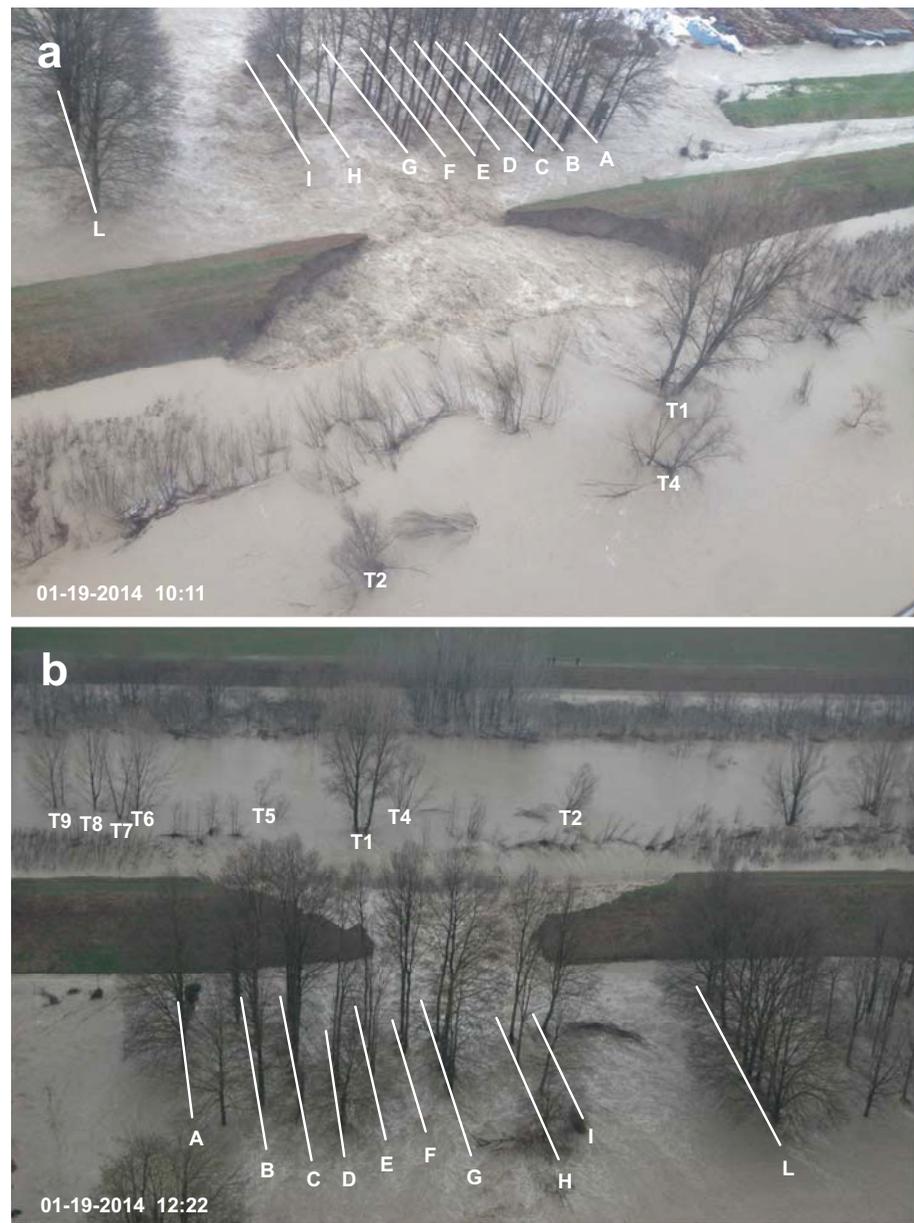
The breach that occurred along the Secchia River on 19 January 2014 (Figures 1 and 4) was first detected at 6:30. It has been reported by several observers that the breach developed from above and that a large erosive flow was spilling out from the river to the landside bank of the levee at the time of the detection. Given

Figure 4. Photographs of the breach formed along the Secchia River at San Matteo taken from helicopters at 10:11 (Figure 4a) and 12:22 (Figure 4b) of 19 January 2014. Relevant geometrical features of the land surface close to the breach (trees T1–T9 in the riverbed and tree rows A–L in the landside plain) are identified on the photographs to allow the breach configuration to be georeferenced and transferred to relevant aerial photographs (Figures 5b and 5c).

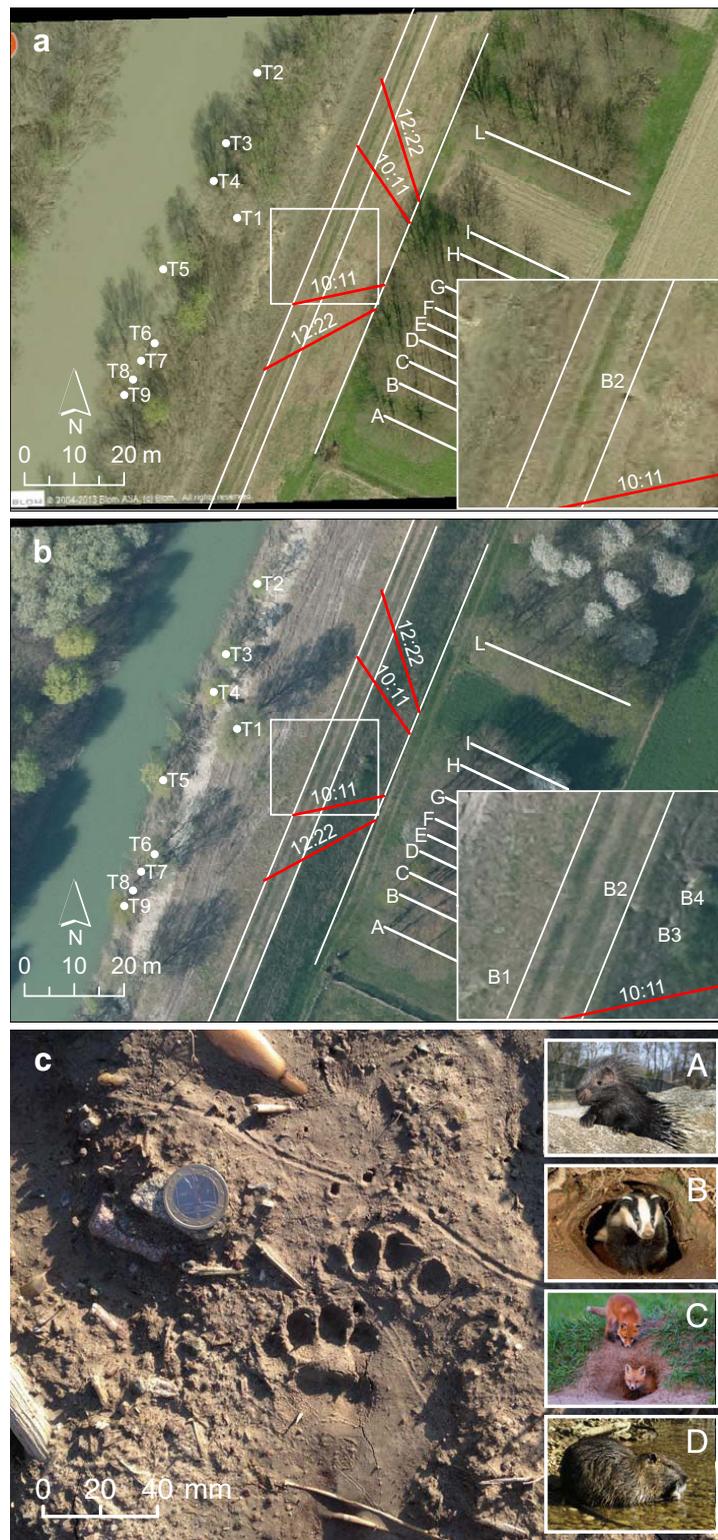
Evidence of wildlife impact on the failed levee was derived from the analysis of 10 cm resolution aerial photographs taken in 2010 and 2012 (Figures 5a and 5b, respectively). This evidence was confirmed by field inspection of the Secchia River after the disaster (Figure 5c). More generally, extensive field inspection conducted along the Secchia and Panaro Rivers revealed an emergent risk connected to the activity of crested porcupines *Hystrix cristata* (Linnaeus, 1758), European badgers *Meles meles* (Linnaeus, 1758), red foxes *Vulpes vulpes* (Linnaeus, 1758), and nutria *Myocastor coypus* (Molina, 1758) (insets A, B, C, and D, respectively, in Figure 5c). The information of the photographs taken from helicopters in the early stage of breach development, at 10:11 and 12:22 (Figure 4), and of previously taken aerial photographs (Figures 5a and 5b) were combined to determine the precise location of the levee where the failure mechanism originated (section A2). Animal burrows (B1, B2, B3, and B4) were found to exist in the levee location where the breach originated (Figures 5a and 5b). In addition, terrain analysis based on a 1 m resolution digital elevation model (DEM) generated from a lidar survey revealed the positions of the animal burrows observed in Figure 5b along the cross section of the failed levee (section A2). Results are reported in Figure 6.

Figure 5. Evidence of burrowing animals in the location of the Secchia River levee that failed on 19 January 2014. Long parallel lines mark the top and landside bottom boundaries of the levee. Figure 5a shows animal burrows appearing in the 10 cm resolution aerial photography taken on 27 March 2010. Figure 5b indicates that on 29 March 2012, animal burrows were further developed. Figure 5c shows the footprint of a wild animal (probably a badger or a crested porcupine) observed on 24 February 2014, along the repaired levee. The burrowing animals that have impacted the levees of the Secchia River include those shown in the insets of Figure 5c: (a) crested porcupine *Hystrix cristata* (Linnaeus, 1758), (b) European badger *Meles meles* (Linnaeus, 1758), (c) red fox *Vulpes vulpes* (Linnaeus, 1758), and (d) nutria *Myocastor coypus* (Molina, 1758).

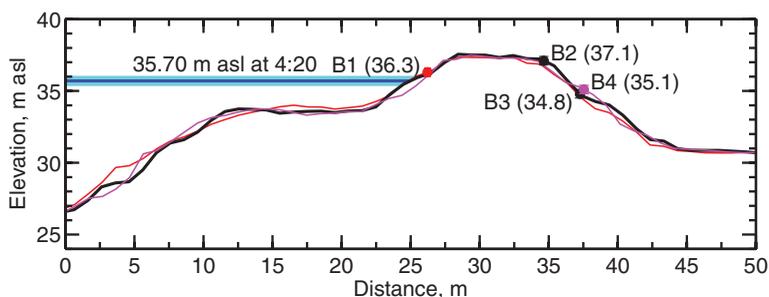
Figure 6. Geometrical relationship between the elevations of burrows B1, B2, B3, and B4 observed (in 2010 and 2012) in aerial photographs (Figures 5a and 5b) of the Secchia River at San Matteo and the river stage reconstructed from hydraulic modeling for the same levee location on 19 January 2014 at 4:20 (Figure 3). Direct river inflow into the den system can be considered possible if an uncertainty of 0.3 m in the determination of both burrow elevations (uncertainty bars) and river stages (light blue band) is acknowledged (hypothesis 1 and section 4.1).

row located on the riverside of the levee (36.3 ± 0.3 m asl) at 4:20, when the river stage was estimated to be 35.70 ± 0.30 m asl (Figures 3b and 6). Since it can be clearly observed that the system of dens developed significantly from 2010 (Figure 5a) to 2012 (Figure 5b), and burrowing animals like badgers or crested porcupines were still living along the repaired levee in 2014 (Figure 5c), it is likely that the den system was more developed at the time of the levee failure than shown in the photograph taken in 2012 (Figure 5b). This would further support the triggering of internal flow and erosion processes by direct river inflow into the riverside entrance of the den system.

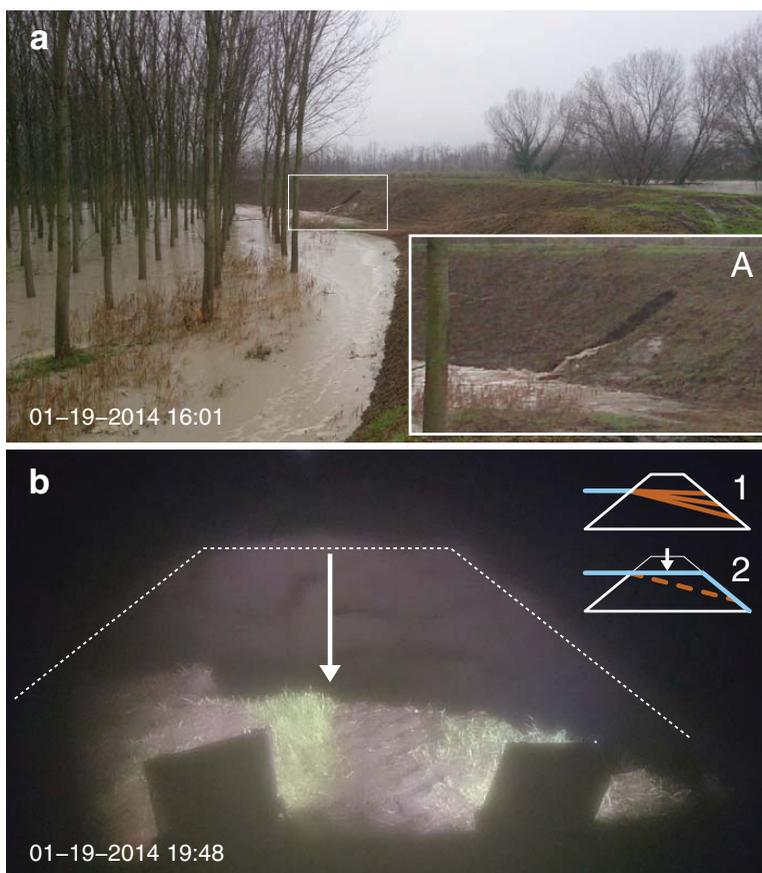
Having observed the disastrous levee failure along the Secchia River, the technical staff of the responsible agency, the “Agenzia Interregionale per il Fiume Po,” and of the Civil Protection executed an emergency response plan by closely watching the levee systems of the Secchia and Panaro Rivers. On 19 January 2014, a developing internal erosion process was observed on a levee along the Panaro River at Via Tronco (Figure 1), at a site where a crested porcupine den was known to exist (Figure 7). The internal erosion process shown in Figure 7a (inset A) was observed at 16:01 on 19 January 2014, but it most likely started at least 1 h before, as indicated by the ponding depth of turbid water lying on the soil surface at the landside of the levee in Figure 7a. The internal flow and erosion processes depicted in Figure 7a are focused at the den of a crested porcupine (inset A of Figure 5c) that was observed and had been filled with earth in the past. The internal erosion process was observed to continuing developing during the period of time from about 16:01 to 19:50 as sketched in the inset 1 of Figure 7b. At about 19:50, the top of the levee was observed to collapse on the gallery caused by internal erosion as sketched in the inset 2 of Figure 7b. The levee top then, lowered by about 3 m, would have been further eroded and overtopped by a river flow loss if a rapid repair operation were not carried out by filling the breach with earth and compacting this earth with an excavator. The collapsed levee was thus repaired, preventing a second disaster.

This levee failure mechanism observed along the Panaro River can realistically be inferred to be similar to the disastrous levee failure mechanism that occurred along the Secchia River at San Matteo (Figure 1).

Figure 7. Observational evidence of the levee failure mechanism occurred along the Panaro River at Via Tronco (Figure 1) on 19 January 2014, under hydroclimatic conditions similar to those occurred along the Secchia River at San Matteo (Figure 2). An internal erosion process was observed at 16:01 as documented in Figure 7a. This internal flow process developed around a crested porcupine den that was observed and filled with earth in the past. The collapse of the levee top over the gallery formed by internal erosion was documented at 19:48 as reported in Figure 7b. The picture reported in Figure 7b was taken from the top of the levee close to the collapsed portion highlighted by the arrow directed downward. The failure mechanism consisted therefore of two stages. In stage 1 (Figure 7a and sketch labeled “1” in Figure 7b), the internal erosion develops around the animal den. In stage 2 (Figure 7b and sketch labeled “2” in Figure 7b), the levee top collapses by filling the gallery in the eroded levee and by exposing the collapsed material to further erosion and overtopping. The collapsed levee was rapidly repaired, preventing a second disaster.

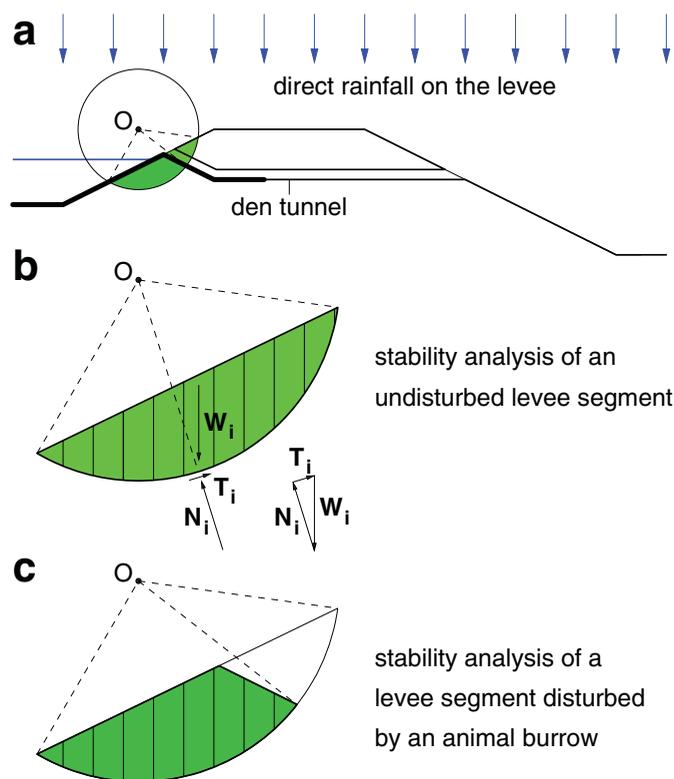
Figure 8. Sketch of the slope stability analysis performed to assess the impact of animal burrows on equilibrium conditions (hypothesis 2 and section 4.2). The bold line in Figure 8a indicates the levee portion on which the analysis focuses. The equilibrium of green segments shown in Figures 8b and 8c is evaluated: O is the center of the circular sliding surface, W_i is the weight of the i th element composing the sliding segment, T_i and N_i are the shear and normal components of W_i to the sliding surface. The blue vertical arrows indicate the direct rainfall on the levee. The blue horizontal line indicates the river stage. The two cases in which the animal burrow is not present (Figure 8b) or is present (Figure 8c) are considered.

The stability of the riverside slope of the disturbed levee under the reconstructed hydroclimatic conditions was assessed by applying the Fellenius method [Fellenius, 1927] to the hypothetical system sketched in Figure 8. The hypothetical tunnel geometries considered are compatible with reconstructed animal burrows (section A2) and data describing badger setts in the literature [Roper, 1992a, 1992b]. The hydroclimatic forcing was determined from rainfall and river flow modeling as reported in Figures 2b and 3b, respectively (section A1). Soil saturation and soil matric potential were determined by solving the 3-D Richards equation through the FEFLOW model [Diersch, 2014] (section A3). The center of the circular segment subjected to stability analysis was varied numerically to consider all the possible geometries of the potentially unstable (disturbed) levee portions. The weight of the elements composing the segment were computed by considering the porous medium and the water (partially) filling the voids in response to variable infiltrated rainfall and river stage as obtained from detailed seepage flow modeling. In the performed analysis, the effective cohesion was assumed to be $c' = 0$, the effective angle of internal friction was assumed to be $\phi' = 32^\circ$, and the unit weight in saturated state was assumed to be $\gamma_{\text{sat}} = 19,000 \text{ N m}^{-3}$.

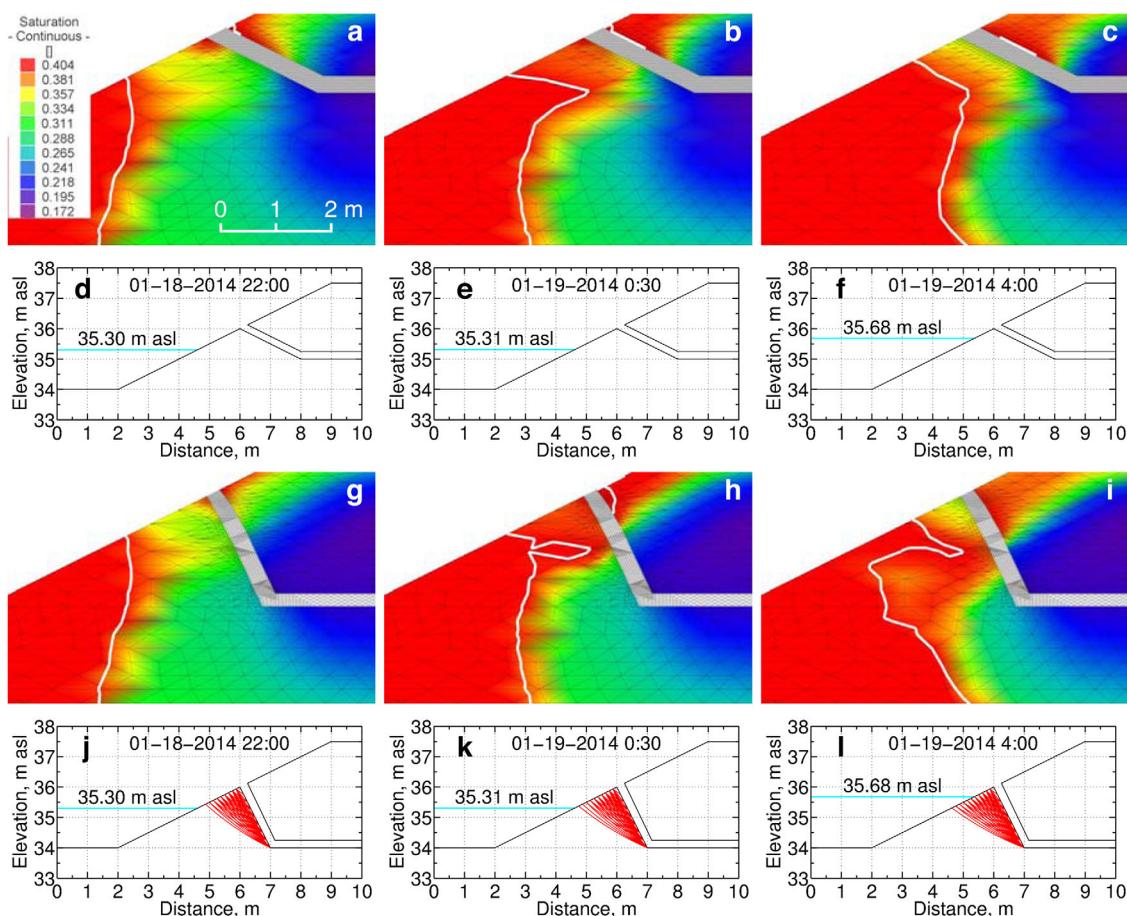
Figure 9. Simulated response of the levee of the Secchia River at San Matteo to direct rainfall on the levee (Figure 2b) and river stage (Figure 3b) in the case sketched in Figure 8 (hypothesis 2). Two possible hypothetical configurations for the tunnel extending from the riverside animal burrow into the levee are reported in Figures 9a–9f and 9g–9l, respectively. The simulation period started at time 22 December 2013 at 0:00 to mitigate the memory effects on the reconstructed levee status. The reconstructed fields of volumetric soil water content are reported at times 18 January 2014 at 22:00 (Figures 9a, 9d, 9g, and 9j), 19 January 2014 at 0:30 (Figures 9b, 9e, 9h, and 9k), and 19 January 2014 at 4:00 (Figures 9c, 9f, 9i, and 9l). The term “saturation” reported in the legend of Figure 9a is used in the FEFLOW program to denote the volumetric soil water content. The white line in Figures 9a–9c and 11g–11i denotes the phreatic (zero pressure) surface.

A Fellenius slope stability analysis was then performed by varying the center of the circular sliding surface and considering all the forces acting on the variably saturated sliding soil segment (section A4). It is important to note that this was a simplified 2-D stability analysis, and as such the results should be both meaningful for evaluating hypothesis 2 and on the conservative side. The results are reported in Figure 9. A first set of numerical experiments reveals that no instabilities occur by considering a realistic configuration of the tunnel extending from the riverside den entrance into the levee (Figures 9a–9c). No red lines indicating critical sliding surfaces are shown in Figures 9d–9f. The (unknown) internal tunnel geometry is varied in the second set of numerical experiments until red lines indicating critical sliding surfaces came out (Figures 9g–9i). These critical geometrical settings are, however, found to be unrealistic because they produce levee failures also in times when no failures were observed to occur (Figures 9j–9l).

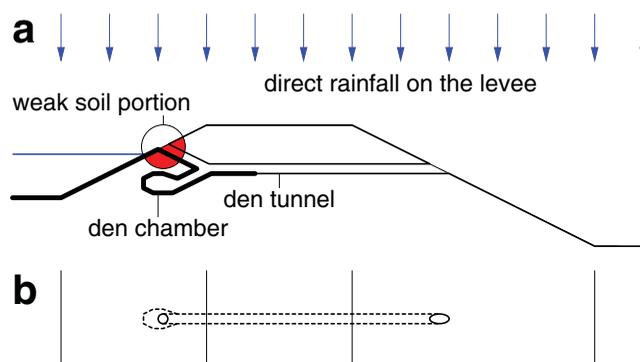
The third hypothesis explored in the present investigation is that a den system similar to the one sketched in Figure 10 was present at the time of the levee failure [Roper, 1992a, 1992b]. A hypothetical 1 m earthen wall separating the levee riverside from an internal den chamber was assumed to exist. This is a realistic hypothesis given the development of the den system observed in aerial photographs from 2010 to 2012

Figure 10. Sketch of the den system hypothesized to explore the possible triggers of internal flow and erosion processes occurred on 19 January 2014, along the Secchia River at San Matteo (hypothesis 3 and section 4.3). Plan and profile views are reported in Figures 10a and 10b, respectively. The bold line in Figure 10a indicates the levee portion on which the analysis focuses. The red circular segment indicates the portion of weak soil centered around the den entrance. The blue vertical arrows indicate the direct rainfall on the levee. The blue horizontal line indicates the river stage.

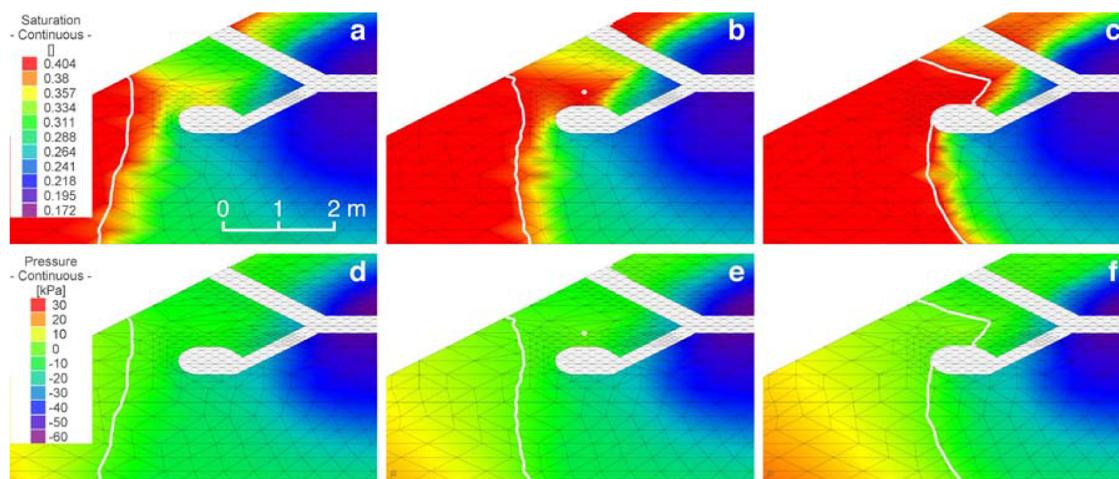
pressure (Figures 11d–11f) become critical at 4:00 of the day 19 January 2014 (Figures 11c and 11f), and that these critical conditions do not occur in other times of the simulation period (December 2013 and January 2014) as should be expected (e.g., Figures 11a–11c and 11f). At 4:00 of 19 January 2014, the ceiling of the chamber became saturated and the soil water pressure became positive. This occurrence would have likely implied the collapse of the den system and the triggering of internal flow and erosion, even with the elevations of animal burrows observed in 2012 (section A5).

It is remarked that the geometry of the considered den system is hypothetical. However, the results reported in Figure 11 provide a reliable proof-of-concept about the processes that may have triggered internal flow and erosion along the Secchia River on 19 January 2014, because critical conditions are only reproduced at the day of the observed failure and not in other days of the simulation period. It is finally reported that numerical modeling of the system considered in the present section (hypothesis 3) reveals that no critical soil saturation around the den chamber occurs by applying separately one of the two components of the observed hydroclimatic forcing, namely river stage and direct rainfall on the levee (see supporting

Figure 11. Simulated response of the levee of the Secchia River at San Matteo to direct rainfall on the levee (Figure 2b) and river stage (Figure 3b) in the case sketched in Figure 10 (hypothesis 3). The simulation period started at time 22 December 2013 at 0:00 to mitigate memory effects on the reconstructed levee status. The reconstructed fields of volumetric soil water content and pressure are reported at times 18 January 2014 at 22:00 (Figures 11a and 11d), 19 January 2014 at 0:30 (Figures 11b and 11e), and 19 January 2014 at 4:00 (Figures 11c and 11f). The term “saturation” reported in the legend of Figure 11a is used in the FEFLOW program to denote the volumetric soil water content. The white line denotes the phreatic (zero pressure) surface.
