The “unusual” Ca’ Bonettini landslide (Province of Modena, Italy)

Abstract

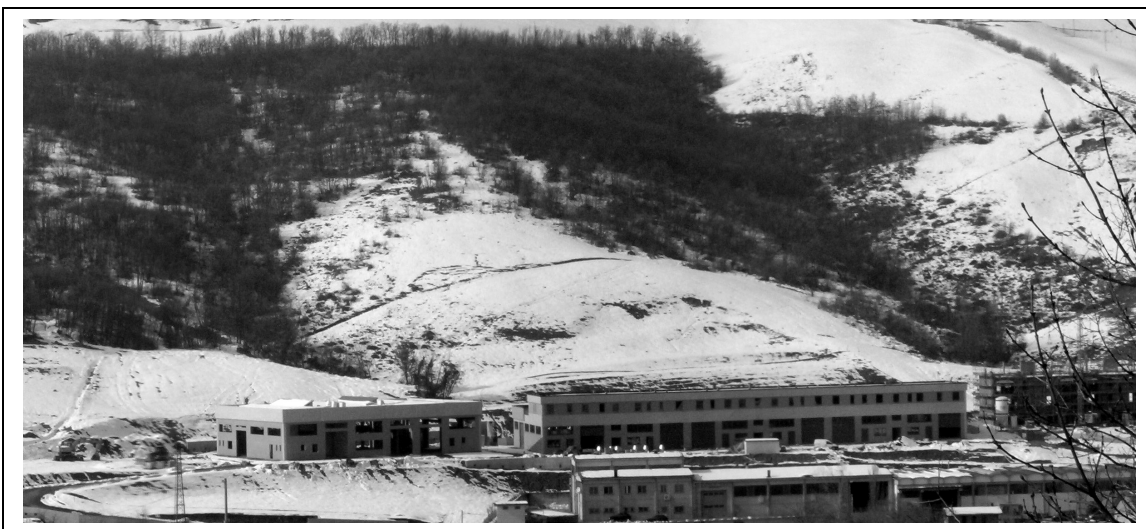
Another predisposition cause for landsliding should also be considered. Since the mid-1960s the area near the foot of the Ca' Bonettini landslide body, in proximity to the valley floor, has been subject to human activities, mainly consisting of industrial and office buildings as witnessed by photographs taken in that period (cf. Fig. 2). Late in August 2003, just weeks before the landslide's first reactivation, building activities were extended towards the landslide foot with the construction of another two buildings, preceded by considerable morphological changes with the removal of large amounts of earth to make room for new constructions (Fig. 4). These works further reduced the stability of the slope, since it is well known that the removal of material from the zone of accumulation of a dormant landslide leads inevitably to a general decline of stability conditions.

Fig. 4 – Industrial buildings recently constructed at the foot of the Ca' Bonettini landslide (March 2004)
