IMPREGNATED CARBON FABRIC REINFORCED CEMENTITIOUS MATRIX COMPOSITE FOR REHABILITATION OF THE FINALE EMILIA HOSPITAL ROOFS: A CASE STUDY

In this paper, the mechanical performance of concrete beams strengthened by an impregnated Carbon Fabric Reinforced Cementitious Matrix (CFRCM) composite is investigated. The study is aimed at the rehabilitation of the Finale Emilia hospital roofs, severely damaged by the 2012 Northern Italy earthquake. A 8-m-long concrete beam could be taken from the building for reinforcement and testing in a beam test setup. The composite is designed to be externally applied to the existing thin clay tile layer bonded to the concrete beam intrados. Two lamination cycles are considered, which differ in the way the partially-organic adhesion promoter is applied to the fabric. It is found that impregnation thorough fabric immersion provides a 1.5-fold increase in the ultimate strength of the strengthened beam compared to expedited impregnation with a brush. Besides, clay tiles make a very good supporting substrate, to the extent that cohesive fracture at the tile/concrete interface takes place on the verge of concrete failure near the hinge zone. Conversely, exped

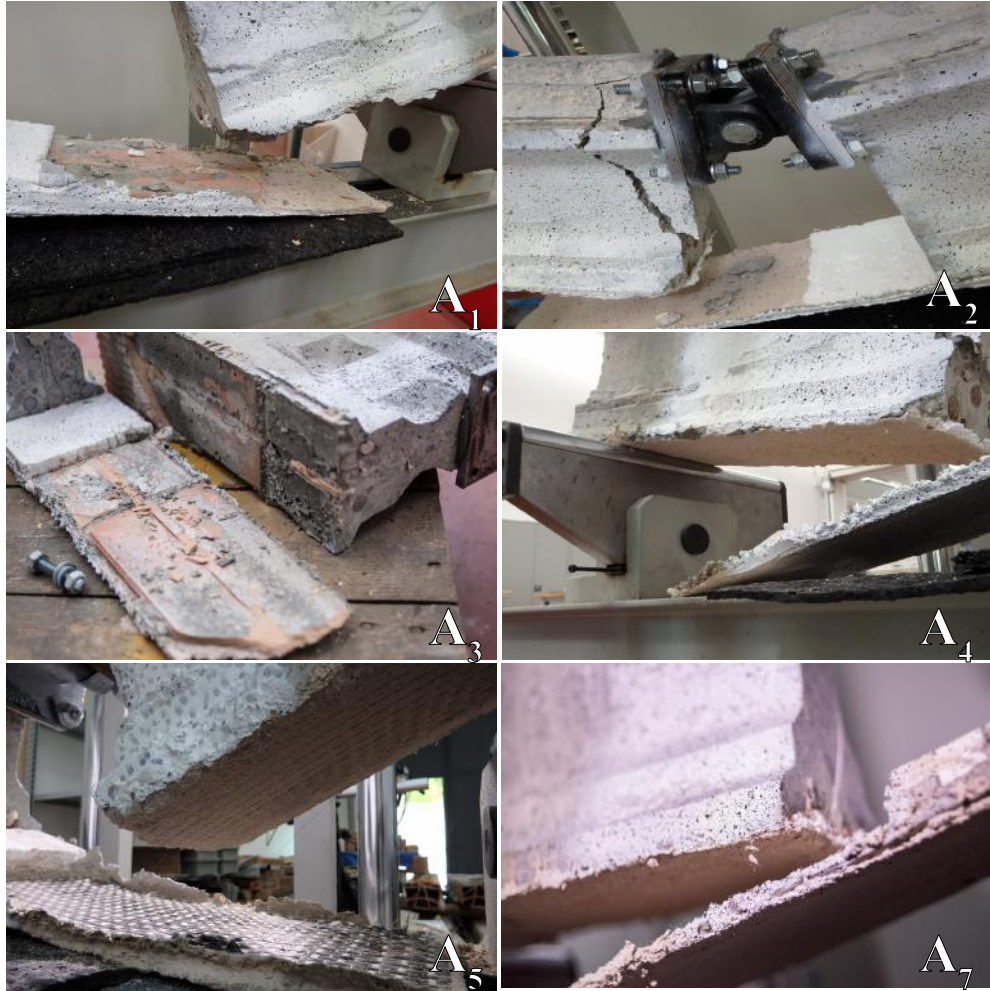
FIG. 8. Failure modes: cohesive fracture (specimen A1 and A3), tensile failure in the concrete (A2), delamination (A4,A5,A7)

where Γ_{fd} is the specific fracture energy which depends on the ultimate slip s_u (see also D'Ambrisi et al. 2013 for a suitable choice of s_u for FRCM materials) and parameters are given in Table 4. Clearly, for maximum performance, the bonded length l_b should exceed l_e . Indeed, a bonded length $l_b = 300 \text{ mm}$ was considered with no special anchoring device (e.g. U-wrapped fabric, transverse bars, abrasive blasting of the substrate surface etc.). The bending test was carried out under displacement control at 1 mm/min knife speed. Fig.7 gathers the results of the beam test while Fig.8 presents the failure mechanism for each specimen. Failure in specimens A1–A3, treated according to Cycle A, is either due to cohesive fracture in the thin tile layer, also known as intermediate debonding, or to tensile failure in the concrete (for a brief description of the different fracture mechanisms see CNR DT200 (2004)). Indeed, specimen A2 displayed clear evidence of tensile failure in the concrete near the hinge, which was accompanied by mixed cohesive fracture at the laminate interface.

Conversely, delamination of the fabric with fracture taking place at the fabric/matrix interface is always met in specimens A4–A7, prepared according to Cycle B. The difference in the failure mechanism reflects itself in a sharp difference among the ultimate loads, which exceed 60 kN for Cycle A as opposed to well below 50 kN for Cycle B. It is observed that
