1                   **IMPREGNATED CARBON FABRIC REINFORCED**  
2                   **CEMENTITIOUS MATRIX COMPOSITE FOR**  
3                   **REHABILITATION OF THE FINALE EMILIA HOSPITAL**  
4                   **ROOFS: A CASE STUDY**

7                   In this paper, the mechanical performance of concrete beams strengthened by an impreg-  
8                   nated Carbon Fabric Reinforced Cementitious Matrix (CFRCM) composite is investigated.  
9                   The study is aimed at the rehabilitation of the Finale Emilia hospital roofs, severely damaged  
10                  by the 2012 Northern Italy earthquake. A 8-m-long concrete beam could be taken from the  
11                  building for reinforcement and testing in a beam test setup. The composite is designed to be  
12                  externally applied to the existing thin clay tile layer bonded to the concrete beam intrados.  
13                  Two lamination cycles are considered, which differ in the way the partially-organic adhesion  
14                  promoter is applied to the fabric. It is found that impregnation thorough fabric immersion  
15                  provides a 1.5-fold increase in the ul

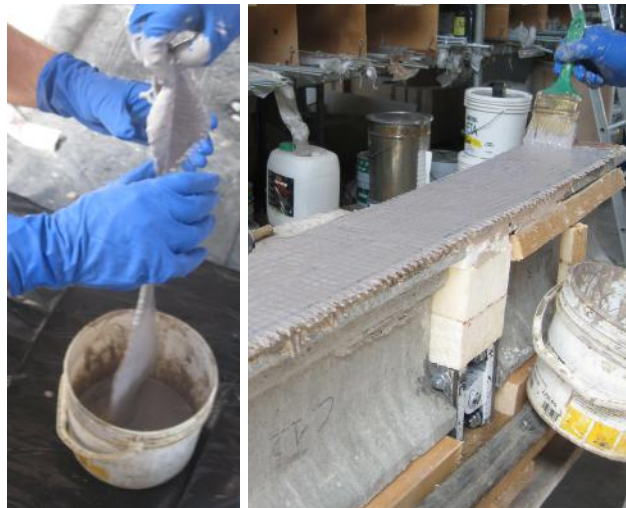
**FIG. 3. Application of the liquid impregnation agent to the cut-to-size carbon fabric: (a) impregnation through immersion (Cycle A), (b) application with a brush to the carbon fabric already placed on the mortar bed (Cycle B)**

- 71 1. the substrate (i.e. the clay tile) is wetted and then a water-based liquid inorganic  
72 adhesion promoter is applied with a brush;
- 73 2. a first mortar bed, roughly 5 mm thick, is laid;
- 74 3. cut-to-size pairs of uni-directional carbon fabric reinforcement sheets are impregnated  
75 by the adhesion promoter through immersion and then squeezed out to eliminate the

76 excess of impregnating agent (only for Cycle A, see Fig.3);

82 Alongside this treatment, which is termed Cycle A, a simpler process is considered, named  
83 Cycle B, which dispenses with step 3. According to this simpler application cycle, the liquid  
84 impregnation agent is applied with a brush directly to the carbon fabric already placed on  
85 the mortar bed, both after steps 4 and 5 (Fig.3). The reason for this second option is that the  
86 expected performance decay could be weighted against the advantage of a more expedited  
87 process and the lower cost it conveys. All materials adopted in the analysis are commercially  
88 available and their main properties are gathered in Table 1 for the mortar and in Table 2  
89 for the fabric. The mortar (coded B) and the impregnation agent are characterized as single  
90 components in Nobili (2016). The main reason for adopting this fairly low-strength mortar is  
91 compatibility with the clay tile mechanical properties. Besides, this mortar, in conjunction

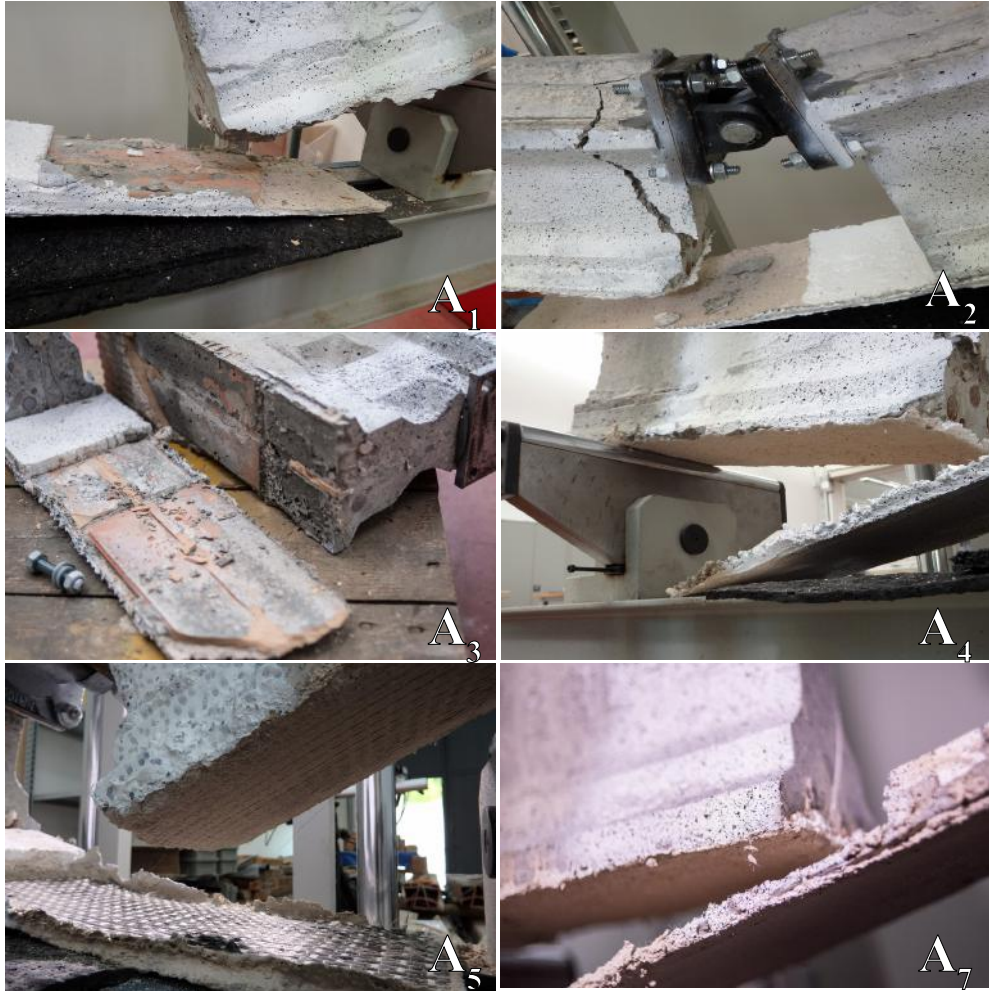
**FIG. 8. Failure modes: cohesive fracture (specimen A1 and A3), tensile failure in the concrete (A2), delamination (A4,A5,A7)**

where  $\Gamma_{fd}$  is the specific fracture energy which depends on the ultimate slip  $s_u$  (see also D'Ambrisi et al. 2013 for a suitable choice of  $s_u$  for FRCM materials) and parameters are given in Table 4. Clearly, for maximum performance, the bonded length  $l_b$  should exceed  $l_e$ . Indeed, a bonded length  $l_b = 300$  mm was considered with no special anchoring device (e.g. U-wrapped fabric, transverse bars, abrasive blasting of the substrate surface etc.). The bending test was carried out under displacement control at 1 mm/min knife speed. Fig.7 gathers the results of the beam test while Fig.8 presents the failure mechanism for each specimen. Failure in specimens A1–A3, treated according to Cycle A, is either due to cohesive fracture in the thin tile layer, also known as intermediate debonding, or to tensile failure in the concrete (for a brief description of the different fracture mechanisms see CNR DT200 (2004)). Indeed, specimen A2 displayed clear evidence of tensile failure in the concrete near the hinge, which was accompanied by mixed cohesive fracture at the laminate interface.

Conversely, delamination of the fabric with fracture taking place at the fabric/matrix interface is always met in specimens A4–A7, prepared according to Cycle B. The difference in the failure mechanism reflects itself in a sharp difference among the ultimate loads, which exceed 60 kN for Cycle A as opposed to well below 50 kN for Cycle B. It is observed that
