# Severely Damaged Reinforced Concrete Circular Columns Repaired by Turned Steel Rebar and High-Performance Concrete Jacketing with Steel or Polymer Fibers

**Abstract:** A new strategy that repairs severely damaged reinforced concrete (RC) columns after an earthquake is proposed as a simpler and quicker solution with respect to the strategies currently available in the literature. The external concrete parts are removed from the column surface along the whole plastic hinge region to uncover the steel reinforcement. The transverse steel is cut away, and each longitudinal rebar is locally substituted by steel rebar segments connected by welding connections to the original undamaged rebar pieces outside the intervention zone. The new rebar segments have a reduced diameter achieved by turning to ensure plastic deformation only in the plastic hinge, protecting the original rebar and the welding connections. The connection is specifically designed to be effective and simple, and is directly realized on column reinforcement. Finally, the removed concrete is restored by a jacket built with high-performance concrete with steel or polymer fibers. The use of concrete with high volume fractio

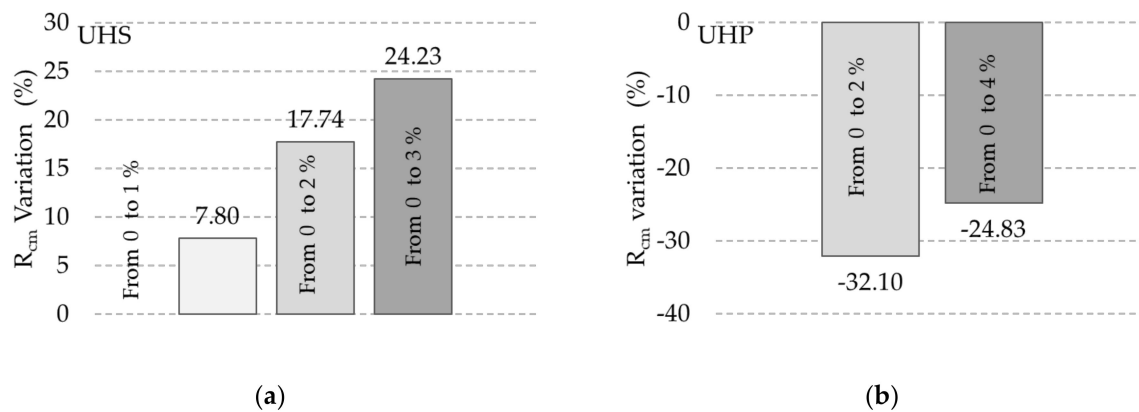
**Figure 1.** Mean cube compressive strength variation increasing the fiber volume fraction: (a) concrete reinforced with steel fibers (UHS) and (b) concrete reinforced with polymer fibers (UHP) after seven days of curing.

- (1) The concrete with steel fibers (UHS) showed an increase in strength as the fiber volume fraction increased (Figure 1a). That phenomenon was not constant but it tended to reduce increasing the fiber percentage.
- (2) The concrete with polymer fibers (UHP) presented a decrease in the strength when the fiber volume fraction increased (Figure 1b).

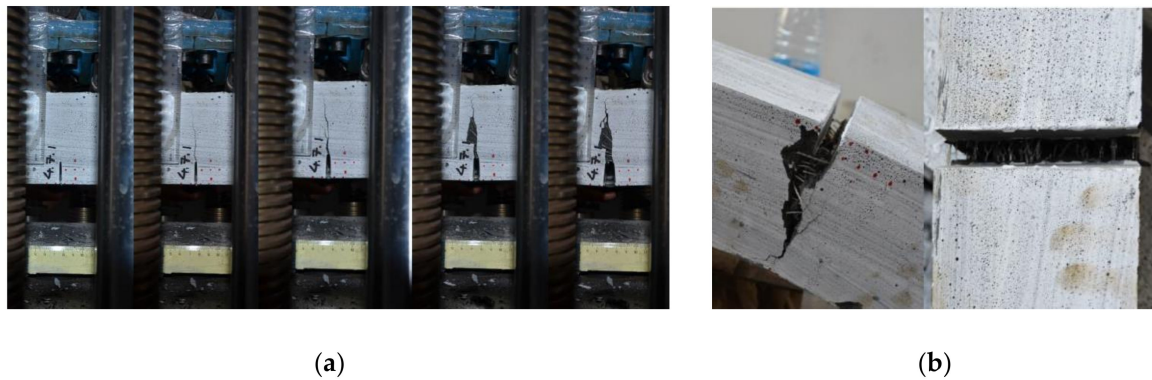
**Figure 3.** Bending tests on HPFRC beams: (a) Crack opening measured on a notched beam with a 4% volumetric fraction of polymer fibers, and (b) fibers crack bridge effect.

The typical crack for the notched beam with fibers bridging effect after the test is showed in Figure 3b.

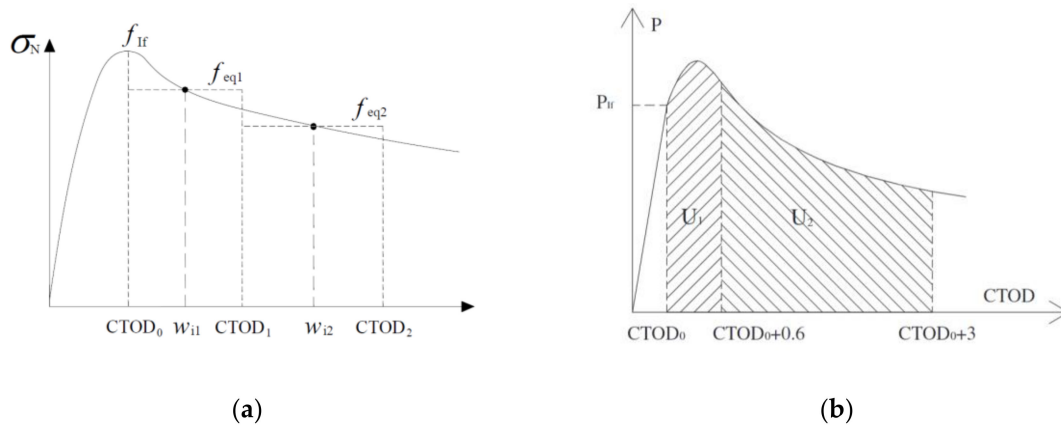
**Figure 6.** (a) Tensile strength based on the bending test results; (b) load-CTOD curve example. Figures extracted from CNR DT 204/2006 [55] and from UNI 11039-2 (2003) [52].

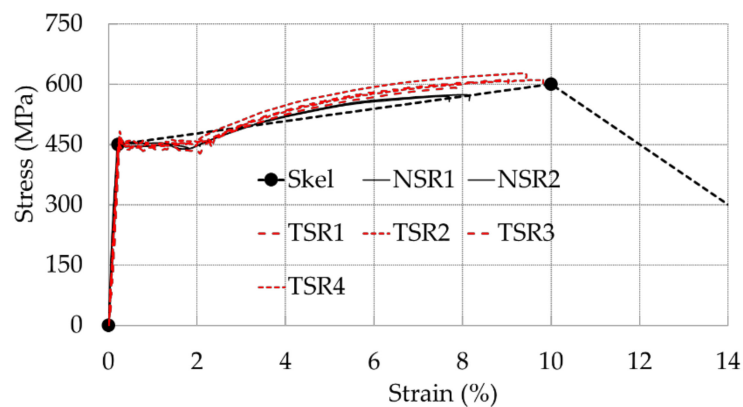
**Figure 8.** New rebar segments tested in tension: Not turned (NSR) and turned (TSR) segments; skeleton curve (Skel) to calibrate the steel material model in OpenSees.

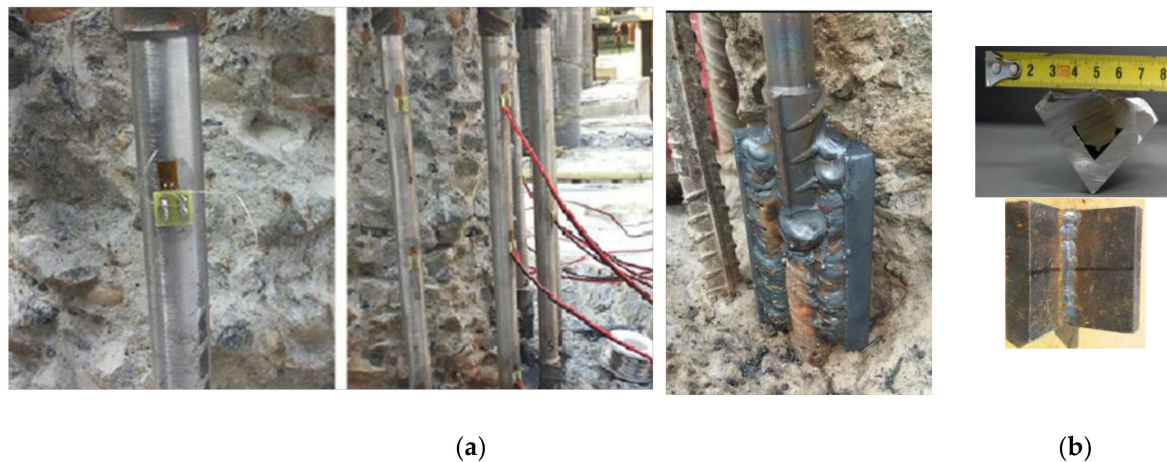
**Figure 9.** Damaged longitudinal rebar substitution: (a) Turned rebar geometries; and (b) rebar connection geometries.

The geometries of the steel coupler and of the welding chords are shown in Figure 9b. This steel coupler was realized by welding two steel plates. The connection required three steps: (1) The new rebar segments were located along the same axis of the existing rebar, (2) the coupler was placed

behind the rebar, and (3) the welding chords were built among rebar and coupler and between the rebar's end (Figure 9a). This operation was carried out on the front side of the connection.

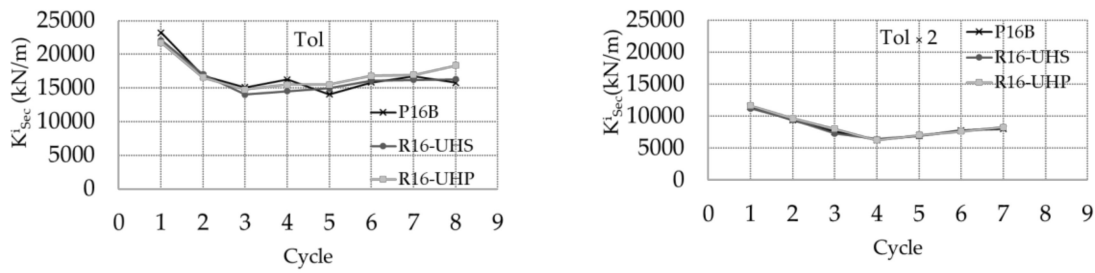
**Figure 12.** Experimental secant stiffness ( $k^i_{sec}$ ) measured at each cycle for the column P16B (the ASB column) and the RR columns R16-UHS and R16-UHP during the Tol and Tol  $\times$  2 parts of the displacement history.

The stiffness degradation due to the damage under cyclic loading was evaluated for each column considering the peak-to-peak secant stiffness of each cycle of the imposed displacement history (Figure 12). The secant stiffness calculated for the first cycle ( $K^1_{\text{sec}}$ ) of the Tol displacement history was similar for each column (Table 5). The repair strategy was able to restore the initial column capacity in terms of strength because the same displacements were applied to each column during the tests. It is evident that the secant stiffness variation of the RR columns was similar to that observed for the ASB column. The evolution of the secant stiffness (Figure 12) provides information about the evolution of the BS from cycle to cycle because each column was subjected the same displacement history. The repair strategy was able to restore capacity in terms of strength because the variation in the BS during the test was very similar for the ASB and RR columns. For the Tol part of the displacement history (Figure 7b), the main secant stiffness variation was observed during the first three cycles and then remained practically constant. For the Tol  $\times$  2 part of the displacement history (Figure 7b), the main secant stiffness variation was observed during the first four cycles and then increased a little, probably due to the effect of steel rebar hardening.

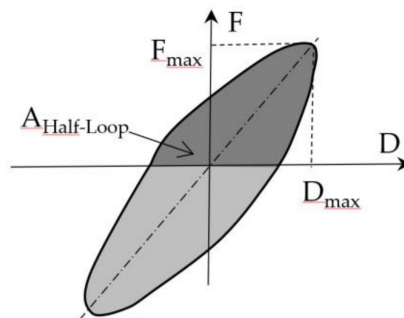
**Figure 13.** Example of damping determination for a hysteresis force (F) displacement (D) half-cycles.

In the case of seismic loads, the imposed displacements are asymmetric, and the loops may not be closed. The dissipated energy ( $E^i_d$ ) should be evaluated appropriately for each half loop (i) during the test as the area of the  $i$ th half loop, in Equation (14) in Rodrigues et al. [68], as indicated in Figure 13.

where  $F_{\max}^i$  and  $D_{\max}^i$  are the maximum displacements and force for each half cycle, respectively (Figure 13). The values of the hysteretic damping ( $\xi^i$ ) are given in Figure 15a,b for the ASB column (P16B) and the repaired columns (R16-UHS and R16-UH) for the negative (Figure 15a) and the positive (Figure 15b) half loops.

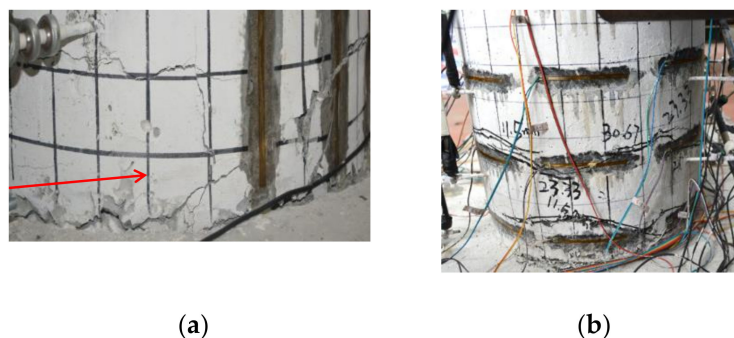
**Figure 17.** Damage at the end of the cyclic tests on: (a) The ASB column and (b) the RR columns.

The rigid strain penetration rotations moved above the lower rebar connection where the moment was large, and the rebar diameter was smaller (turned rebar). The strain penetration rigid rotations of the RR column were smaller than in the ASB column because the maximum force in the turned rebar segment was smaller than in the anchorages, and the anchorage of the turned segment corresponded to the connection zone with a surface greater than that of the original rebar. For the same total displacement applied on each column, the reduction in the strain penetration displacement in the RR columns probably increased the plastic part of the displacement, and thereby the column dissipation capacity. The reduction in the strain penetration increased the initial tangent stiffness of the column and therefore the reduced stiffness—measured at the end of the test on the ASB column—was improved restoring the ASB stiffness before the test.

After the removal of the concrete cover, the connections and the new rebar were intact without buckling deformation in compression or the local high concentration of steel plastic deformations [36]. The new rebar segments effectively distributed the plastic deformation only in the plastic hinge. The connection and the original rebar also showed no plastic deformation or failure after the application of a strong earthquake  $Tol \times 2$ .
