A structural analysis of the Modena Cathedral / Baraccani, S.; Silvestri, S.; Gaspoarini, G.; Palermo, M.; Trombetti, T.; Silvestri, E.; Lancellotta, R.; Capra, A.. - In: INTERNATIONAL JOURNAL OF ARCHITECTURAL HERITAGE. - ISSN 1558-3066. - 10:2-3(2016), pp. 235-253. [10.1080/15583058.2015.1113344]

# A structural analysis of the Modena Cathedral

## **THE STRUCTURAL ANALYSIS OF THE MODENA CATHEDRAL**

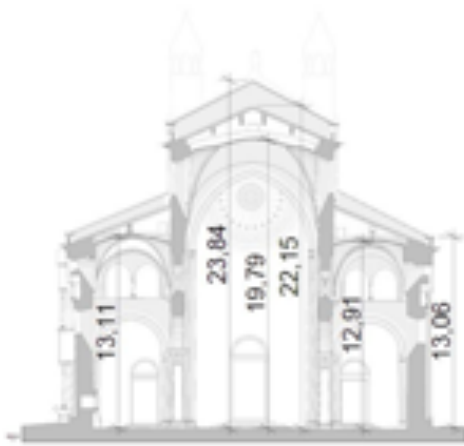
Figure 2. a) A 3D view of the Modena Cathedral (Google Earth); b) Cross-section of the Cathedral of Modena

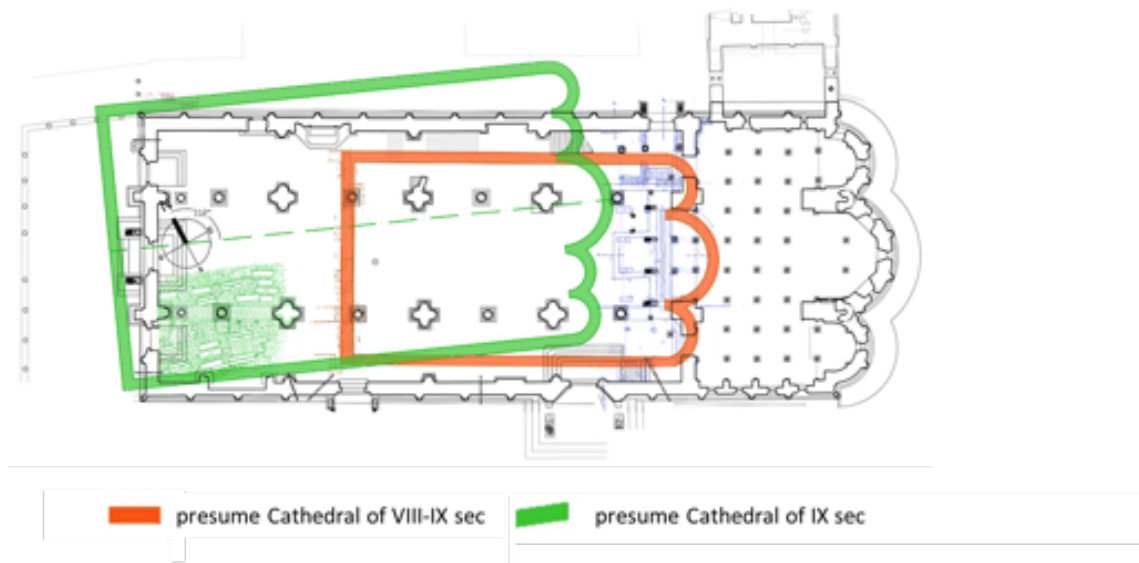
Figure 3. The pre-existing cathedrals

Three cathedrals were built on the necropolis containing the tomb of St. Geminiano (the founder of the church of Modena), before the current one (Labate 2007). The tombstone is the only remaining evidence of the first cathedral. A second cathedral was erected in the same place around the VIII-IX century. The remains indicate that the church had a length of around 32 m and width of 18 m. The presence of polylobate pillars (Bertoni 1914), discovered during past excavations, allow supposing the existence of another cathedral, presumably built around the XI century (Figure 3) (Frankl 1927).

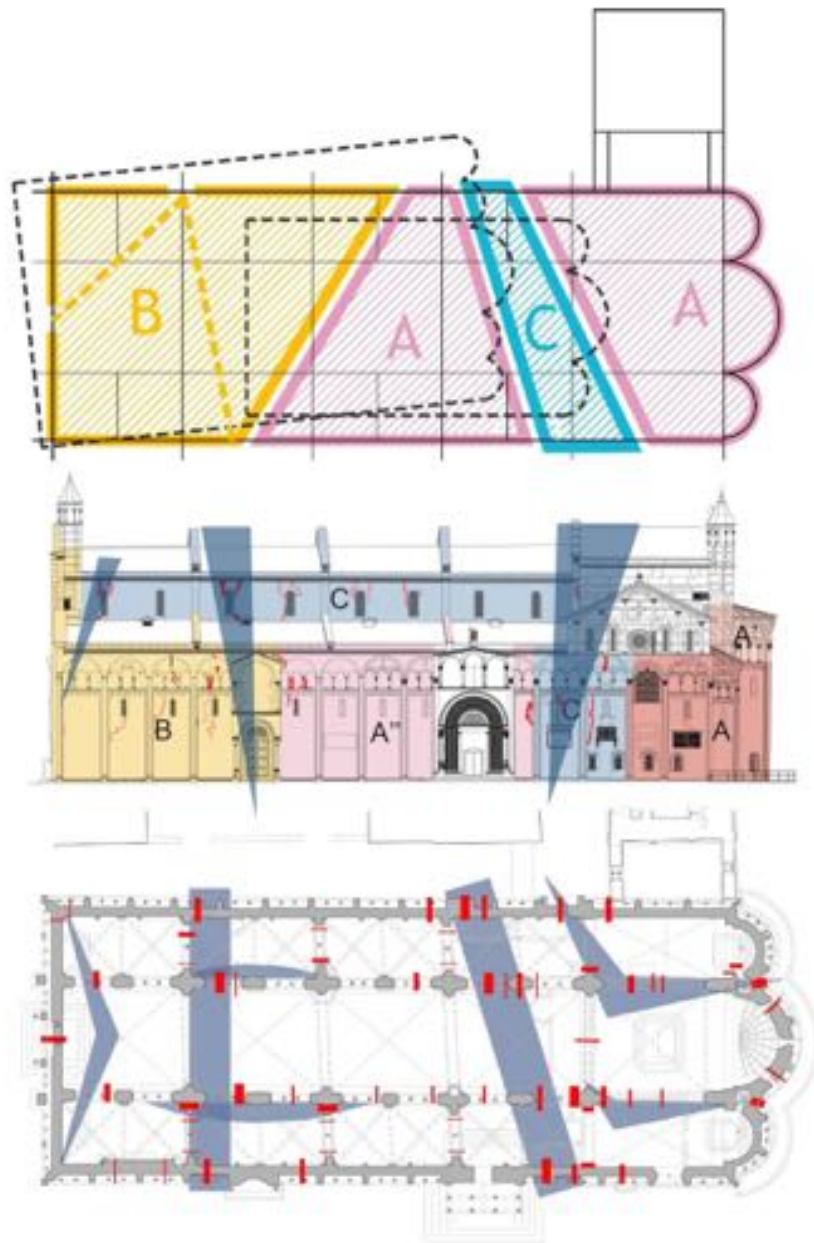
Figure 4. Relationship between the construction phases and the cracking pattern

was interrupted in order to maintained the portions of the pre-existing cathedral (phase C). According to more recent historical studies (Silvestri 2013), the construction did not proceed in parallel from the two sides, namely the main façade and the apsis, but started from the apses to end with the main façade (phases A and B). In light of this alternative hypothesis, the phase C was necessary to repair some damages due to early soil settlements manifested during the first two phases. Figure 4 graphically represent the three construction phases according to the last hypothesis.

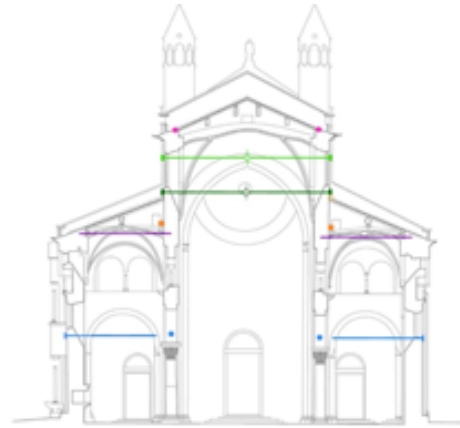
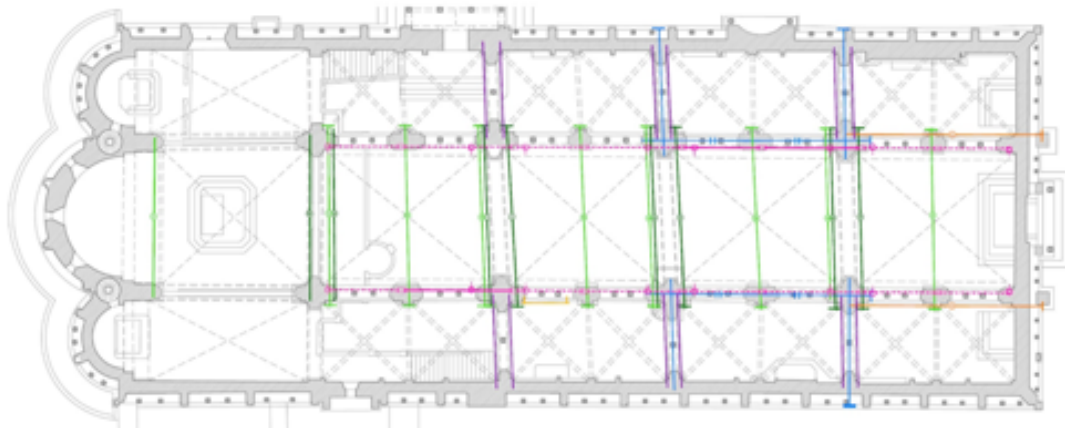
Figure 5. Survey of the tie-rods installed on the Cathedral during the years and respective photographers.

Several interventions after the end of the construction (end of XXII century) were carried out during the years. According to most critics, the roof system, initially made of wooden trusses system arranged in the transversal direction, was rebuilt starting from the 1413. The orientation of the principal beams were changed when the vaults of the naves were constructed. Probably during this phase, the wooden beams have been renewed. This intervention probably caused further deformations of the longitudinal walls. Later, other interventions were necessary to retrofit the Cathedral after the earthquakes occurred in the 1501, 1505 1671 and 1832. The main interventions affected the vaults, the arches, the façade and the portions of walls adjacent to the Ghirlandina tower (Dondi 1896). In the following years, additional strengthening interventions were performed, such as refilling the main cracks, repairing the roof (new wood structures connected to the masonry wall trough tie-rods) and better connecting the walls through iron tie-rods in the naves at different heights (Figure 5).

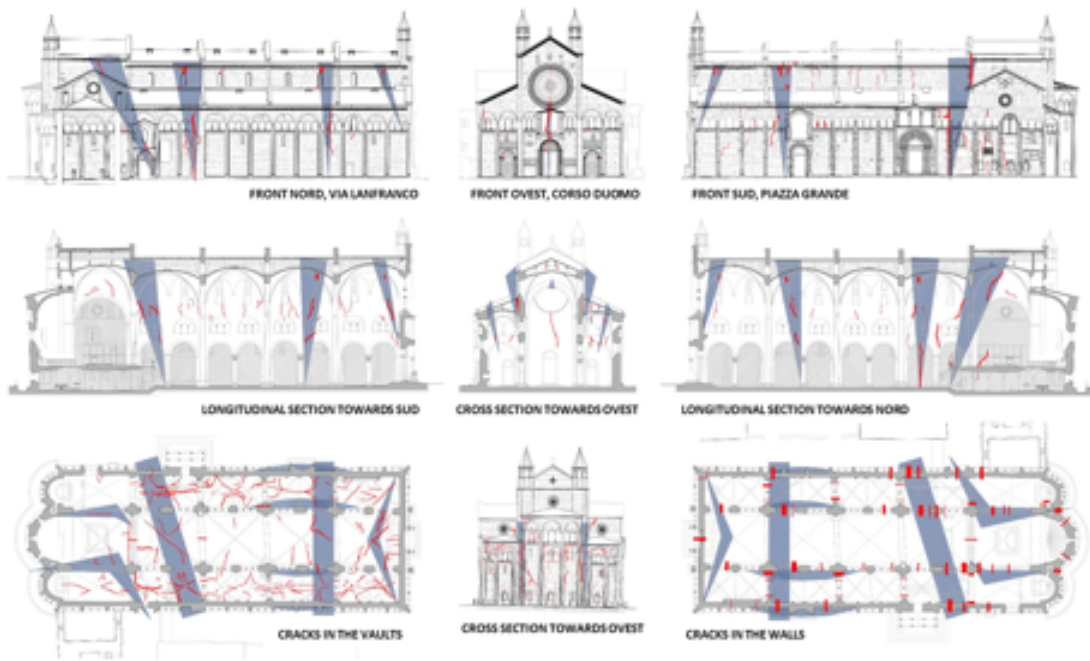
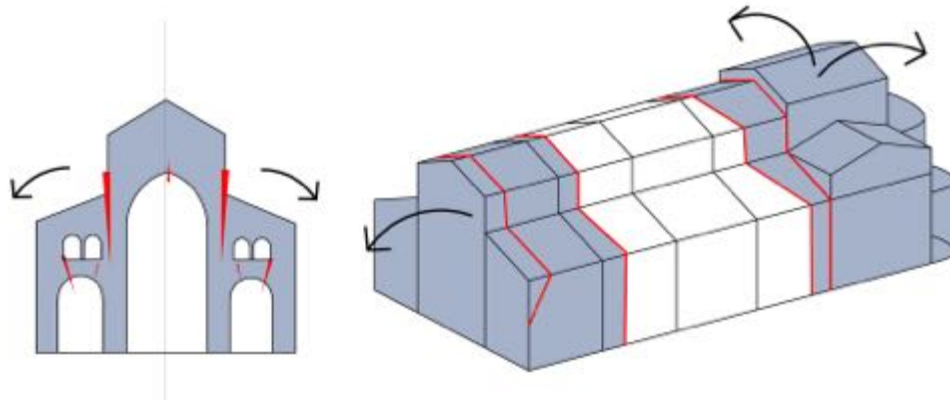
Figure 6. a) Crack pattern of the Cathedral of Modena and b) main failure mechanisms of the Cathedral on the longitudinal and transverse direction

The initial crack pattern (2010) has been identified not only to monitor the state of the main cracks but also to correlate their location within the construction phases and main interventions. The analyses of past studies also helped in the classification of the cracks. In particular, the correlation between the damage and the past interventions allow to identify probable causes and distinguish between stable cracks and still evolutionary situation. The major cracks are displayed in Figure 6. The main cracks are indicated in red, while grey areas indicates concentration of cracks, i.e. portions of potential high vulnerabilities. It can be noted:

- a large vertical crack is located in the main facade, just below the big rose window;
- a concentration of cracks has been identified in the connection between the walls, all along the portion of the building constructed during the phase C, in the fourth span from the west;
- another cracks concentration appears near the main facade, along a line parallel to the façade, in the second span from the west;
- vertical cracks along the main transversal walls and arches separating the central naves from the lateral naves;
- the grey areas are mainly located in the portion of the cathedral coinciding with the location of the old ones.

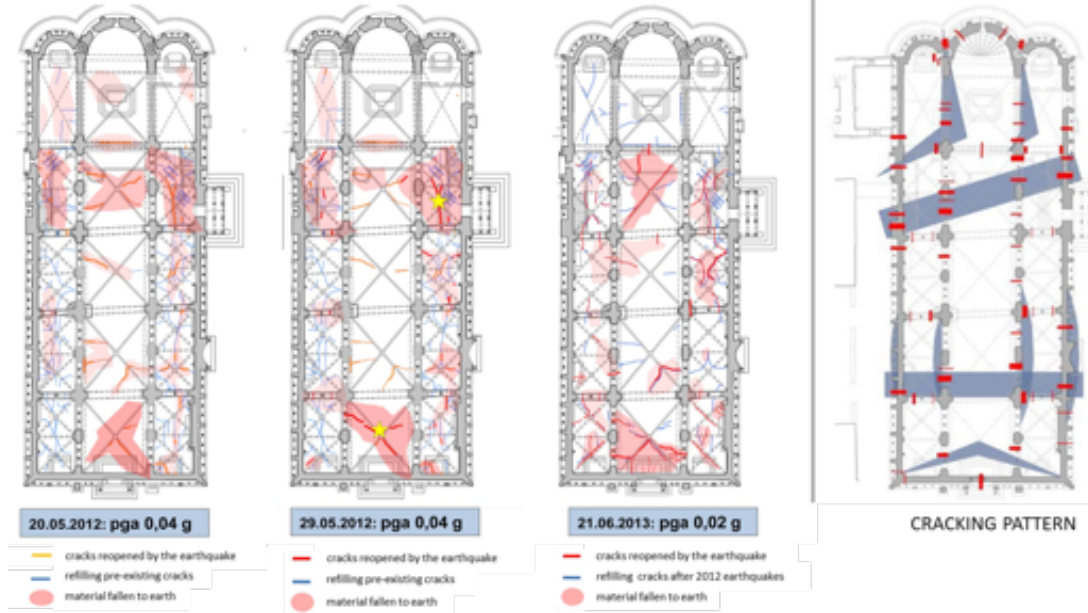
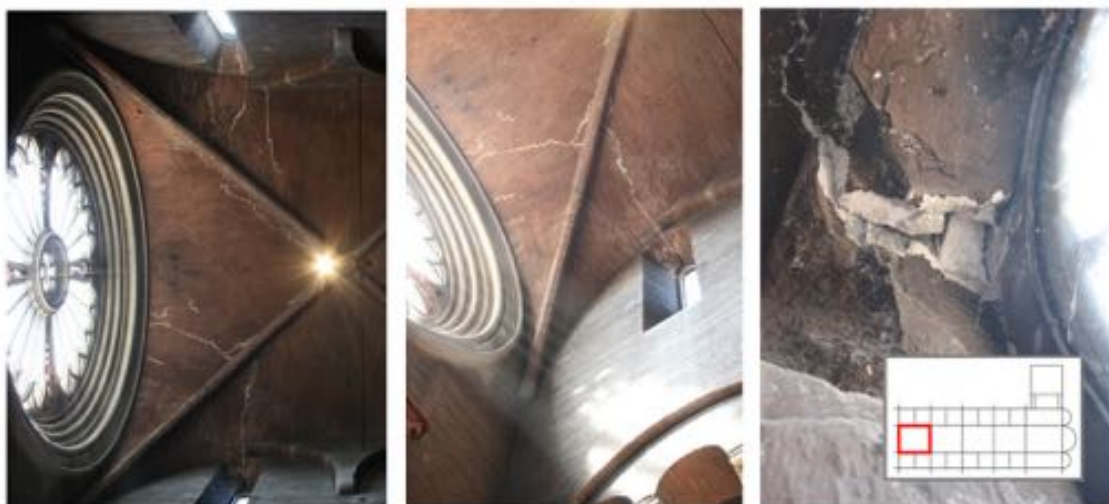
Figure 7. a) Maps of the cracks detected on the vaults after the earthquakes of the 20 and 29 May 2012 and 21 June 2013 and comparison with the crack pattern and b) photographs on the damage caused by recent earthquakes.

During the survey after the 2012 Emilia Earthquake, new cracks appeared in the intrados of the main vaults. Moreover, also an evolution of some existing cracks has been observed (Figure 7).

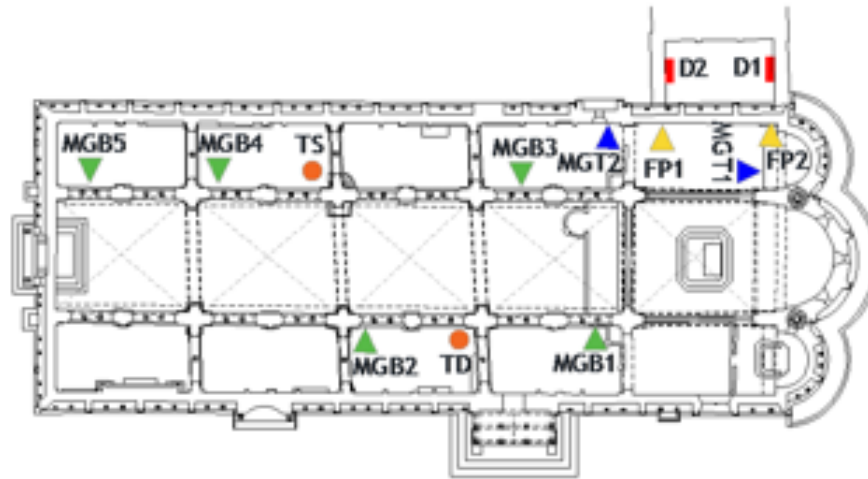
Figure 8. Location of the device installed on the Cathedral

The monitoring system installed in the Cathedral is composed of biaxial and triaxial joint meters (MGB-MGT), inclinometers (FP), deformometers (D) and thermometers (T) to monitor the main cracks across the walls and vaults, the inclination of the external longitudinal walls, the relative displacements between the cathedral and the tower and the internal temperature, respectively (Baraccani et al. 2014). A plan view with the indication of all installed instruments is provided in figure 8. For instance, the record of a biaxial joint meter (MGB1) is displayed in Figure 9a together with the record of the thermometer. A strong correlation of the oscillations with the thermal excursions may be noted. For the sake of conciseness, only the most significant results as obtained from the 10 years of monitoring by the joint meter can be summarized as follows (see also Figure 10):

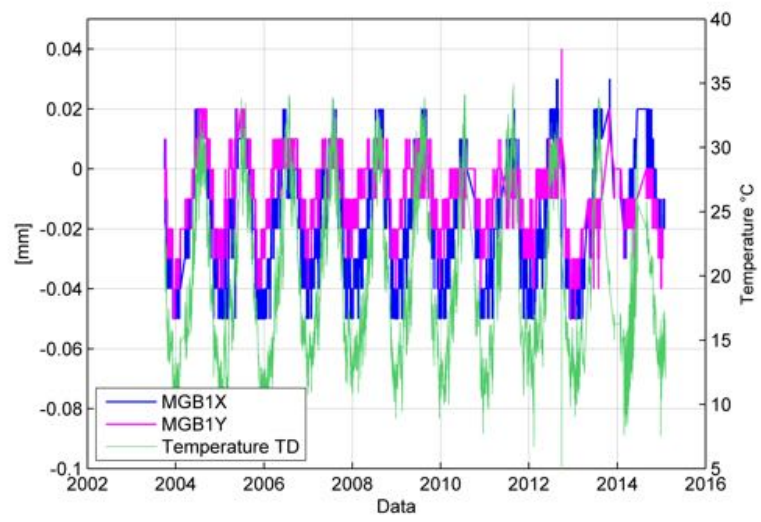
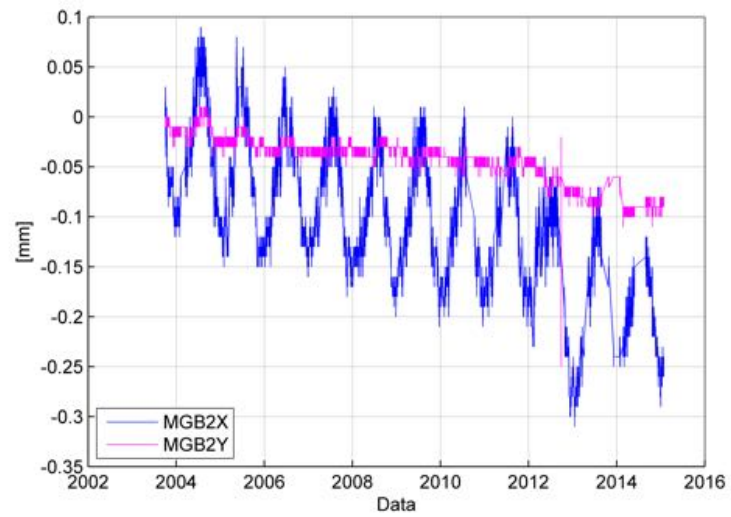
Figure 9. a) Trend recorded by the biaxial joint meter MGB1 and the temperature TD, b) Trend recorded by the biaxial joint meter MGB2

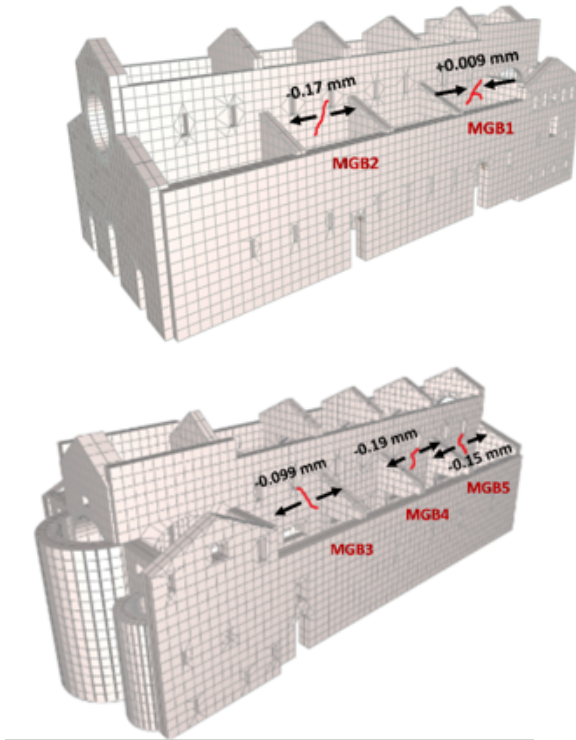
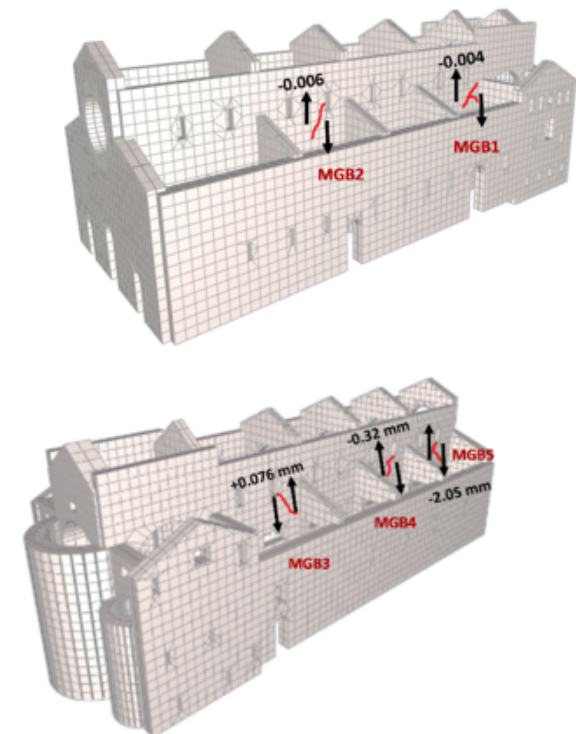
Figure 10- a) Amplitude variations in the X direction of the cracks observed by MGB1-2-3-4-5, b) Movements in the Y direction of the cracks observed by MGB1-2-3-4-5

- the average daily oscillation is around  $1\text{--}7\cdot 10^{-3}$  mm;
- the average annual oscillation is around  $1\text{--}40\cdot 10^{-2}$  mm;
- in general a quite stationary response is observed, with the exception of few instruments (such as MGB2, see Figure 9b), which show a slightly increasing trend (average annual rate around  $10^{-2}$  mm/year).

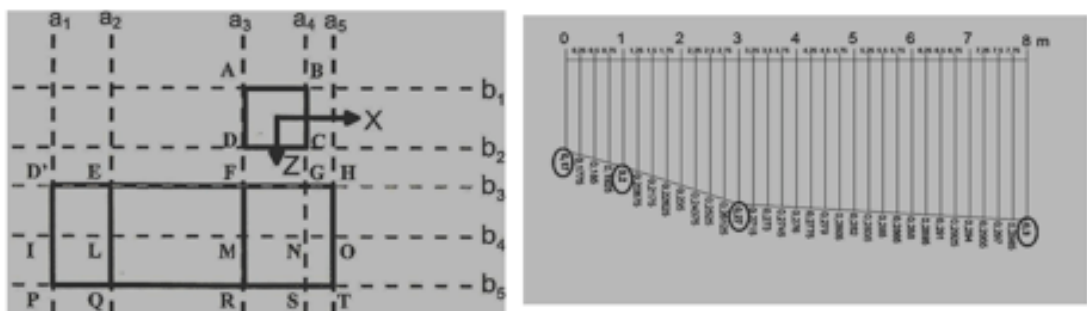
Figure 11. Imposed vertical differential displacements at the base due to the interaction between the Cathedral and the Ghirlandina Tower

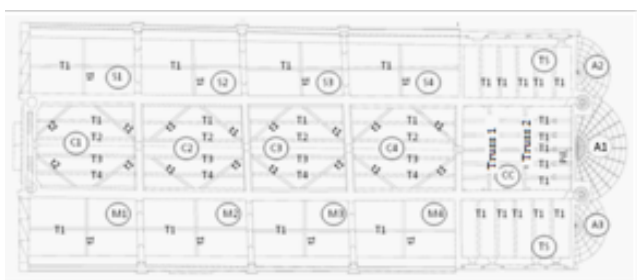
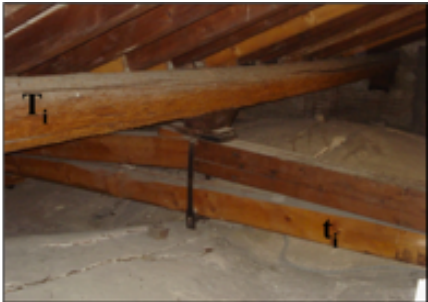
Figure 12. a) Structural roof elements and b) Main beams ( $T_i$ ) and trusses system ( $t_i$ )

The actual roof geometrical configuration is made of principal beams arranged in the longitudinal direction, which rest on secondary beams or transversal trusses systems (indicated as  $T_i$  and  $t_i$  respectively, in Figure 12).

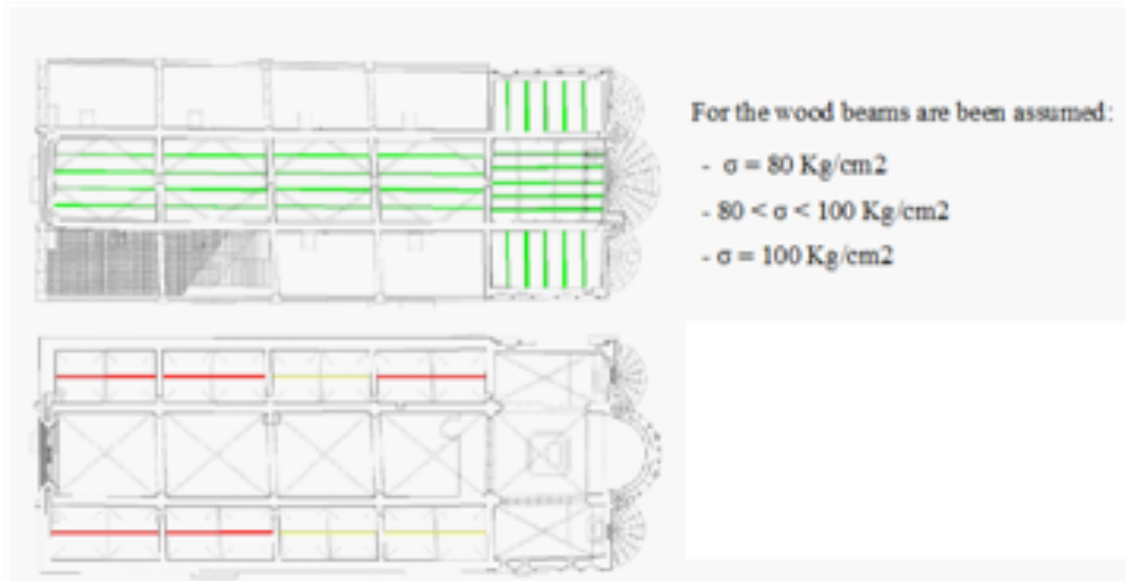
Figure 13. Stress level of the roof elements

Maximum normal stresses for the main beams due to self-weight only are around: 50 kg/cm<sup>2</sup> for the central nave, 80 kg/cm<sup>2</sup> for the area of transept, 100 kg/cm<sup>2</sup> for the aisles. The addition of the snow load lead to an increase in the maximum stresses of about 35% leading to maximum stresses close to material strengths. In detail, Figure 13 shows the stress levels (in a colour scale) of the roof beams. The stress levels in the secondary elements (trusses) are of the order of 10-15 kg/cm<sup>2</sup>, well below material strengths. It is worth to note that, due to the absence of specific tests performed on the wood elements, the assumed strength is conservative.

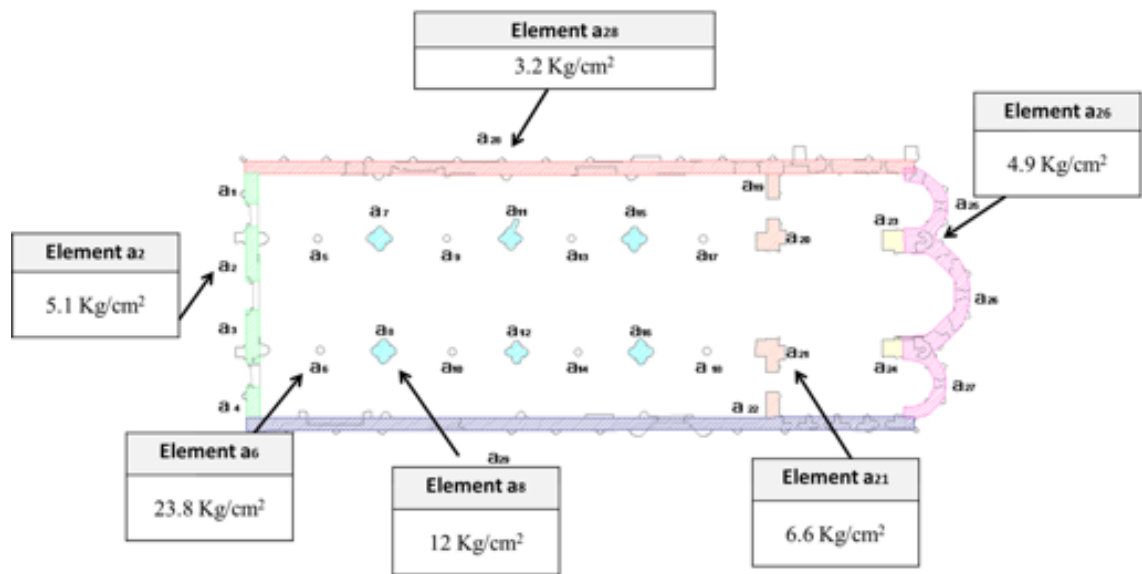
Figure 14. Reference values of the stress level at the base of the principal structural elements.

First, the results of the simple hand-made schematizations in terms of stress levels at the base (Figure 14) are compared with those of the ideal perfectly vertical FE models (Figure 15). Then the influence of the actual geometrical configuration is accounted for.

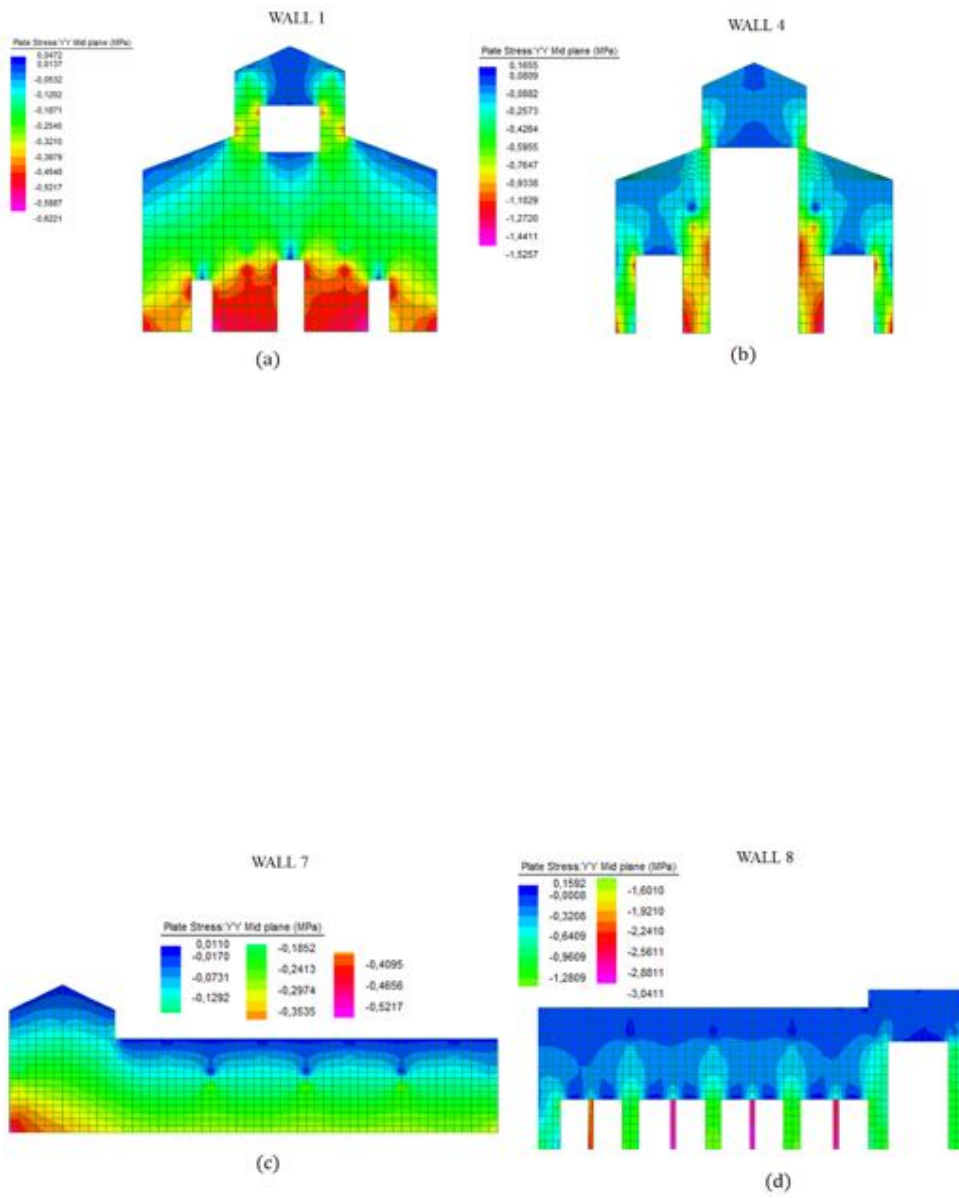
Figure 15. Contour maps of the normal stresses at the base of some walls obtained with two-dimensional FE models: (a) Wall 1; (b) Wall 4; (c) Wall 7; (d) Wall 8;

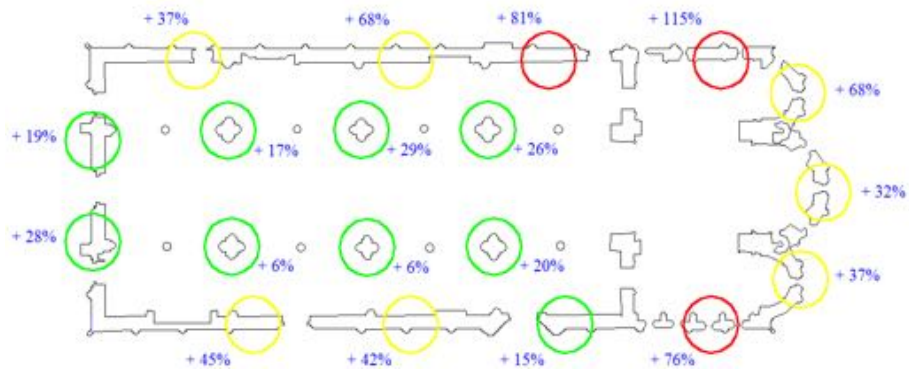
Figure 16. Increments of the stress at the base of the walls due to the inclination of the vertical elements.

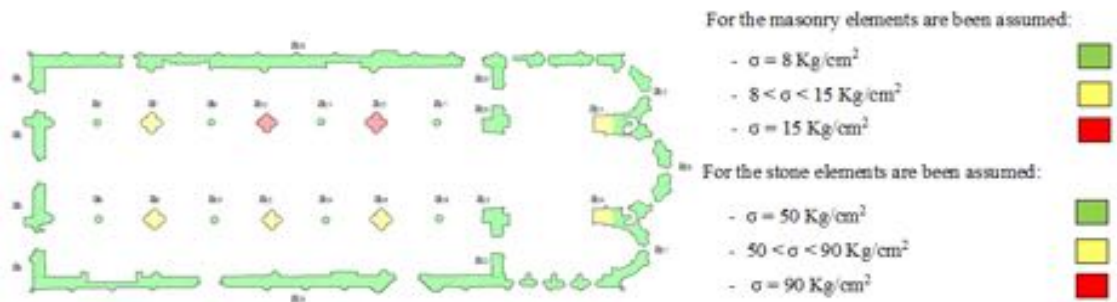
Figure 17. Level of stress at the base of the vertical elements including the effects of the inclinations.

To account for the walls overhanging, in a simplified way, the thrusts transmitted by the internal arches have been calculated and applied at the top of the walls to estimate the increase in the normal stresses. Figure 16 provides a schematic plan indicating the percentage increment of the normal stresses at the base of the walls and pillars due to their inclination. The green color represents increments below 30%; the yellow color increments between 30% and 70%, while the red color represents increments larger than 70%. The ranges of the normal stresses at the base of the walls and pillars by also including the effect of walls inclinations are provided in the plan schematization displayed in Figure 17. Maximum stresses are around 15 kg/cm<sup>2</sup> for the masonry walls and 90 kg/cm<sup>2</sup> for the stone pillars. All values are well below material strenghts.

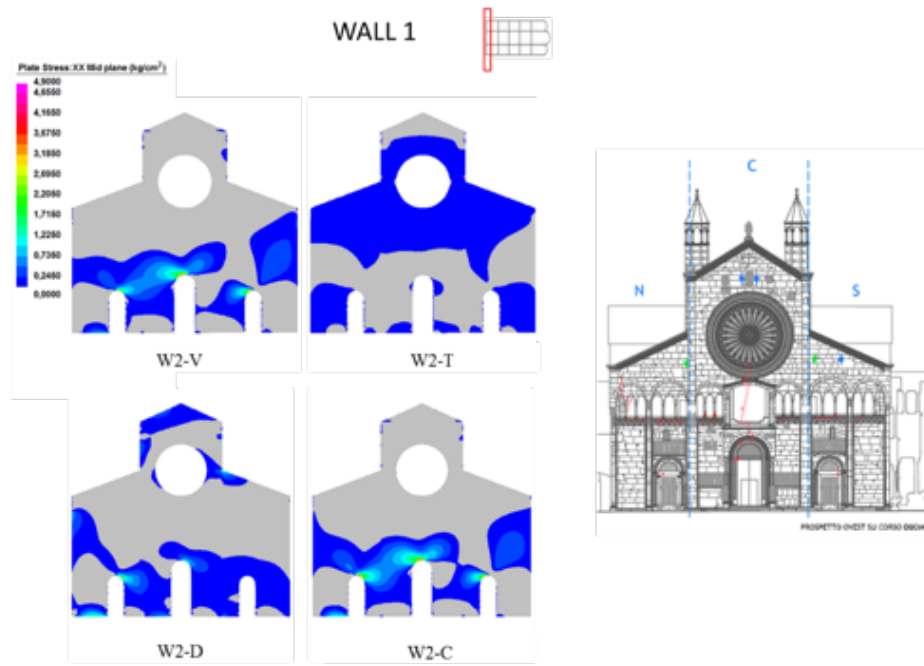
Figure 20. Stress of the wall 1 obtained from the W2 model with the different load cases and compared with the observed cracking patterns.

The stress state for a specific longitudinal wall and transversal wall as obtained from the UD-C and the W2 restrain considering all the single load cases is summarized in Figures 19 and 20. It can be noted that the locations of the peaks of the tensile stresses are in good agreement with the location of the main cracks.

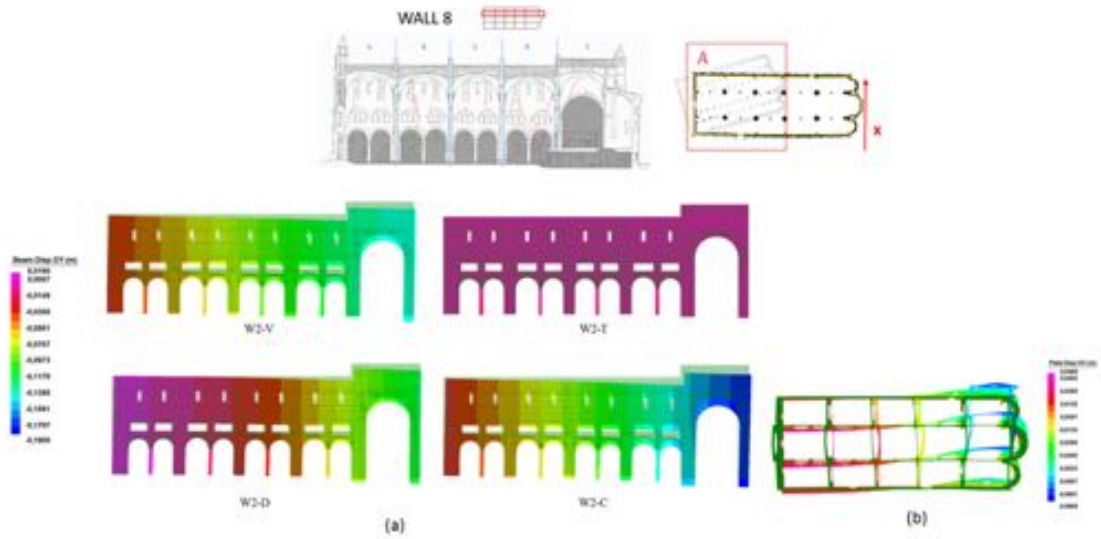
Figure 21. (a) in-plane deformed shape for the wall 8; (b) out-of-plane deformed shape (x direction) for all walls.

The in plane and out-of-plane deformed shapes for a specific longitudinal wall are represented in Figure 21 and compared with the results of the 3D laser scanning. The deformed shapes are consistent with the 3D laser scanning indicating that: (i) the presence of the ancient ruins of the pre-existing churches reduces the deformations within the zone A (as indicated in figure 21(a)); (ii) the interaction between the Cathedral and the Ghirlandina Tower causes significant out of plane displacements (Figure 21(b)) of the longitudinal walls, especially for those walls closer to the tower. These out-of-plane- displacements are quite larger than those caused by the arches thrust.
