A structural analysis of the Modena Cathedral / Baraccani, S.; Silvestri, S.; Gaspoarini, G.; Palermo, M.; Trombetti, T.; Silvestri, E.; Lancellotta, R.; Capra, A.. - In: INTERNATIONAL JOURNAL OF ARCHITECTURAL HERITAGE. - ISSN 1558-3066. - 10:2-3(2016), pp. 235-253. [10.1080/15583058.2015.1113344]

A structural analysis of the Modena Cathedral

THE STRUCTURAL ANALYSIS OF THE MODENA CATHEDRAL

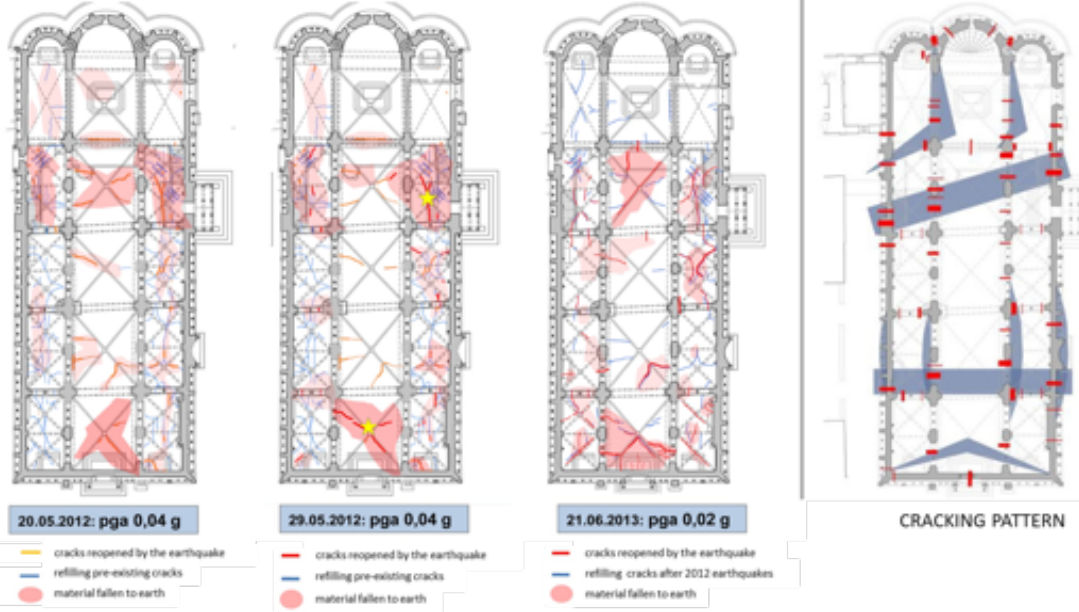
Figure 7. a) Maps of the cracks detected on the vaults after the earthquakes of the 20 and 29 May 2012 and 21 June 2013 and comparison with the crack pattern and b) photographs on the damage caused by recent earthquakes.

During the survey after the 2012 Emilia Earthquake, new cracks appeared in the intrados of the main vaults. Moreover, also an evolution of some existing cracks has been observed (Figure 7).

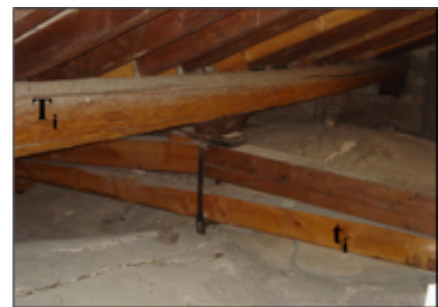
Figure 12. a) Structural roof elements and b) Main beams (T_i) and trusses system (t_i)

The actual roof geometrical configuration is made of principal beams arranged in the longitudinal direction, which rest on secondary beams or transversal trusses systems (indicated as T_i and t_i respectively, in Figure 12).

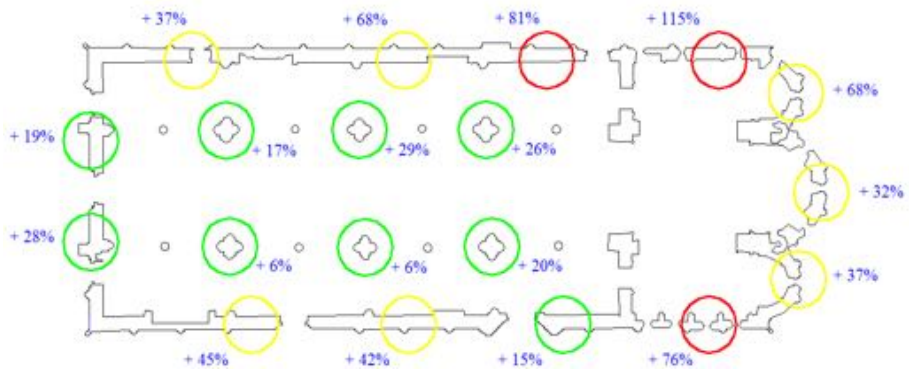
Figure 16. Increments of the stress at the base of the walls due to the inclination of the vertical elements.

To account for the walls overhanging, in a simplified way, the thrusts transmitted by the internal arches have been calculated and applied at the top of the walls to estimate the increase in the normal stresses. Figure 16 provides a schematic plan indicating the percentage increment of the normal stresses at the base of the walls and pillars due to their inclination. The green color represents increments below 30%; the yellow color increments between 30% and 70%, while the red color represents increments larger than 70%. The ranges of the normal stresses at the base of the walls and pillars by also including the effect of walls inclinations are provided in the plan schematization displayed in Figure 17. Maximum stresses are around 15 kg/cm² for the masonry walls and 90 kg/cm² for the stone pillars. All values are well below material strenghts.
