Supporting Information for:

Distribution Depth of Stone Consolidants Applied On-Site: Analytical Modelling with Field and Lab Cross-Validation

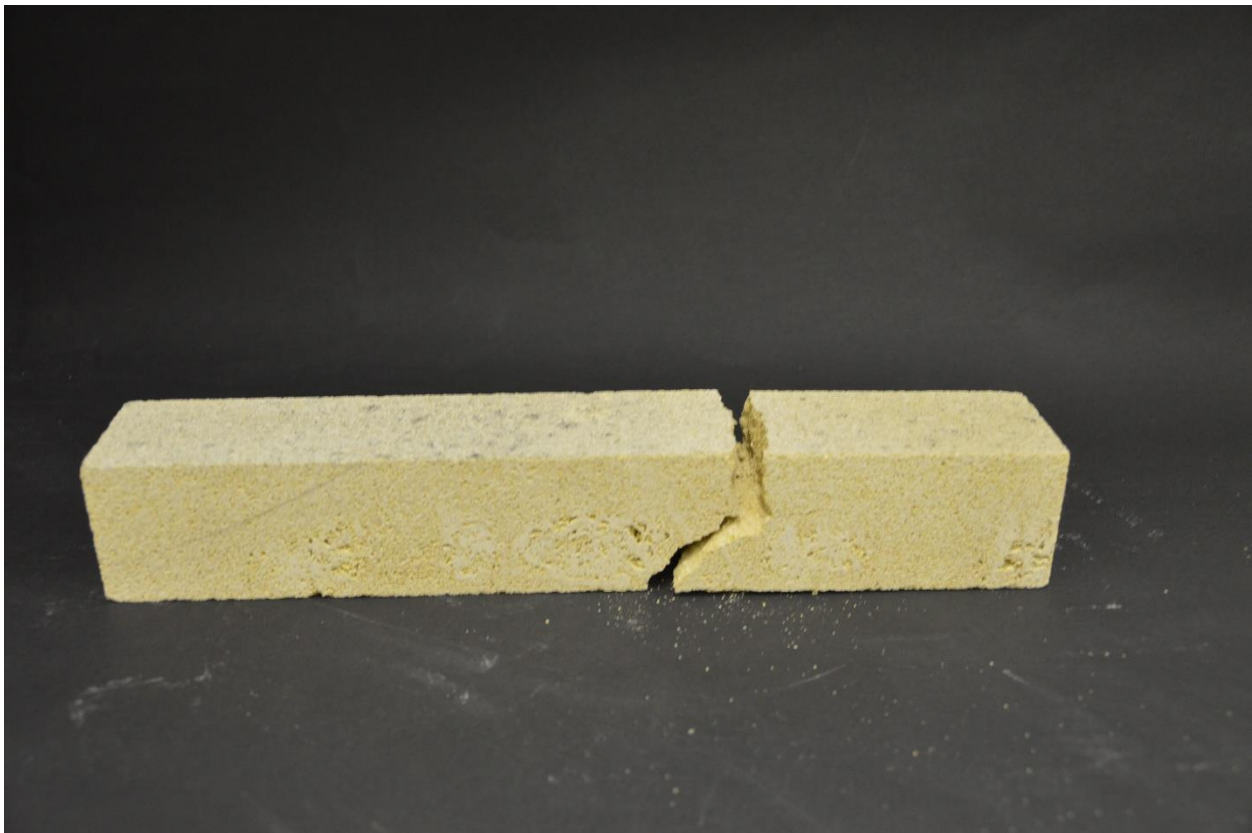
Figure S2. *St. Margarethen* after 56 cycles. Complete failure of the sample.

Sample	Apparent Vol. V_{b0} [ml] before and after 168 cycles	Note
SM1	730 to 725	
SM2	744 to 739	
SM3	732 to 723	
SM4	---	Specimens with major cracks and/or broken (e.g. Fig. S2)
SM5	---	
SM6	---

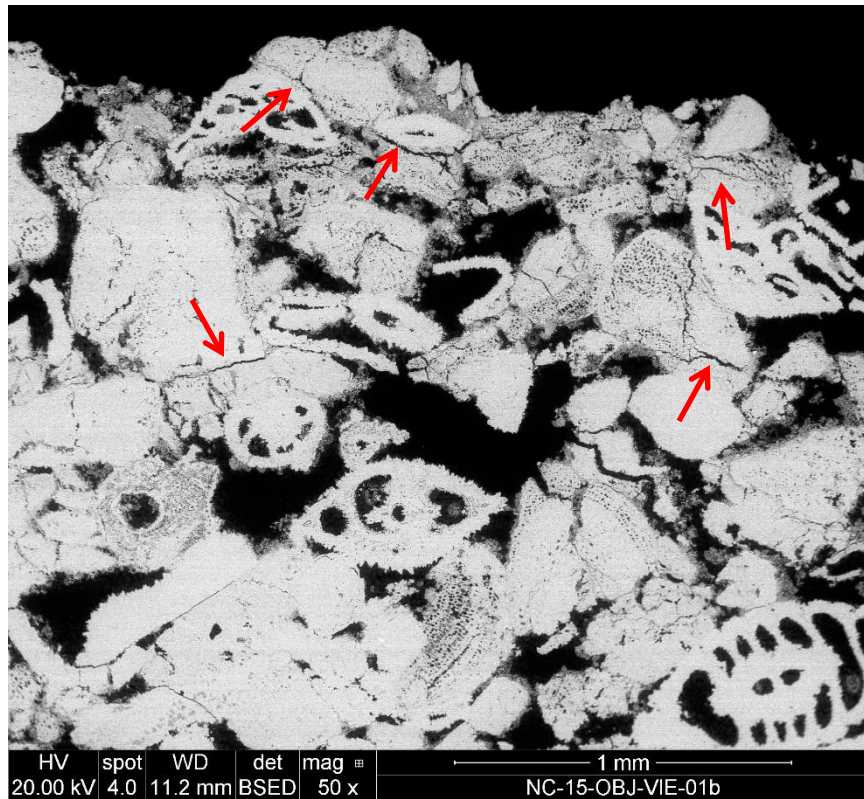
Figure S4. SEM-BSE, overview of the surface and subsurface zone exhibiting cracks parallel to the surface and between the fragments.

The predominate methods for checking the efficacy of the artificial ageing was ultrasonic pulse velocity (apparatus Labek, oscillation frequency 40 kHz) and water absorption coefficient after one hour. One concrete, reproducible result that could be attained quickly with thermal aging was a reduction in ultrasound pulse velocity and an increase of water absorption capillarity, both of which correspond to a reduction in a stone sample's soundness by formation of new micro cracks and the opening of existing cracks (see **Table S10** and **Figure S12**). A general finding of this pre-screening was that heating the stone is by far the most time efficient way to deteriorate and to reach a reduction of soundness reflective of the degradation processes observed in-situ (compare **Figure S4** to **Figure S8** with **Figure S13**), that is, the formation of micro cracks.

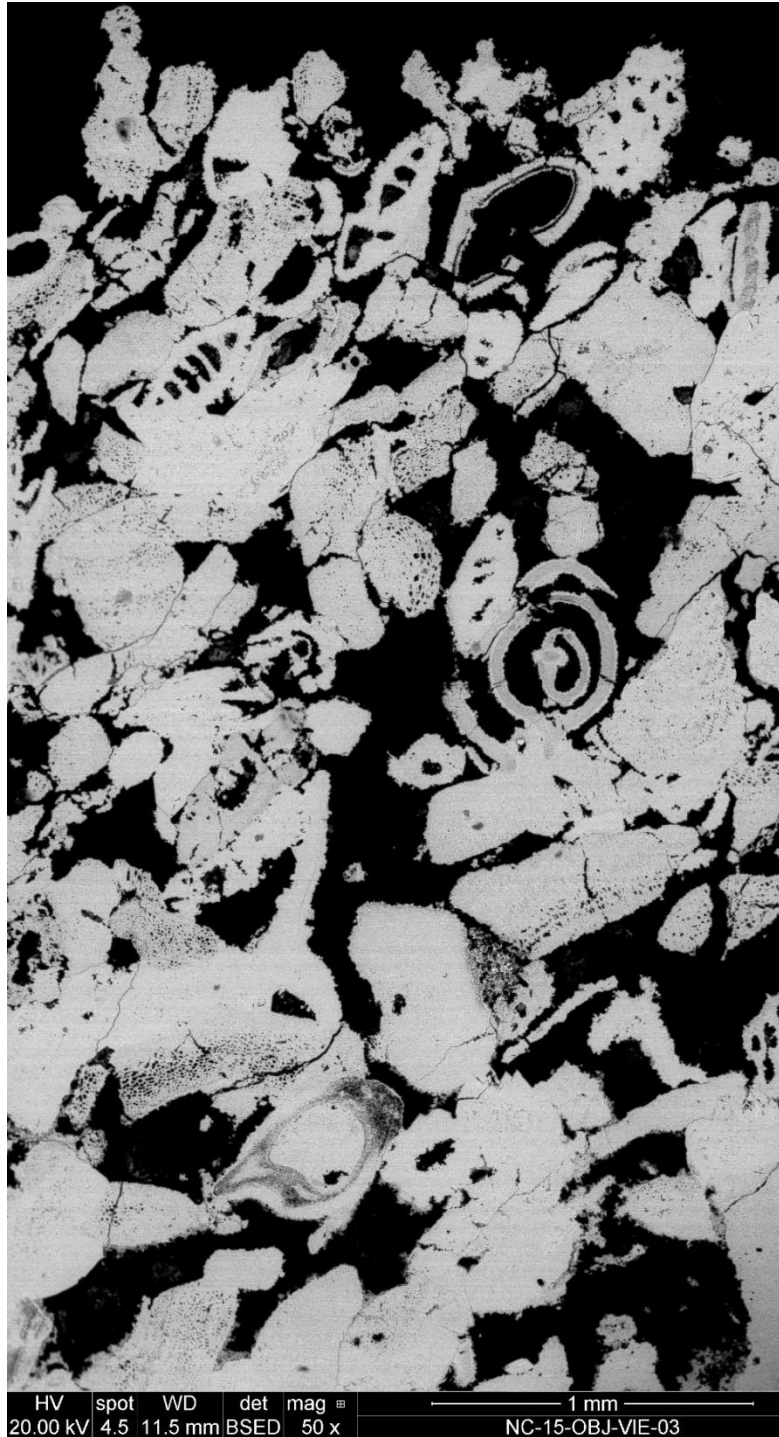
Figure S6. SEM-BSE, stitched micrograph, overview of dissolution effects (upper part of the sample), granular disintegration with inter- and intragranular micro cracks and the porous microstructure.

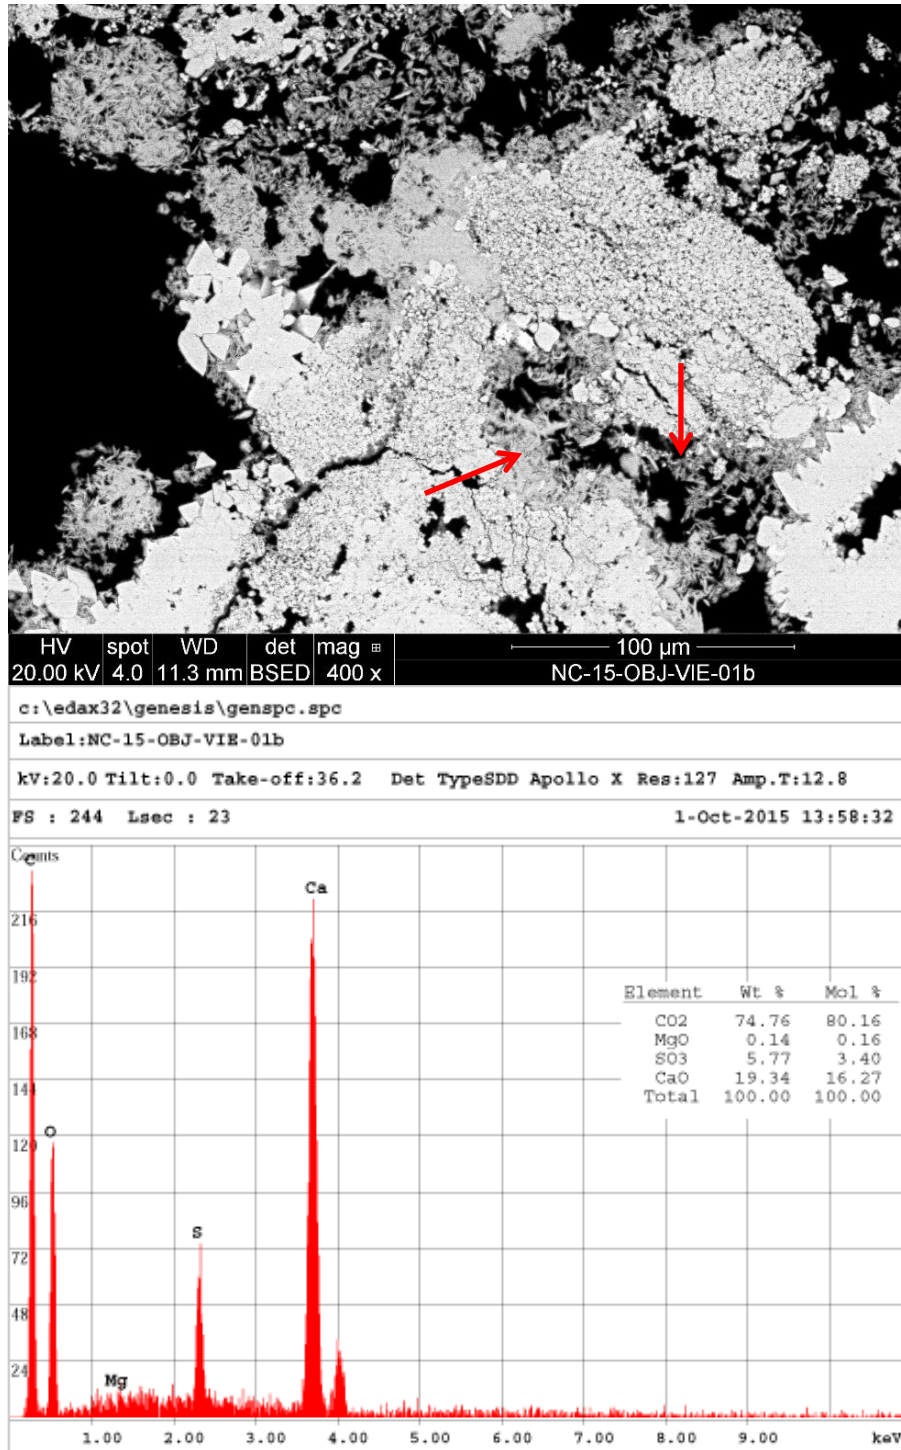
Figure S7. Upper figure: SEM-BSE, details of cracks and presence of gypsum (arrow-indicated). Lower graph: SEM-EDX analysis of the gypsum.

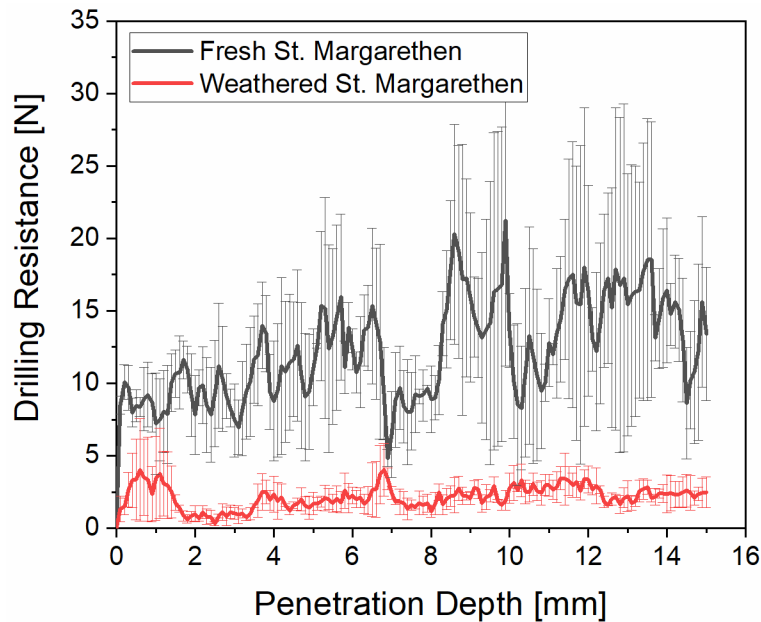
Figure S9. Drilling resistance measurement of weathered and fresh quarried *St. Margarethen*. The curve represents an average of three drilling holes for each condition. The weathered surfaces belong to the studied on-site areas where the consolidants were applied.

The predominant decay phenomenon is the calcite to gypsum transformation in varying depths and densities as well as the creation of black crusts on the surfaces of the studied lithotype. Secondary decay patterns observed on-site include granular disintegration and erosion. The consolidation focused on the former to restore the lost cohesion between the grains. Granular disintegration caused a weakened stone substrate and in severe cases, overlapping with additional decay patterns, a scaling and delamination. The granular disintegration was observed in form of micro cracks and a loss of the microsparitic calcite binder by means of microscopic techniques (see **Figures S4** to **Figure S8**). Furthermore, it was confirmed by means of drilling resistance measurements that the substrates soundness and mechanical strength were reduced (see **Figure S9**).

These water absorption tests are commonly used to assess the condition of architectural surfaces [6]. The results reveal how inhomogeneous the substrate is, even when it seems homogeneous by visual inspection. Moreover, the wide spread of values in the initial stage of adsorption (i.e., Contact Sponge) as well as after one hour (i.e., Karsten Tube and Mirowski Pipe) indicates that an averaging is not possible. Furthermore, not only the surface but also the profile of degradation exhibits a substrate which condition is in need of a consolidation treatment (see **Figure S9**).

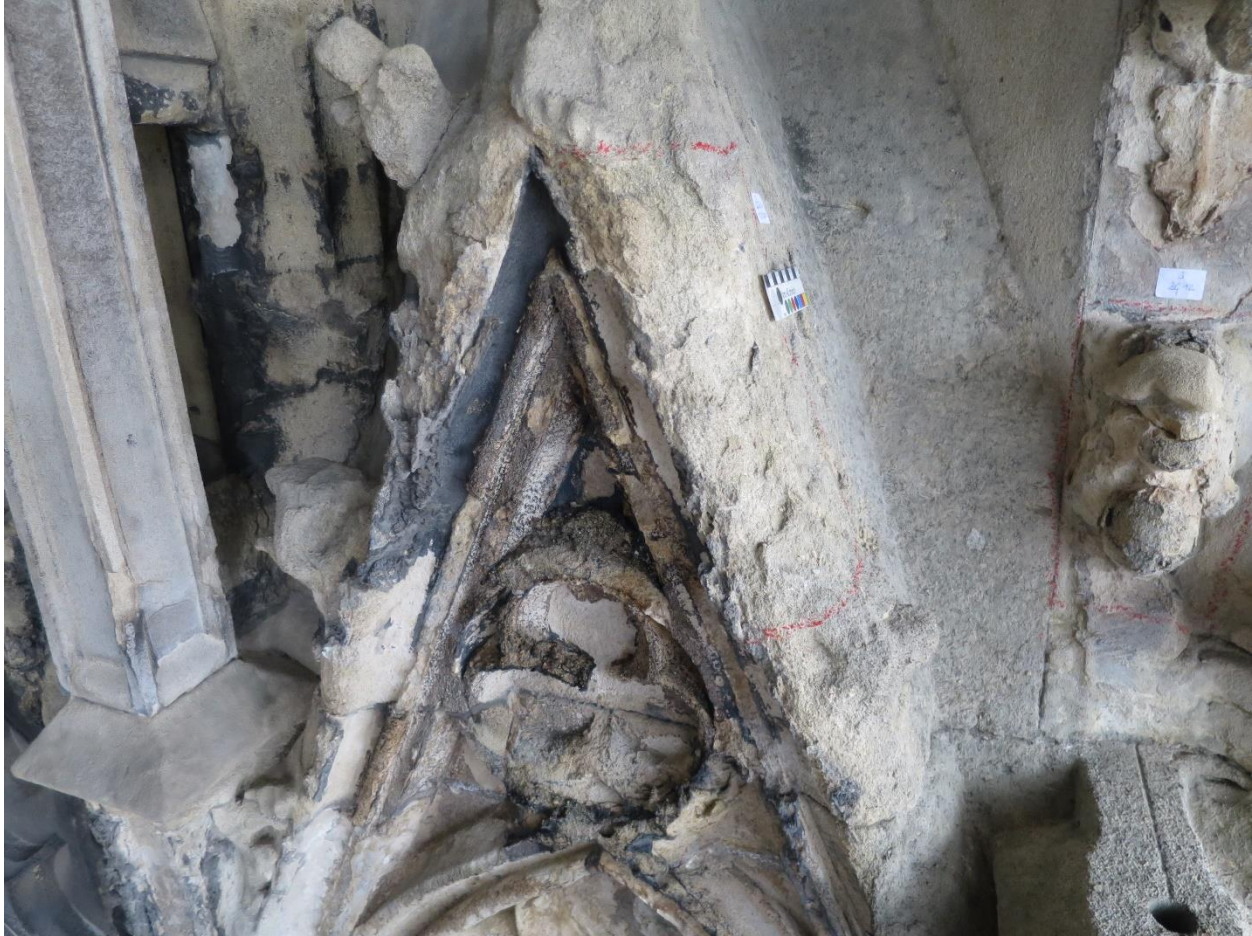
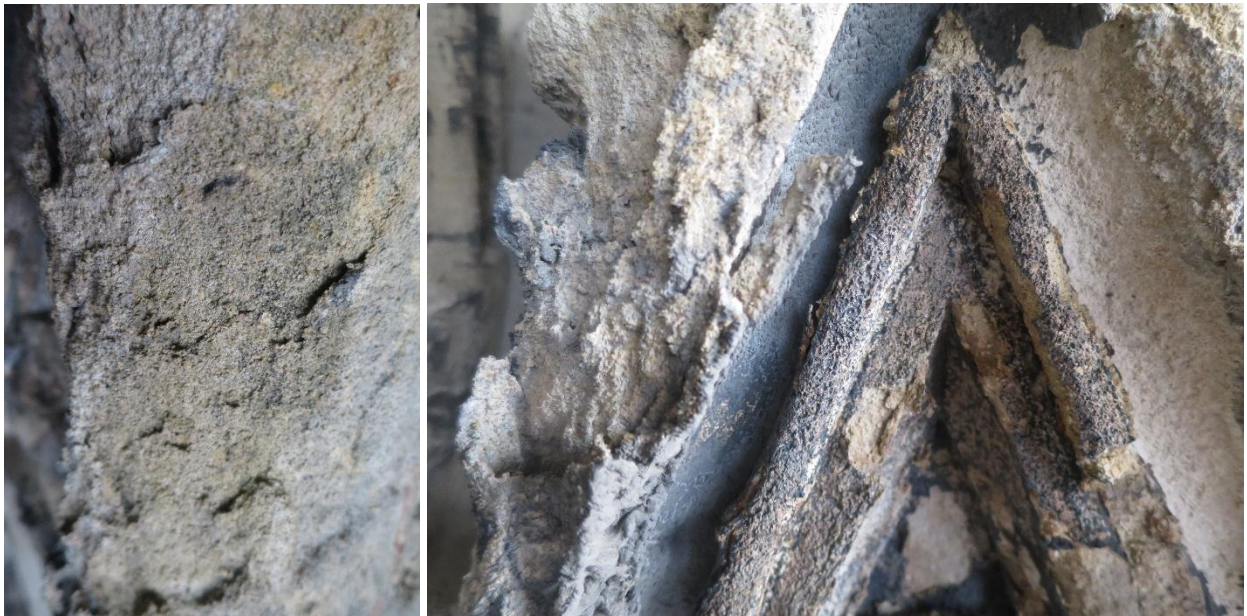
Figure S10. Intermediate restoration state, during the cleaning procedure and before treatment application. The rain exposed surfaces marked in red (top figure) have been used for consolidation purposes in the frame of this work. Bottom figures exhibit the differences in densities and decay patterns.

One of the main disadvantages of the studied on-site area was its variable morphology and thus varying porosity, as can be observed in **Table S9**, **Figures S10** and **Figure S11**.

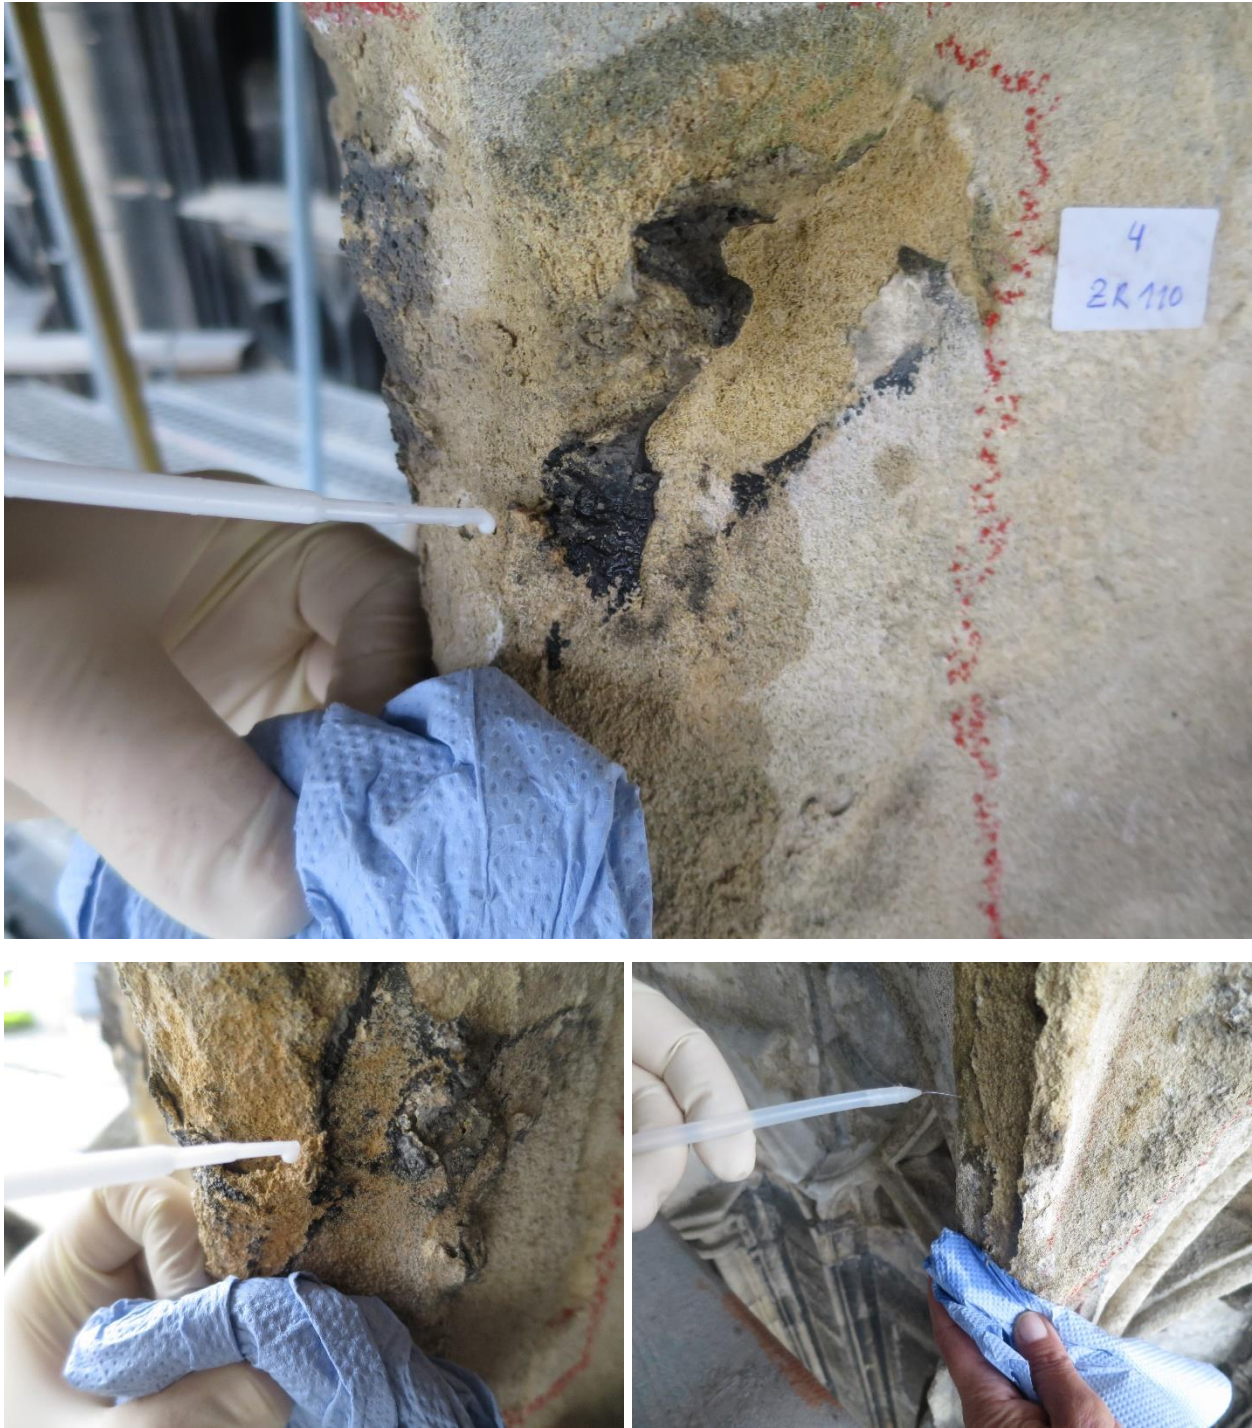
Figure S11. Intermediate restoration state, during the cleaning procedure and treatment application. The consolidants were applied by means of run-off methods with varying utensils.

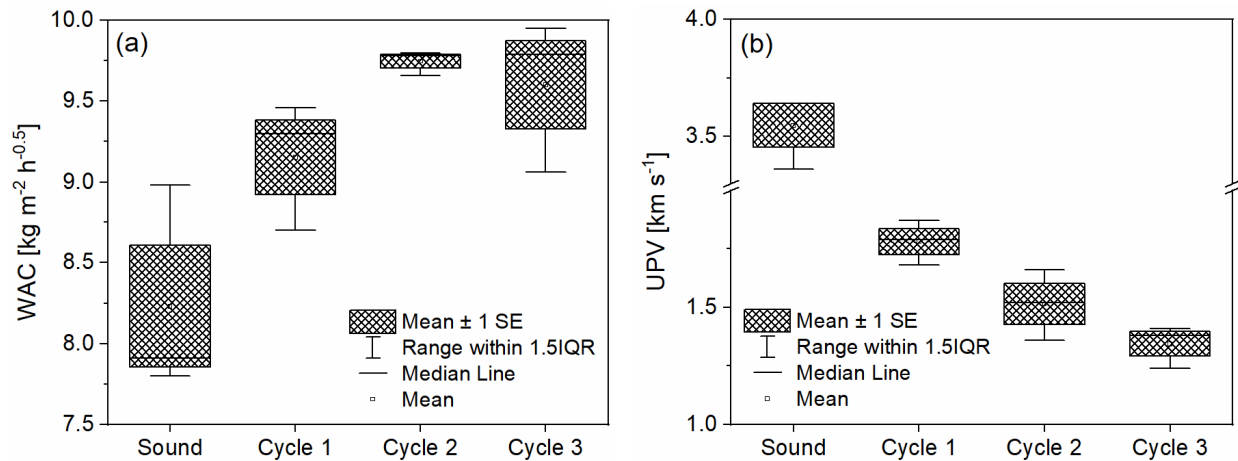
Figure S12. (a) Increase of water absorption coefficient [kg/(m²h^{0.5})] and (b) decrease of ultrasound pulse velocity (km/s) after each cycle of heat treatment at 600 °C. An average of three specimens, 5 x 5 x 5 cm in size, is reported.
