Plasters and mortars from the theatre in Nea Paphos (Cyprus): A multidisciplinary study

Paola Pizzo^{a,b,*}, Jan Válek^a, Petr Kozlovce^a, Dita Frankeová^a, Alberto Viani^a

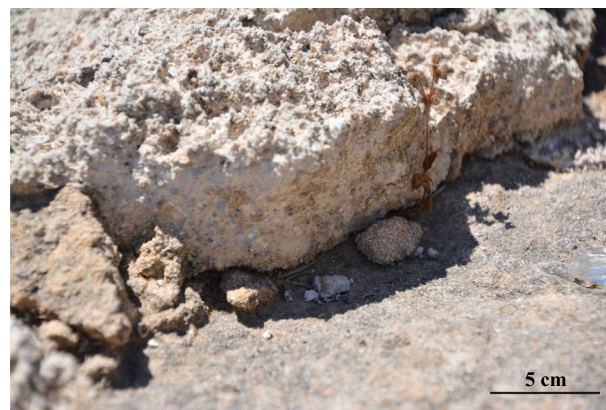
Fig. 2. Sample NPT 8, in situ before the collection, on the crest of the wall of the vomitorium. On the top part it is possible to observe traces of weathering and recrystallization.

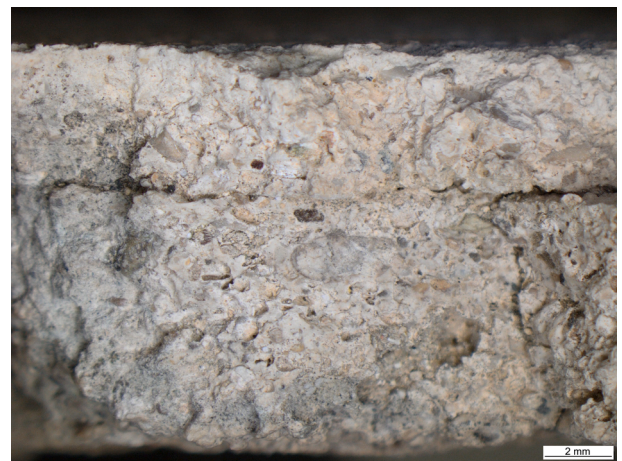
Fig. 13. Stereomicrograph of sample NPT 7b section. Finishing layer is on top.

a production model consisting of a double-layered system (Figs. 13 and 15) of lime plasters with a well-smoothed, polished, and occasionally painted surface (Fig. 14). The first layer, in direct contact with the stone blocks of the seats, consists of a coarser mortar mixture of lime and well sorted river sand. The presence of radiolarian chert and magmatic rocks – including olivine, serpentine and basalt – allowed us to identify the source of this sand in the hydrogeological basin of the Diarhizos river, which collects magmatic rocks and minerals from the Circum Troodos catch. The second, thinner, layer, also defined as “finishing layer”, consists of a much finer mixture of lime binder and shells’ fragments. Through the observation of the thin sections it was possible to deduce that the first layer was levelled and partially dried before the application of the finishing one (Fig. 15).
