The Garisenda Tower in Bologna: Effects of degradation of selenite basement on its static behaviour.

ABSTRACT: The Garisenda tower in Bologna, a 48 m tall structure with a square base of 7.45 meters per side, is characterized by an overall out of plumb of 3.32 m in the South-East direction. Its construction dates back to the XI century and, due to its impressive leaning, in 1350–1353 the original height of 60 m was reduced to the 48 m of the present day (Cavani 1903; Giordano 2000). The tower can be seen as partitioned in a lower portion, with walls composed by two external leaves of selenite stones filled with rubble conglomerate, and an upper portion where the external leaves are made of masonry bricks. Recent investigations have proved that selenite blocks of the basement have been altered as a result of (a) exposition to high temperatures during important fires, that took place at the end of XIV and XVII centuries, and possibly because of the presence of forges (that were demolished at the end of the XIX centuries) and (b) high level of humidity in the inner lower part of the tower. This process has produced a gradual local disintegration of the selenite stones, leading in som

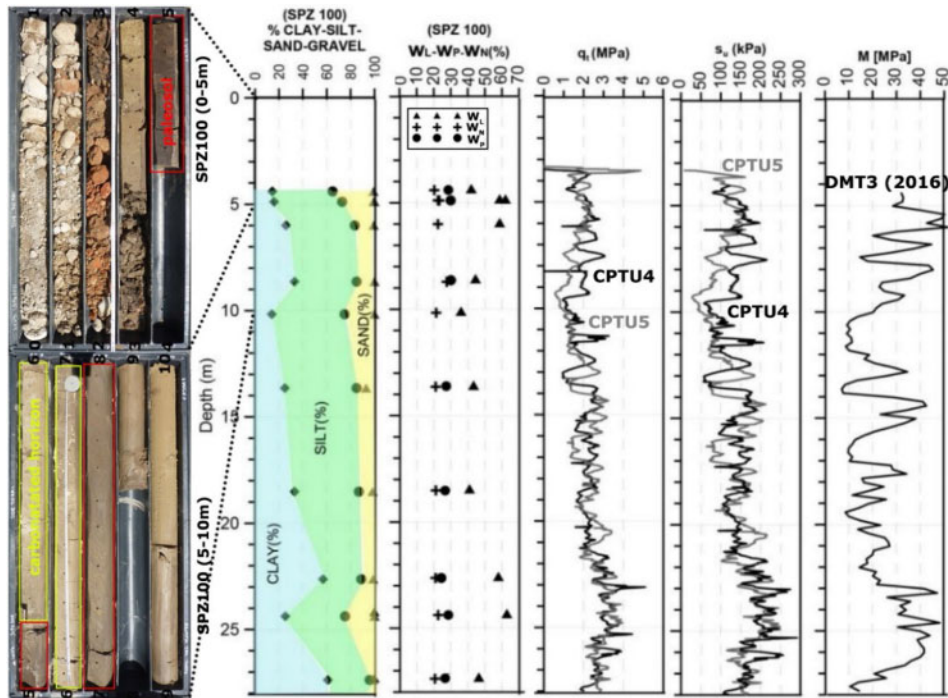
Despite the lithological uniformity of the deposits (e.g. grain size distributions and Atterberg limits in Figure 3), their mechanical properties appear heterogeneous both laterally and vertically. As an example, Figure 3 shows the scatter of the undrained strength (s_u) profiles, deduced from CPTU tests carried out in proximity of the north-east corner of the Garisenda tower.

Figure 3. From the left: photo of soil samples extracted from the continuous coring borehole SPZ100 (2016 campaign); soil profile of the investigated site, showing the grain size distribution, Atterberg limits, cone tip resistance (q_t) and shear strength (s_u) as deduced from the CPTU 4 and CPTU 5 (2016) profiles and the constrained modulus as deduced from the dilatometer test DMT3 (modified from Marchi et al. 2019).

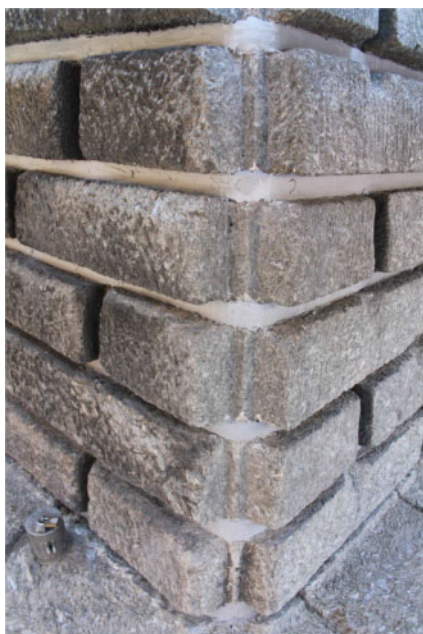
Figure 6. FRCM belting (A).

(a) passive confinement of the tower base obtained through FRCM belting along horizontal joints of stonework, with the voids between the “bugnato” and the selenite leaves filled using ad hoc elements that can be easily removed in the future;

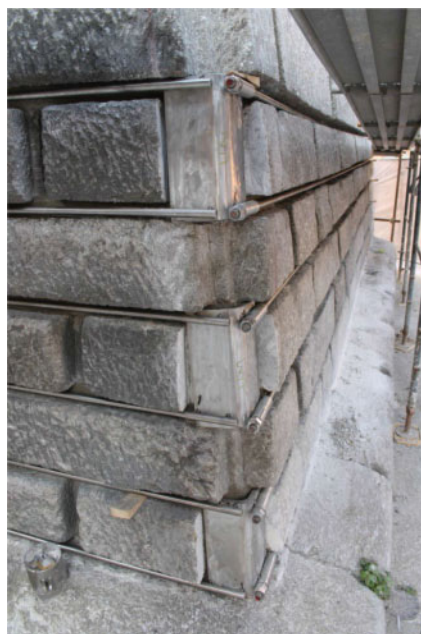
Figure 7. Post tensioned steel bars (B).

(b) active confinement of the tower corner by insertion of post tensioned stainless steel bars 24 mm in diameter (stainless steel AISI 304) and corner stainless-steel plates;

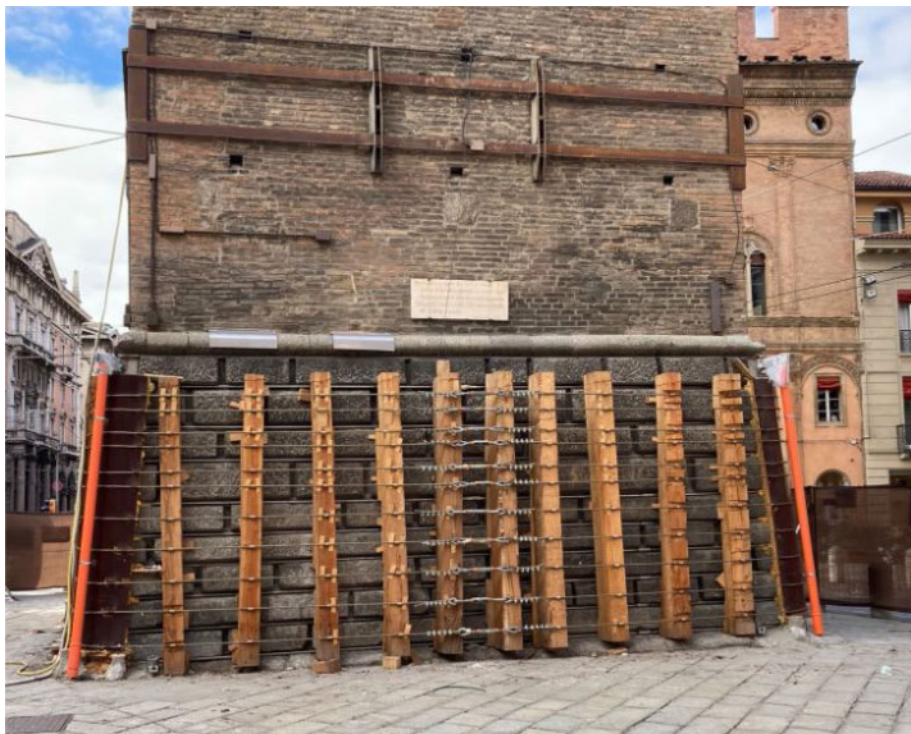
Figure 6. Confinement of the bugnato (C).

(c) active confinement of the “bugnato” through a funicular belting of the tower base. This was obtained by a monitored post tensioning of steel-cables with the insertion of wood blocks (of different thickness) between the “bugnato” and the cables.
