**Giovanni Tosatti\***

## The “unusual” Ca’ Bonettini landslide (Province of Modena, Italy)

**Key words:** *landslides, Northern Apennines, geomechanical characterisation*

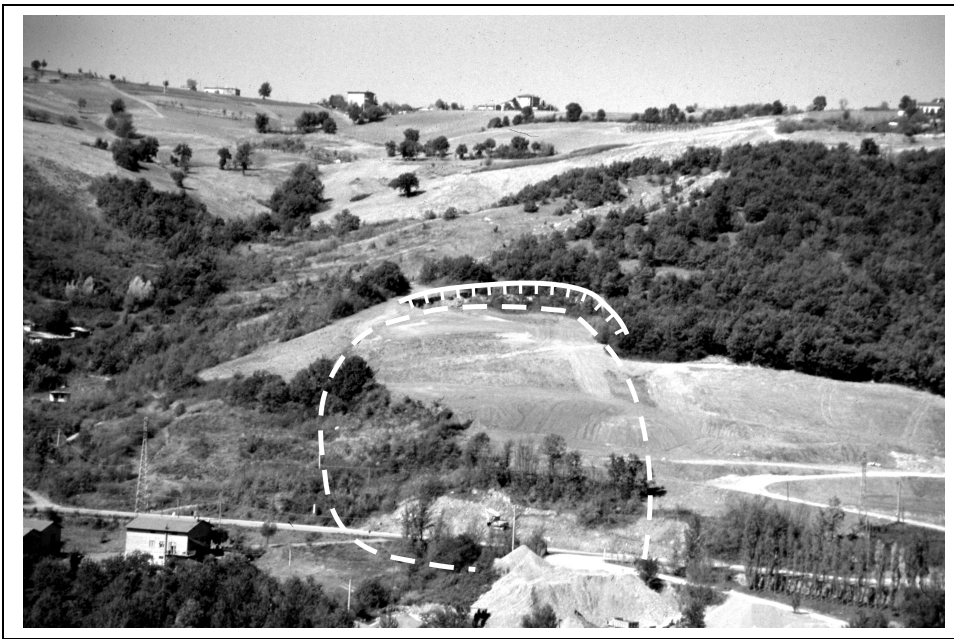
*Fig. 1 – Panoramic view of the slope where the Ca’ Bonettini landslide took place. Broken lines represent the landslide’s crown and body (courtesy of D. Castaldini)*

Early on 15<sup>th</sup> September 2003 a slope movement took place near Ca’ Bonettini, a group of houses in the Municipality of Marano sul Panaro (Modena Apennine hills), on the left-hand side of the River Panaro valley (Fig. 1). According to seismological data, an earthquake, VII-VIII degree MCS, 5.2 magnitude, was recorded late on 14<sup>th</sup> September 2003 in the nearby Bologna Apennines.

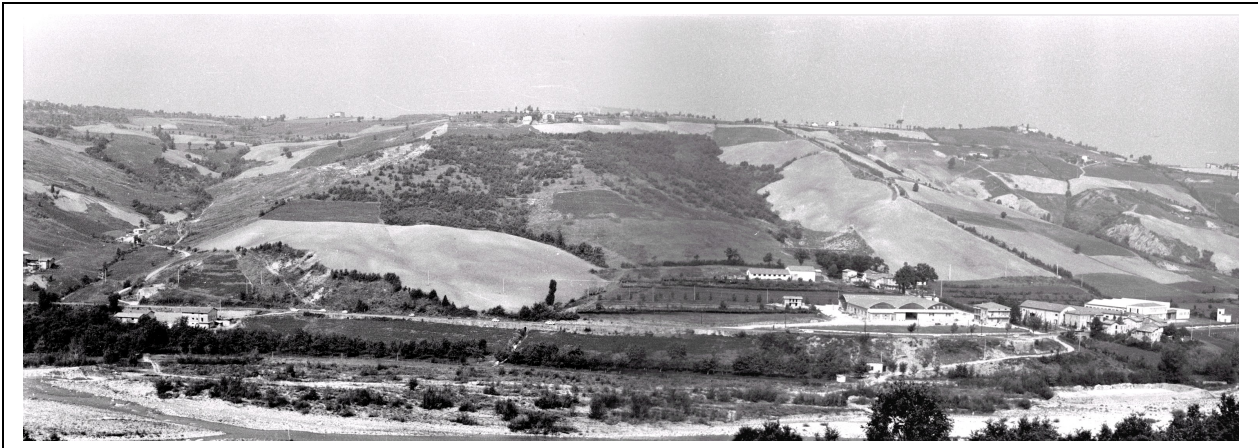
*Fig. 2 – General view of the Ca' Bonettini slope on the left-hand side of the Panaro Valley showing dormant landslide bodies in September 1969 (courtesy of M. Pellegrini)*

As confirmed by photographs and aerial images from the 1960s-70s, a dormant landslide body was already present along the slope where the Ca' Bonettini landslide of 15<sup>th</sup> September 2003 took place. In those years the slope's lower portion was cultivated whereas its upper part was partially covered by scanty vegetation (Fig. 2). Therefore, in accordance with the great majority of mass wasting processes occurring in the Northern Apennines, also this landslide is a reactivation of a previous movement of unknown origin, probably going back to thousands of years ago, at the end of the last Ice Age (10,000-9,000 yrs BP), when extremely severe

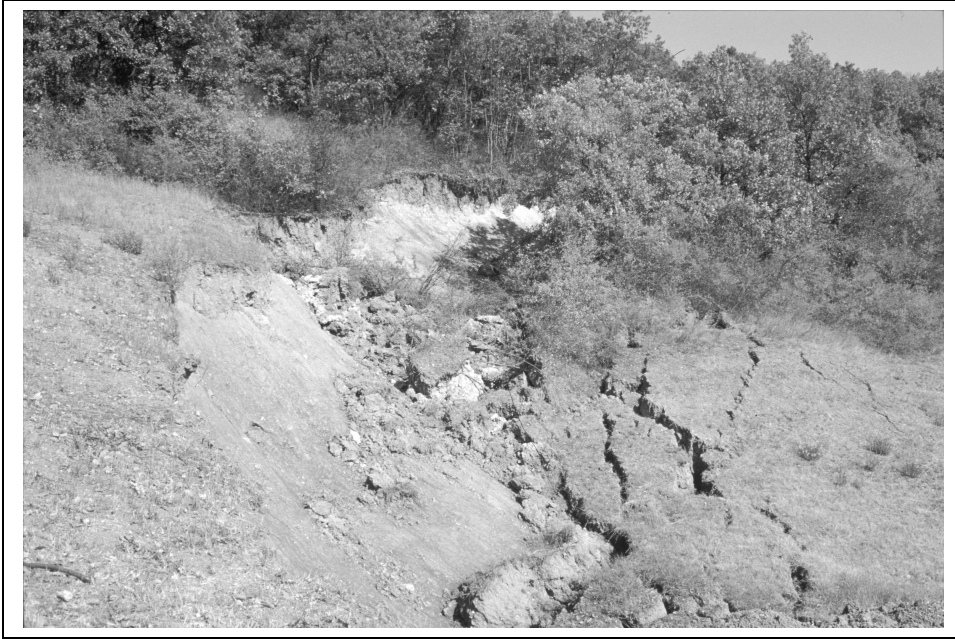
*Fig. 3 – The source area of the Ca' Bonettini landslide: slip surfaces and open ground fissures (September 2003)*

The 2003 Ca' Bonettini landslide affected a 288 m long slope made up entirely of clayey soils with an average displacement velocity of about 0.4 m/h. The landslide crown stretched over a length of about 150 m in a NE-SW direction, at an altitude of 200 to 225 m. The movement involved an area of some 43,000 m<sup>2</sup>, with a surface of rupture located at a depth of 15-24 m (Tab. 1), as was ascertained by mechanical boreholes and seismic investigations (Maccaferri, 2003). The accumulation material of the 15<sup>th</sup> September landslide partially obstructed the Panaro valley provincial road. The immediate intervention of the technical services of the Modena Province was therefore necessary. The first remedial measures consisted in remodelling the landslide toe with the insertion of drain pipes to reduce pore water pressures. Soon after the completion of these works the movement ceased, but after five months, on 22<sup>nd</sup> February 2004, a second reactivation took place, after intense precipitation occurring in the months of January and February all over this portion of the Northern Apennines (Ministero LL. PP., 2004). From a classification viewpoint, this landslide is defined as compound (rotational-translational) earth slides and, locally, earth flows (Cruden & Varnes, 1996) with slow to moderate displacement velocity (Fig. 3).

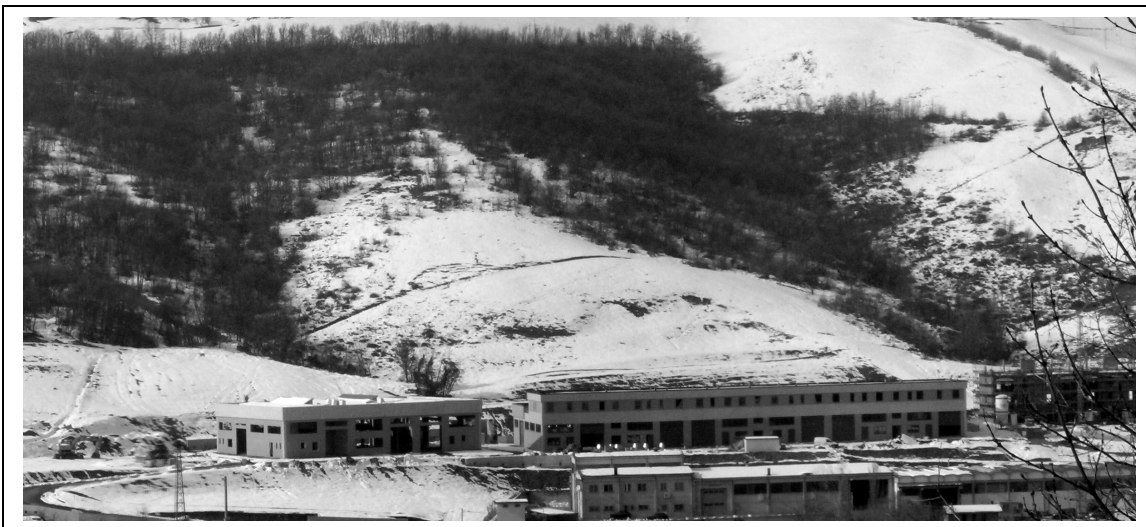
*Fig. 4 – Industrial buildings recently constructed at the foot of the Ca' Bonettini landslide (March 2004)*

Another predisposition cause for landsliding should also be considered. Since the mid-1960s the area near the foot of the Ca' Bonettini landslide body, in proximity to the valley floor, has been subject to human activities, mainly consisting of industrial and office buildings as witnessed by photographs taken in that period (cf. Fig. 2). Late in August 2003, just weeks before the landslide's first reactivation, building activities were extended towards the landslide foot with the construction of another two buildings, preceded by considerable morphological changes with the removal of large amounts of earth to make room for new constructions (Fig. 4). These works further reduced the stability of the slope, since it is well known that the removal of material from the zone of accumulation of a dormant landslide leads inevitably to a general decline of stability conditions.

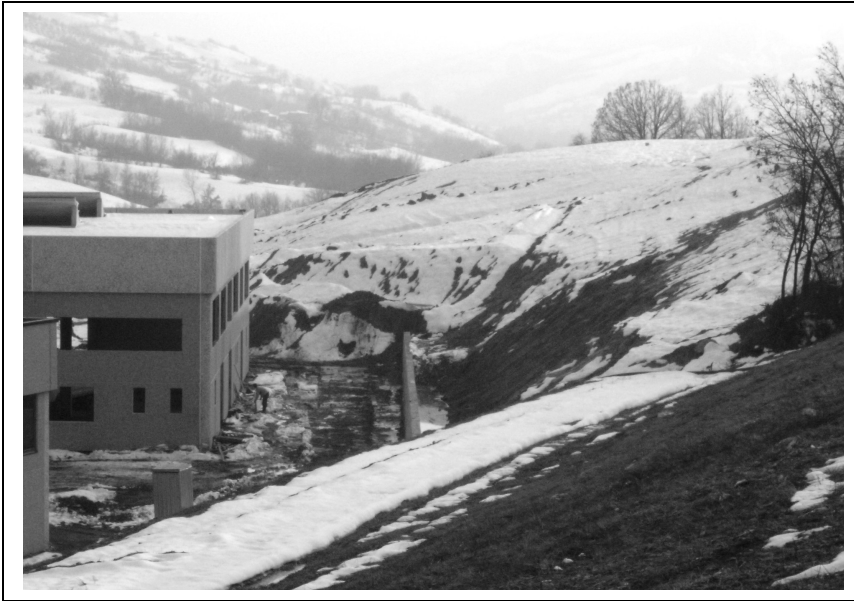
Fig. 5 – Slope cut at the foot of the Ca' Bonettini landslide and containment wall (March 2004)

After the first reactivation and the analysis of seismographic and other instrument data, it was clear that the causes of slope instability were to be found in the excavation and building activities carried out at the foot of the landslide. Therefore, a series of remedial measures was planned in order to increase stability and, at the same time, safeguard the new constructions directly threatened by the movement. The first consolidation works consisted in remodelling the landslide toe with the insertion of drain pipes to reduce pore water pressures, but it was soon obvious that these measures were not sufficient to reinstate the lost stability. Subsequently, a containment wall anchored to the ground by means of 50 m long piles, was constructed uphill of the new buildings (Fig. 5) and surface drains were placed all over the landslide body in order to reduce water absorption.
