GEOMORPHOLOGICAL HAZARD ASSESSMENT OF THE AREA OF THE MEDIEVAL VILLAGE OF RIOLA (BOLOGNA APENNINES, NORTHERN ITALY)

D. CASTALDINI¹, AL. GHINOI², AL. MACCAFERRI²

ABSTRACT. – Geomorphological hazard assessment of the area of the medieval village of Riola (Bologna Apennines, Northern Italy). The medieval village of Riola has recently been gaining increasing interest for possible future tourist exploitation. This study is aimed to assess the geomorphological hazards of that area, through detailed geomorphological mapping (cross-verified by applied-geology investigations). Particularly, the area's instability has been analysed, also with the aim of verifying the official maps of the Bologna Province' territorial plan, where the greatest part of the area has been defined at elevated hydrological risk, strongly limiting future development. This study has demonstrated how a detailed geomorphological mapping, coupled with an hazard classification method adopted, with modifications, from the Swiss hazard-mapping guidelines, can give a more realistic picture of the slope instability framework of a municipality than that given by the provincial maps. The latter are based on geological maps a

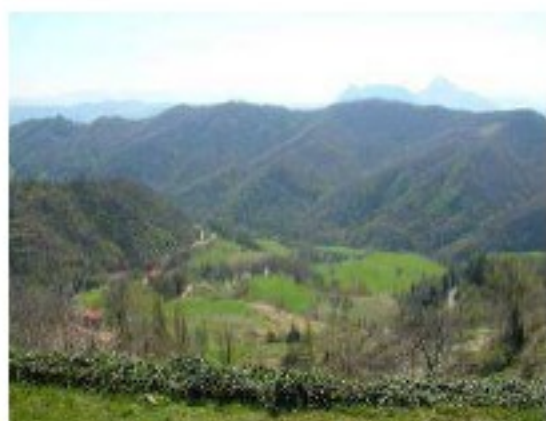
Fig. 5. Panoramic view of the Abbazia di Labante's landslide at whose foot the Aneva Torrent flows.

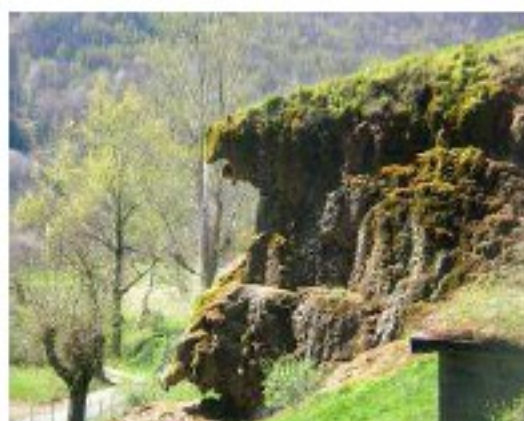
Fig. 6. The travertine waterfall near S. Cristoforo di Labante.

Near San Cristoforo di Labante, the abundance of water flowing out from a spring and the peculiar chemical composition of rocks have determined favourable conditions to calcium-carbonate precipitation and the formation of travertine.

The waters of the S. Cristoforo di Labante's spring feed the homonymous waterfall that, together with the close by "cave of the Germans" represents the main tourist attraction of the area (fig. 6). Nearby, an abandoned mining pit has been converted to a resting place for tourists.

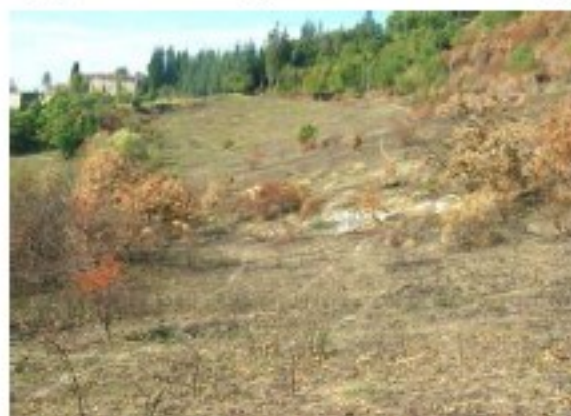
Fig. 7. Along –slope attitude of strata, given by a structural surface, NE of the medieval village of Riola (far left in the photograph). The bedrock is composed by pelitic sandstones of the Membro di Anconella.

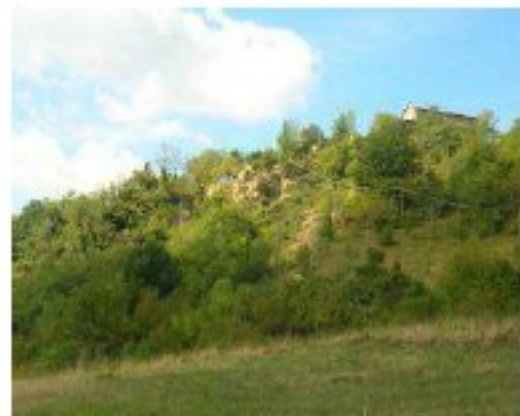
Fig. 8. Panoramic view of the upper part of the Ribecco landslide. Note the detached rock prisms near the landslide scarp, very close to the buildings of Ribecco.

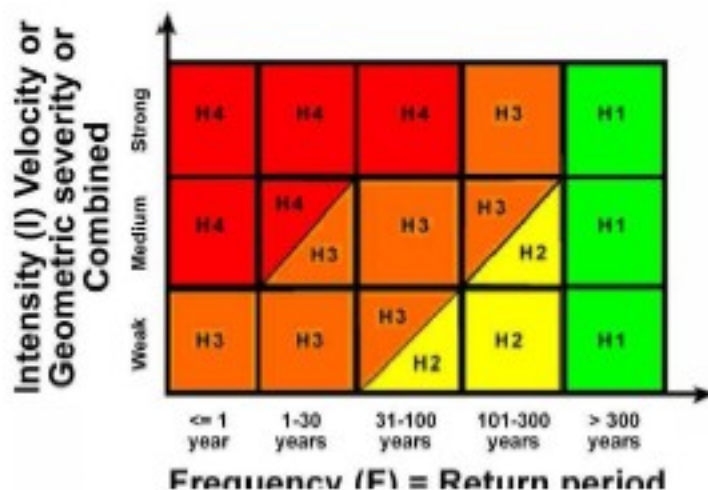
Fig. 9. Evaluation matrix for landslide hazard (from Panizza et al., 2004). H4 = very high; H3 = high; H2 = medium; H1 = residual.

from Heinimann et al. (1998), is based on a classification of the intensity and frequency of landslides (table 1). This is achieved by means of univocal matrix combinations which allow the definition of various levels of geomorphological hazard (fig. 9). The Heinimann et al. (1998) method is still used in Switzerland for landslide mapping and risk assessment (Loup & Raetzo, 2009).
