## LESSONS LEARNT FROM THE SGORIGRAD AND STAVA DISASTERS

### Sgorigrad – Stava: identical disasters

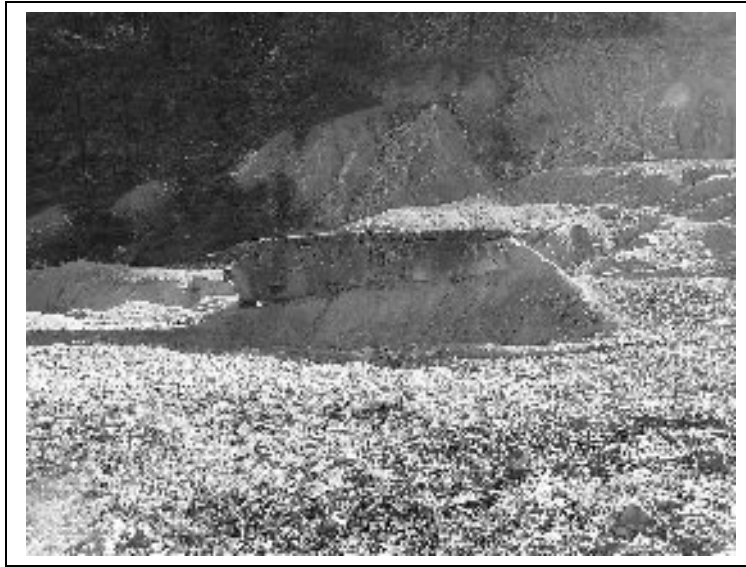
Fig. 1 – The remains of an overflow tower and mine waste where the Sgorigrad tailings dam stood

In 1958 the Placalnica mine in the Western Balkan Mountains, opened in 1902, was equipped with a flotation plant, built on the mountain slope, in order to extract minerals containing zinc, lead and, to a lesser degree, copper and silver. In order to decant and store the residual waste produced by the flotation process, a tailings dam was constructed in a lateral valley overhanging the village of Sgorigrad. The tailings thus produced were conveyed to the basin by means of a pipeline. The stream running on the valley floor was dammed with an embankment and its water was pumped back upstream of the tailings basin. In 1966 the basin attained the approximate height of 60-70 m. The retaining embankment for damming the torrent, the overflow towers and segments of the pipes are still visible today, together with small amounts of decanted mud, which remained in place [1] (Fig. 1).

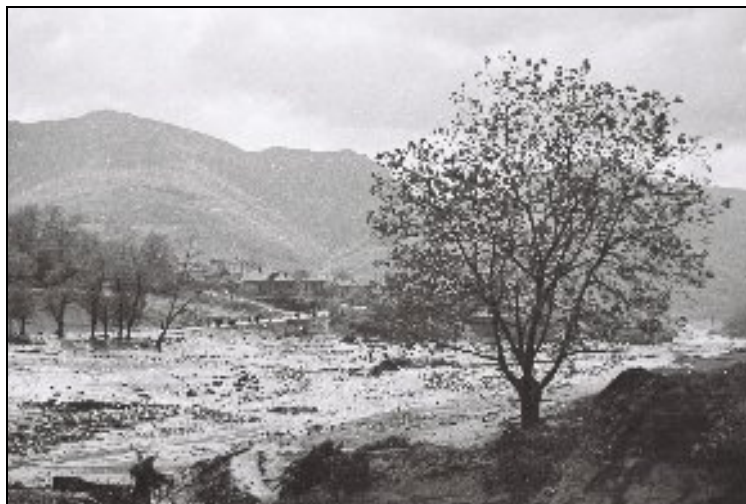
Fig. 2 – The area of Sgorigrad after the tailings dam failure (May 1966)

Failure took place on 1<sup>st</sup> May at 11:15 hours. A 220,000 m<sup>3</sup> flowslide, in some places over 3 m high, ran a distance exceeding 6 km, causing considerable material and environmental destruction (Fig. 2).

The failure of the Sgorigrad tailings dam occurred after three days of heavy rains. The basin was in “high pond” conditions and the tailings were saturated. The decant towers had a low spillway capacity and the pond water level had risen dangerously. In order to avoid overflowing, the operation staff dug two trenches on both sides of the dam but this desperate action was of no help. The dam failed suddenly and a large mass of tailings and water went down like a fast-moving wave of mud. According to eye-witnesses, the dam did not overflow. This was recorded also by aerial photographs. The cause of failure was the sudden loss of stability and the ensuing liquefaction of saturated tailings. For this reason the dam collapsed like a wall. If it had been overtopped, erosion would have taken some time and the failure wave would not have been so vast and fast. On the other hand, failure could have occurred due to water percolation inside the dam coming from a spring located inside the basin which had not been detected before. Very likely, considering the meteorological situation in the days preceding the disaster, failure occurred as a combination of both circumstances [4].

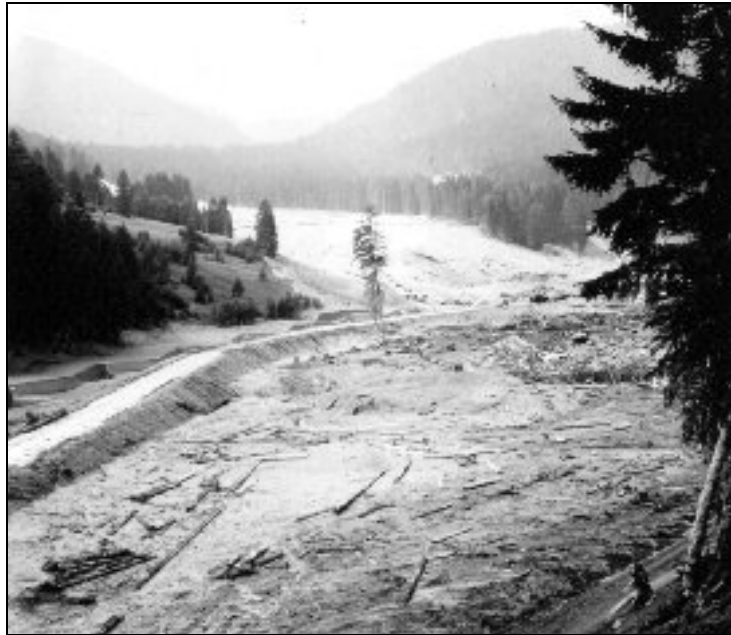
Fig. 3 – The Stava Valley completely devastated by the flowslide (July 1985)

At 12:23 hours of 19<sup>th</sup> July 1985 the dam of the upper basin failed and collapsed onto the lower basin, which also failed. The flowslide composed of water and sand from the dams and the whitish silts they had contained descended downstream at a velocity of nearly 90 km/h [5], sweeping away people, buildings, trees and whatever it met in its path as far as the main valley floor.

Along its path the flowslide caused the death of 268 people, the complete destruction of 3 hotels, 53 houses, 6 industrial buildings and 8 bridges whereas some more buildings were seriously damaged. A layer of mud,

some 20 to 40 cm thick, covered an area of some 435,000 m<sup>2</sup> over a length of 4.2 km. Some 180,000 m<sup>3</sup> of waste material spilled out of the tailings dams, to which another 45,000 m<sup>3</sup> of debris should be added resulting from erosional processes, destruction of buildings and uprooting of hundreds of trees (Fig. 3). The area where the dams stood and the path of the mud flow were completely reclaimed some years after failure.

In the case of Stava, the cause of failure was due to inadequacy and shortcomings concerning the construction of the upper tailings dam which collapsed first. In particular, the stability conditions were never satisfactory and the silts deposited within the basin were not properly consolidated owing to: i) the marshy

nature of the foundation ground, which hindered the consolidation of the muds; ii) the erroneous construction of the upper basin's dam, which did not allow adequate drainage at its foot; iii) the position of the upper basin just uphill of the lower one: as it grew in width the dam came to rest partially on the silts of the lower basin, thus worsening drainage and stability conditions. Other reasons for failure are to be sought in the excessive height and inclination of the dam of the upper basin, which was 34 m high. The gradient of its outer slope was 39°, corresponding to nearly 80%. Furthermore, although the "upstream" method is the quickest and most economical means of raising a dam, it is also the most unsafe. Finally, the poor stability conditions of the upper dam were due also to the wrong location of the water pipes at the bottom of the basins and passing through the dams [6]. For over 20 years, there was no monitoring, nor were any adequate stability analyses ever performed by the public authorities in charge of the Prestavel tailings dams [7].
