LESSONS LEARNT FROM THE SGORIGRAD AND STAVA DISASTERS

Graziano Lucchi¹, Giovanni Tosatti²

Sgorigrad – Stava: identical disasters

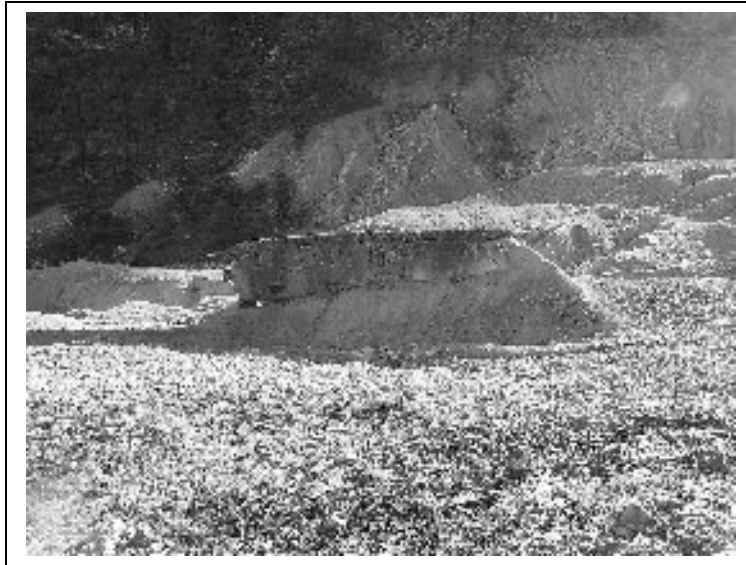
In 1958 the Placalnica mine in the Western Balkan Mountains, opened in 1902, was equipped with a flotation plant, built on the mountain slope, in order to extract minerals containing zinc, lead and, to a lesser degree, copper and silver. In order to decant and store the residual waste produced by the flotation process, a tailings dam was constructed in a lateral valley overhanging the village of Sgorigrad. The tailings thus produced were conveyed to the basin by means of a pipeline. The stream running on the valley floor was dammed with an embankment and its water was pumped back upstream of the tailings basin. In 1966 the basin attained the approximate height of 60-70 m. The retaining embankment for damming the torrent, the overflow towers and segments of the pipes are still visible today, together with small amounts of decanted mud, which remained in place [1] (Fig. 1).

Fig. 1 – The remains of an overflow tower and mine waste where the Sgorigrad tailings dam stood
