Geomorphological analysis of the historic landslide of Sottrù (Badia Valley, Italy) reactivated on December 13, 2012

## Ghinoi, A.<sup>1</sup>, Freddi, R.<sup>1</sup>, Pasuto A.<sup>2</sup> & Soldati, M.<sup>1</sup>

[Landslide, geomorphological mapping, Dolomites, Italy]

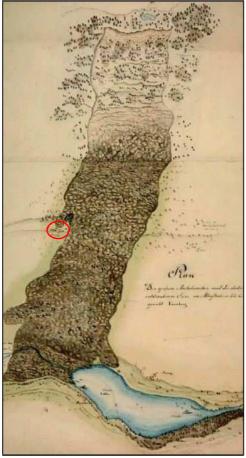
Figure 2. Shape of the 1821 Sottrù landslide and of the lake that formed after the damming of the Gadera torrent. Tiroler Landesarchiv Innsbruck. The red circle identifies the village of Sottrù.

The landslide started on 11 June with small superficial slides, opening of fissures in the ground and soil displacements. Only on 19 June the landslide morphology was similar to the one depicted in historic documents<sup>2</sup> (Figure 2).

The movement seems to have originated from the slope sector above the village of Sottrù, within cultivated and grazing meadows; it propagated downslope passing close to the village and damming the Gadera torrent. Among the effects, the destruction of the hamlet "La Muda" (possibly a station for goods trade along the Gadera torrent) and damages to 17 private

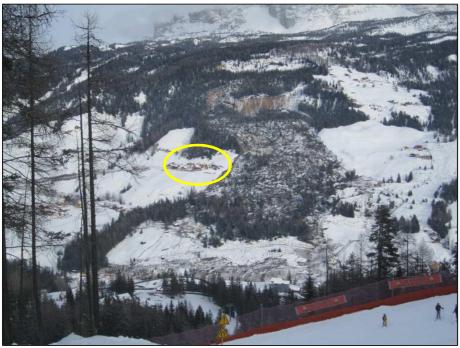
Figure 3. Front view of the 2012 landslide event taken some days after its occurrence. The village of Sottrù is identified by the yellow ellipse. Photograph by M. Soldati.

The geomorphological survey of the Sottrù landslide occurred on 13 December 2012 (Figure 3), performed during the summer of 2014, was aided by the use of a GPS track logger, allowing the precise mapping of geomorphological, hydrographic and hydrogeological details. Important reference maps of the area were the "Carta Geomorfologica dell'Alta Val Badia" and its reference notes (Panizza et al., 2011), and the "Carta Geologica delle Dolomiti Occidentali 1:25.000" (Brandner et al., 2007).

Until a few metres below the village of Sottrù, the lateral scarps are well visible although thinning up. Below Sottrù the accumulation zone starts, reaching the Gadera torrent. From Figure 3 the hummocky morphology characterising the whole toe area can be appreciated.

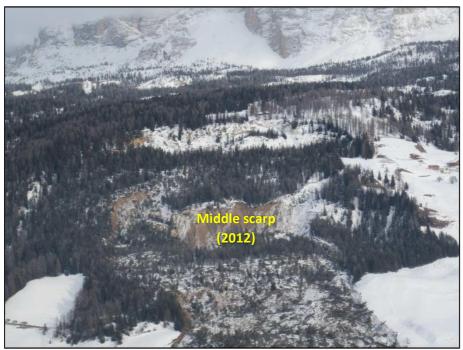
*Figure 5. Middle scarp of the 2012 event and related landslide accumulations. Photograph by M. Soldati.*

The latter, during the last event, experienced a retreat of some metres uphill and the generation of a fresh new scarp, with more or less the same height of the previous one; the thickness of the collapsed material seems to be relatively thin here, up to 5 m. A translational slide can be hypothesised along the scarp, followed by a rotational slide and partly flow at the slope break (Figure 5). The almost uniform and unbroken snow cover (the last snowy precipitation was on the 8 December, 5 days before the landslide occurrence) reveals a certain degree of compaction of the slid material, probably due to the frozen top-soil layer.

The same evolution seems to have characterised also the left part of the middle scarp, where the sliding uncovered an outcrop of the Wengen Formation layers. Field evidence in the days just after the event, when maximum daily temperatures were still around 0°C, shows water discharges starting from the base of the detrital cover and reaching the base of the scarp, testifying the presence of unfrozen subsurface water.
