# REVIEW ON THE INFLUENCE OF BIOLOGICAL DETERIORATION ON THE SURFACE PROPERTIES OF BUILDING MATERIALS: ORGANISMS, MATERIALS, AND METHODS

CHIARA FERRARI<sup>1</sup>, GIULIA SANTUNIONE<sup>1</sup>, ANTONIO LIBBRA<sup>1</sup>, ALBERTO MUSCIO<sup>1\*</sup>, ELISABETTA SGARBI<sup>2</sup>, CRISTINA SILIGARDI<sup>1</sup> & GIOVANNI S. BAROZZI<sup>1</sup>

<sup>1</sup>Department of Engineering 'Enzo Ferrari', University of Modena and Reggio Emilia, Italy.

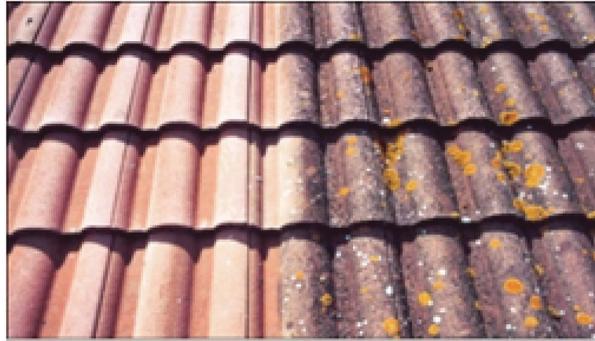
Figure 1: Roof shingle soiled by lichens and pollutants (courtesy of John Gillat, Thor Specialities –UK Limited).

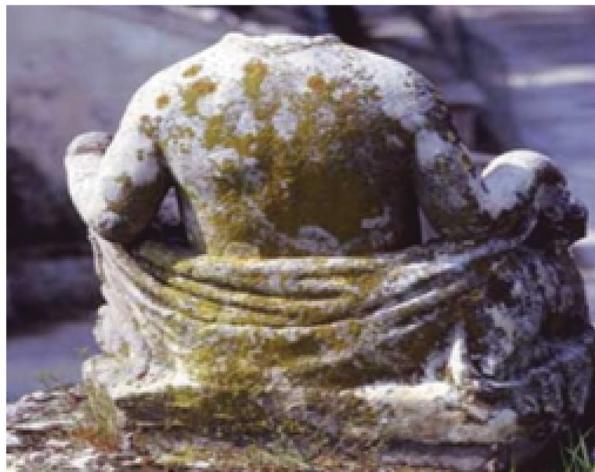
Figure 2: Tivoli, Villa d'Este, putto's statue with lichens (This photo belongs to ISCR in Rome, kindly provided for the exhibition 'Memory/Future. Technology for cultural heritage', edited by Fondazione Rosselli).

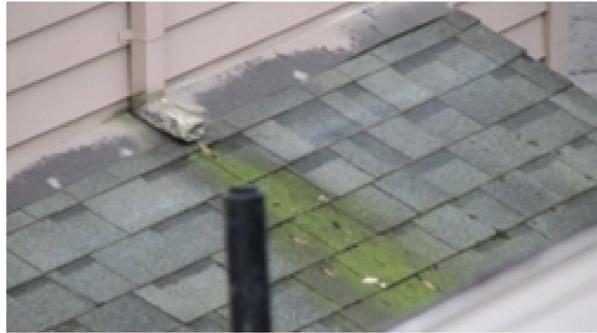
Figure 3: Algae grows in the concentration of nutrients, sunlight and water (source: [www.bradlewis.com](http://www.bradlewis.com)).

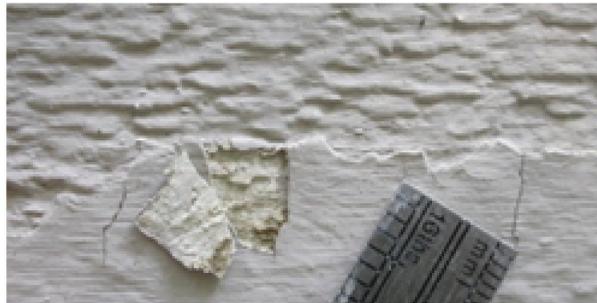
Figure 4: Fungal growth into painted surfaces (source: [www.InspectApedia.com](http://www.InspectApedia.com)).

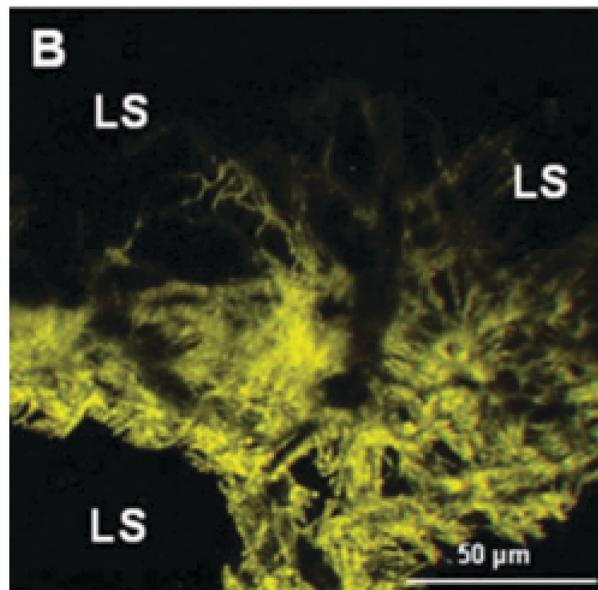
Figure 5: CSLM 3D image of endolithic fungal colonization of limestone (source: [www.scielo.isciii.es](http://www.scielo.isciii.es)).

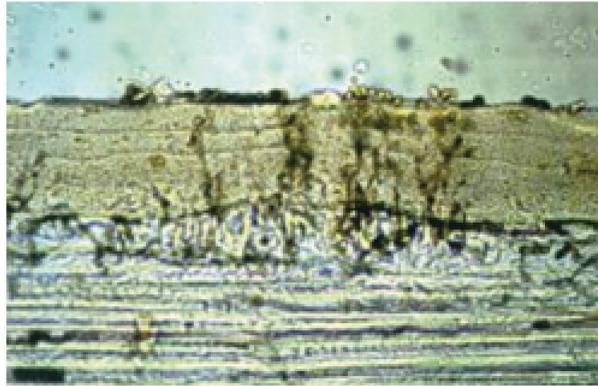
Figure 6: Algal and fungal colonization of a painted surfaces (source: [www.pra-world.com](http://www.pra-world.com)).

concrete ones. As Bravery reviewed [39], the mechanism of colonization and degradation of paint can start with the attachment and germination of spores on the film surface to produce mycelia colonies; the germination can also occur in or on fibres protruding through the film or in cracks allowing mycelia development at the interface between paint layers or between paint film and substrate, as Fig. 6 shows.

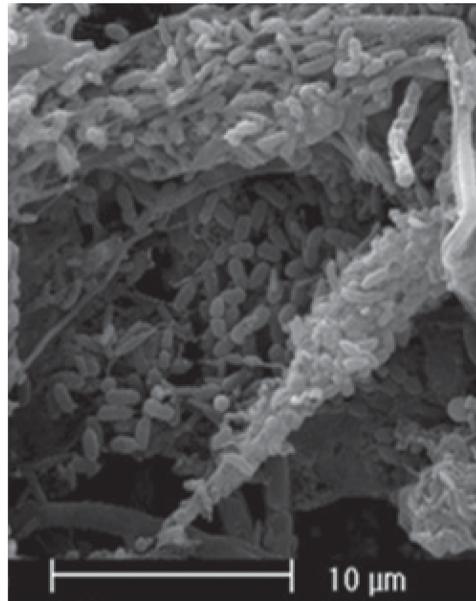
Figure 7: Electron microscope picture of bacteria in a biofilm (source: [www.aquator.nl](http://www.aquator.nl)).

Fungi and algae are not the only organisms involved in the formation of a biofilm that reduces the durability of surfaces and structures, as observed in electron microscope image in Fig. 7. Bacteria can also play an important role. Whereas biocorrosion of concrete and mortar is caused primarily by chemolithotrophic bacteria (*Thiobacillus*, *Nitrosomonas*, *Nitrobacter*), biocorrosion of metal is overall due to and sulphate reducing bacteria (SRB), which are anaerobic [16]. Chemolithotrophic bacteria are prokaryotes that obtain their energy from the oxidation of reduced inorganic compounds such as sulphide, ammonia and hydrogen, and they use carbon dioxide as carbon source. Instead, SRB obtain energy by oxidizing organic compounds or molecular hydrogen while reducing sulphide. All these bacteria are particularly capable to react with metallic ions and this is the reason why they are overall implicated in biogenic corrosion of metal, rather than other substrates. Beech & Gaylarde [55] have deeply studied the effects on metal surfaces exposed to environmental conditions induced by bacteria. The taxa of bacteria involved in the surfaces colonization grow at very low nutrient levels. The species involved in the biodeterioration are showed in Table 3.
