DEBRIS FLOWS IN VAL PARMA AND VAL BAGANZA (NORTHERN APENNINES) DURING THE 13 OCTOBER 2014 ALLUVIAL EVENT IN PARMA PROVINCE (ITALY)

During the 13 October 2014 rainstorm event that affected the Val Parma and Val Baganza area, several debris flows affected the Mt. Cervellino relief (northern Apennines, Italy), causing severe and widespread damages to check-dams, roads and other infrastructures. Such event, together with the Piacenza province event of 2015, has generated the perception of debris flows as a breaking new potential cause of widespread damages in the Emilia-Romagna. The meteorological event of October 2014, reconstructed by means of rain gauges and radar data, reached intensities as high as 80 mm/hour, which is well above any debris flow triggering thresholds presented in literature. However, data show that debris flows have occurred in any location where 30 mm/hour were exceeded. The result was the occurrence of tens of debris flows, which were triggered in zones of failure of slope debris coverage along the streams, and that remobilized and scoured debris along the track and destroyed several check dams and damaged roads that were overflowed by debris. This paper is aim

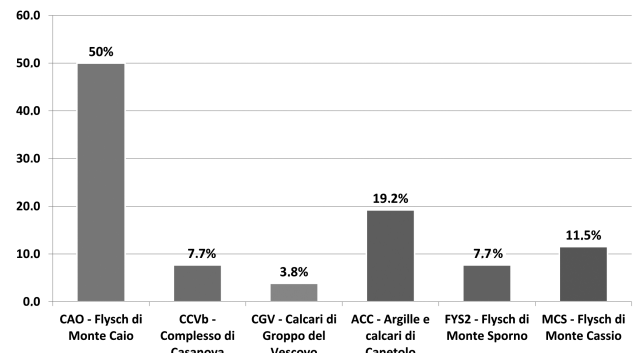
Fig. 7 - Bedrock lithology in debris flow triggering zones: in 13 torrents out of a total of 26, the outcropping lithology is Flysch di Monte Caio

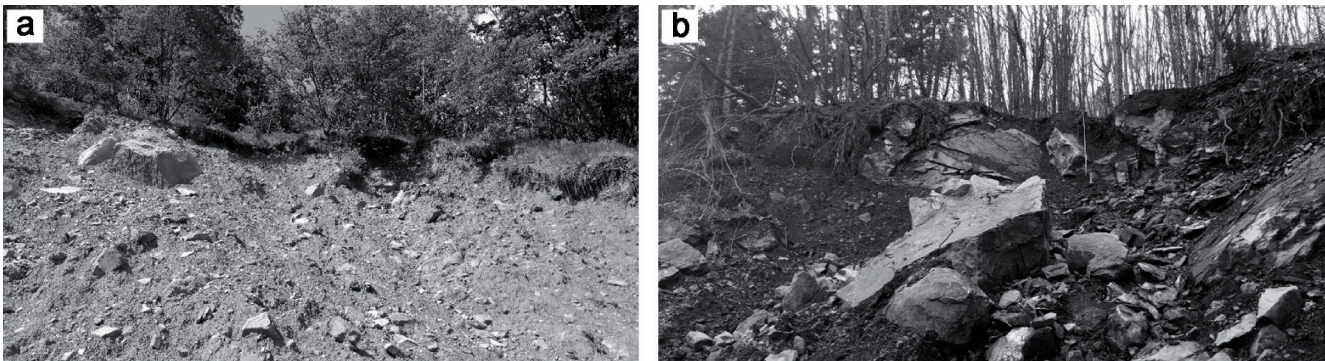
Fig. 9 - a) Triggering zone of debris flow in Rio Roccaferrara; b) Triggering zone of debris flow in Rio Cirone

Field surveys have allowed to map and document several triggering zones, debris flow track channels and deposition areas. In Rio Vestana, slope failure in the triggering zone has affected approximately 10.000 m³ of coarse debris (Fig. 8). A similar situation has been surveyed in many other triggering zones (Fig. 9).

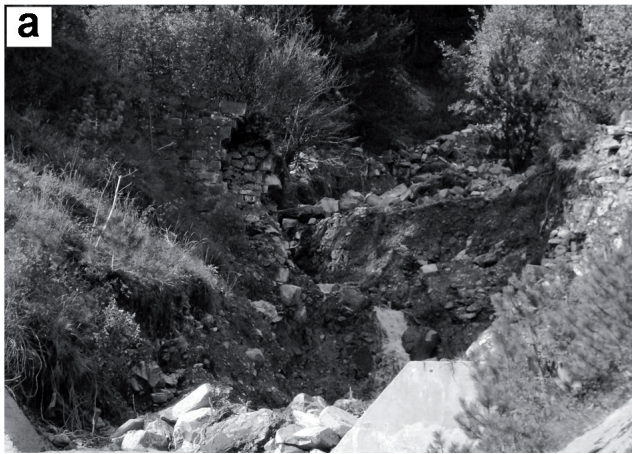
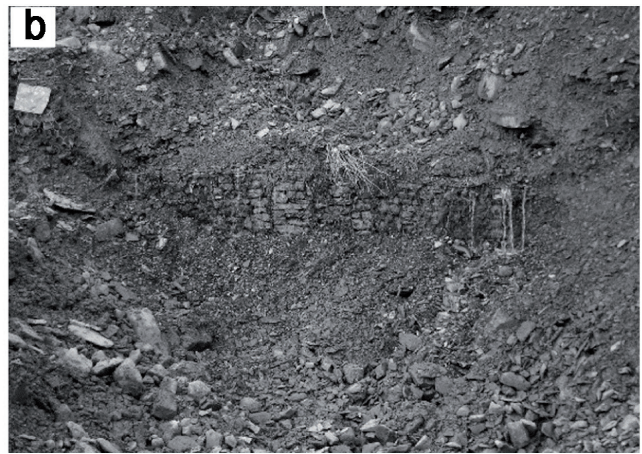
Fig. 13 - Examples of check-dams cut-through by debris flows: a) check-dam in the Rio Vestana destroyed by debris flow; b) check dam in the Rio delle Tane completely submerged by debris

One of the most relevant and widespread damage type associated to debris flow was the cut-through of tens of check dams along the affected torrents (Fig. 13a). This caused the release of large amounts of debris that was previously trapped upslope check-

dams. In the lower portion of the torrents, check-dams were also buried by debris flow deposits (Fig. 13b). Also, almost all of the local roads crossing the debris flow tracks were severely damaged. In practice, in many road crossing areas the torrent had been previously reduced to flow into 1 to 2 m diameter pipes in order to avoid the need for bridges. In these conditions, the flow-pipes were rapidly obstructed by the debris flows: this caused the outburst of pipes, the run of the debris flows on top of the roads and, in many cases, the final erosion and cut-through of the road track and of the areas immediately downslope the road crossing point (Fig. 14). At the base the slopes, large amounts of debris filled bridges and outflow pipes and overflowed main provincial roads. This was particularly severe in the fan-shaped accumulation zones at the confluence of the torrents into the Parma river (Fig. 15a). In some cases, the torrents transported and deposited along roads boulders as large as 5 m³ or more (Fig. 15b).

The surveys conducted after the event, have also evidenced how check dams did have little or no effect in preventing debris flows and that, on the contrary, they were the source for

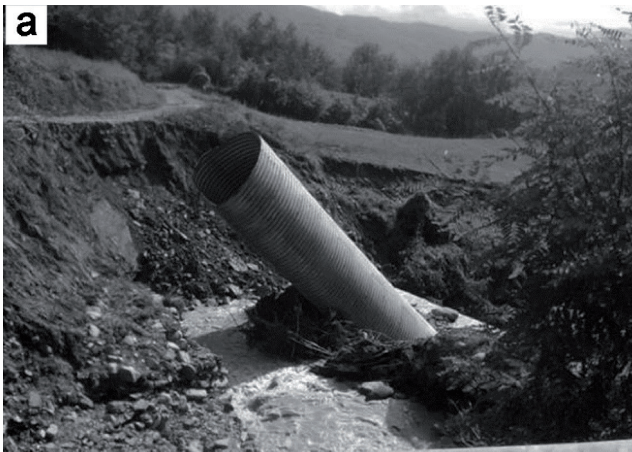
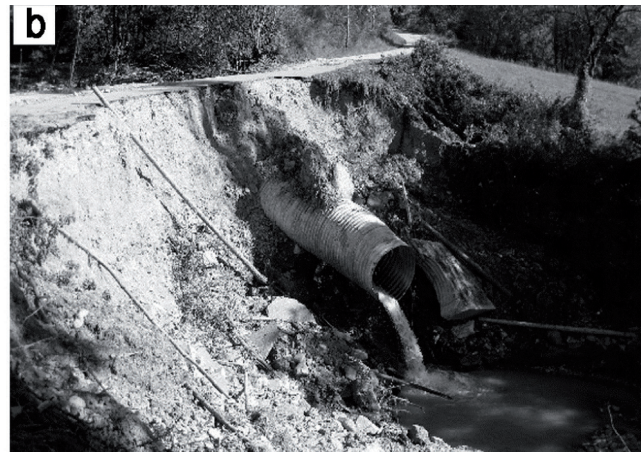
Fig. 14 - Examples of road-crossing area along the track of the torrent: a) Rio Vestana, the pipe for the outflow of the torrent was outburst during the debris flow and significant erosion occurred downslope of the road crossing; b) Rio Roccaferarra, the debris flow overflowed the road and significant erosion occurred downslope of the road crossing zone

mobilization of large amounts of debris when cut-through by debris flows. Also, the road network along the slopes is absolutely inadequate to cope with this type of phenomena. Stream crossing points along roads are mostly characterized by the presence of water pipes that were rapidly clogged by debris and that can overbusted under the pressure of the debris flows, causing severe damages to the road and surrounding zones.
