10th CIRP Conference on Intelligent Computation in Manufacturing Engineering - CIRP ICME '16

Dental failure analysis: the need of a comprehensive failure classification

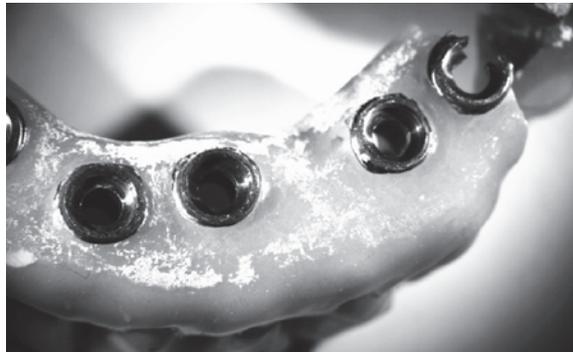
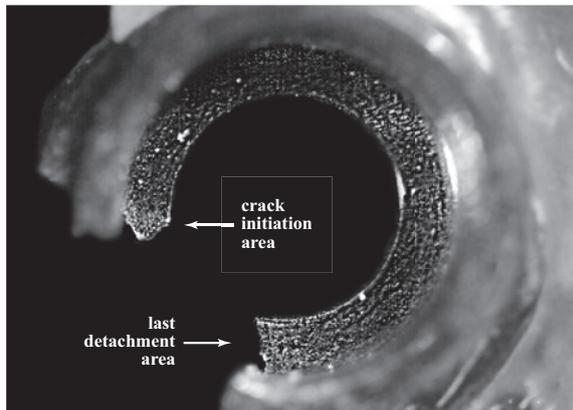
Fig. 1. (a) Overdenture bar and (b) detail of the fractured area.

The overdenture bar is made of Cobalt-Chrome alloy joint by soldering and with a polymer coating. Figure 1 and 2 show observations by optical microscope of the overdenture bar. A

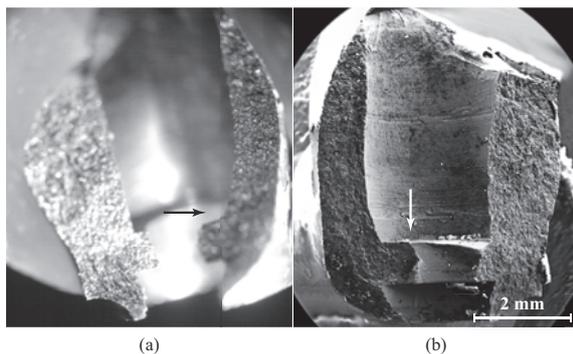
Fig. 2. (a) crack initiation observed on the rupture surface of the bar, (b) the arrow indicates last detachment area of the cylinder.

fracture occurred on the lateral side of the cylinder wall. The observations allow to affirm that the rupture proceeds from the inner surface of the hole toward the outer one. The last detachment area is characterized by high deformation (Figure 2b) while the area where cracking is initiated appears without deformation (Figure 2a). Microscale examination of the fracture surface shows that the highly reflective regions of the fracture surface are created by cleavage or quasi-cleavage while the thin-arc'd arrest regions failed by microvoid coalescence.

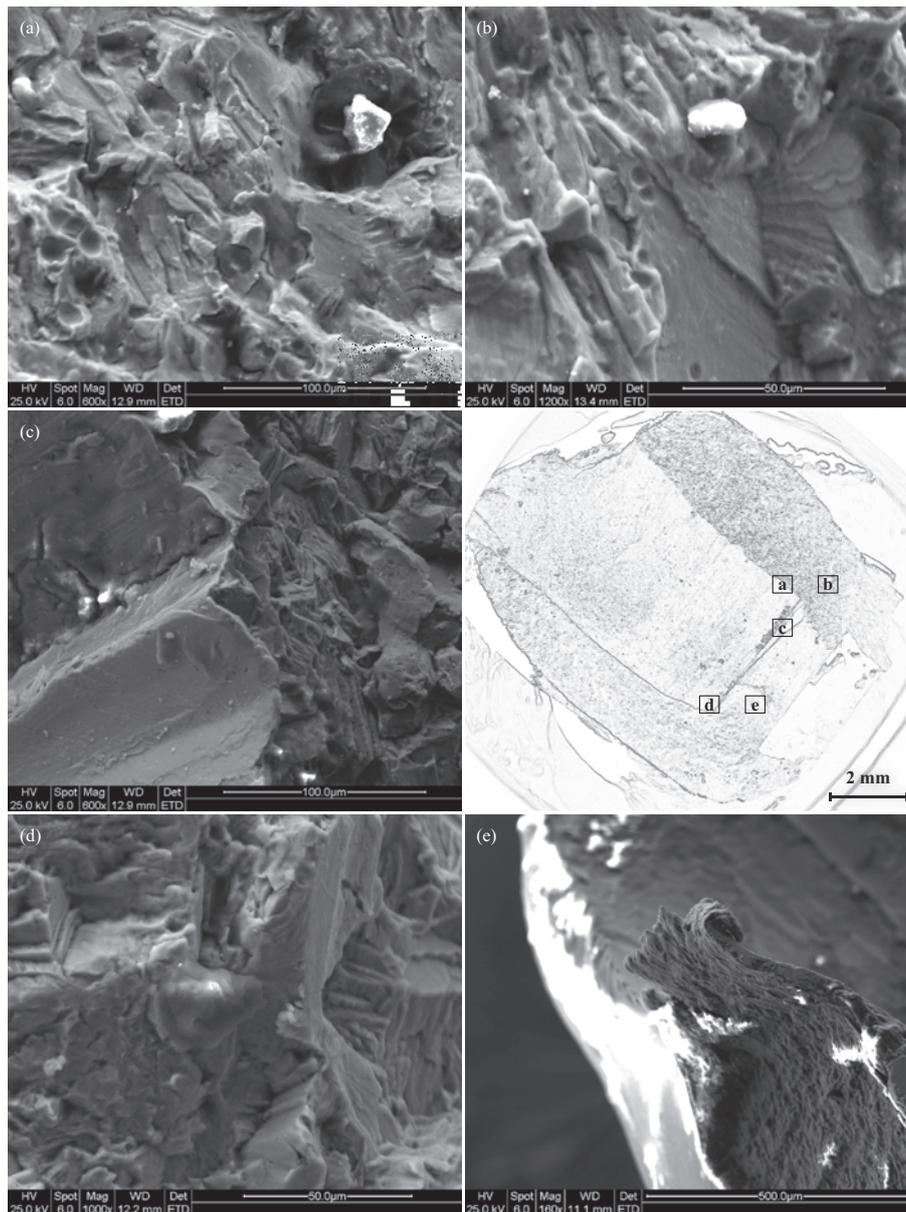
Fig. 3. (a) and (b) evidence quasi-cleavage fracture mode; (c) step due to lack of concentricity between roughing and finishing tool axis, it causes a high local concentration of tension, high constraint region promotes quasi cleavage; (d) intermediate area; (e) zone of last detachment characterized by high deformation.

Near the hypothesized crack initiation zone the micrographs evidence a quasi-cleavage rupture mode (Figure 3a and 3b).

Quasi-cleavage fracture is a localized feature on a fracture surface that exhibits characteristics of both cleavage and plastic deformation [13]. Figure 3c evidences the presence of a helicoidal step at the hole floor. The local concentration of tension due to the step supports the rupture classification as quasi cleavage. In fact some authors report [13] that conditions that impede plastic deformation promote quasi-cleavage fracture. For example, the presence of a triaxle state of stress (as adjacent to the root of a notch), within the ductile-to-brittle transition range. Besides at the stage I fatigue fracture surfaces are faceted, often resemble cleavage, and do not exhibit fatigue striations. Far from the crack initiation the quasi-cleavage

surface is less evident (Figure 3d). The changes in fracture mode are most evident in the general region of the fracture origin and may not be present over the entire fracture surface [13]. The zone of the last detachment is characterized by high deformation (Figure 3e).

The aim of this research is to investigate the failure causes of some implant-supported prosthesis by using SEM analysis. Observations of the failure surfaces of the overdenture bar showed a quasi-cleavage mode of fracture which cannot be attributed to the failure causes identified in literature for metal frameworks. In fact, the observation of the hole geometry evidenced the presence of a step generated by the machining process. This typical manufacturing defect is due to lack of concentricity between roughing and finishing tool axis. The nature of the loading conditions on implant-supported prostheses is cyclic and multidirectional: a combination of tension, compression, bending, and torsion. An average measure of the maximum bite force on bar attachment systems is 300 N [22]. The step caused a high local concentration of tension that probably initiated the fracture at the root of the step.

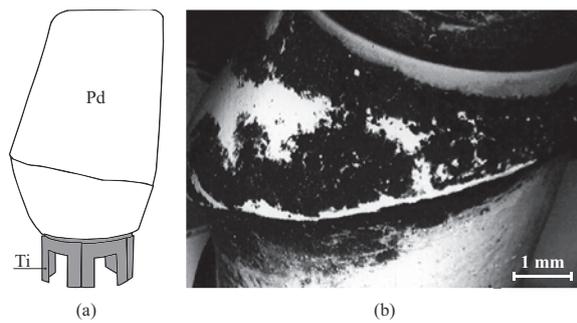
Fig. 4. (a) Scheme and (b) SEM observation of the abutment before cleaning.

The device may be described as two drilled cones opposed with a junction plane oblique to the axis of the hole (Figure 4). The cones are of Palladium (Pd). At the lower face of the bottom cone there is a collar from which a nut cut to obtain five fingers branches off. Collar and nut are Titanium (Ti) ones. The screw has a high ratio length/diameter. Once engaged by the screw, the flare nut would ensure the opening of the fingers positioned on the trunk of the lower cone. The composition of the device was confirmed by the EDAX analysis performed during the SEM observation.

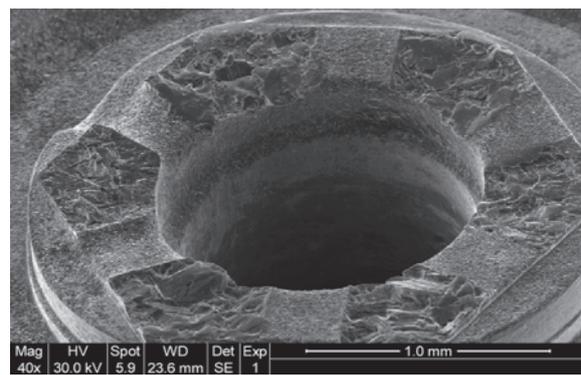
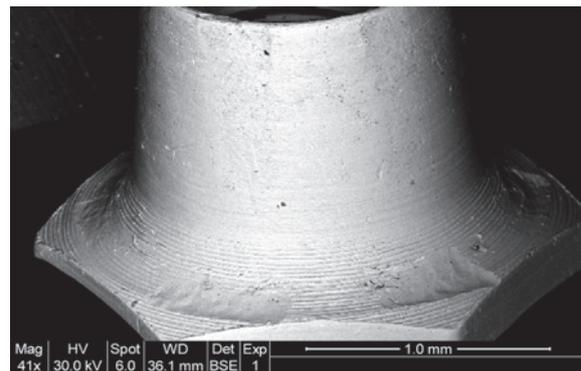
The fractograph of the Ti area (Figure 5a) reveals that the all fingers are absent even if there are the tracks of the previous presence. Indeed, on the rupture surface the titanium abutment hex and the fingers profile at the corner are observed. The fingers would have to open outward due to the action of the conical shape of the nut (Figure 5b). However, the finger marks on the nut suggest that fingers did not open enough and they foot down against the base of the nut. The fractograph of the fingers rupture surface evidences the advancement line of crack. The enlargement of the rupture zone of the fingers (Figure 6) evidences an area with fatigue features that implies low cycle high load [14] advancement line. The high load is due to the sum of preload of the screw and the external load. It is necessary to verify that the abutment fingers are in the proper position for a proper retention when placed into the implant, but in this case also a design problem may exist.

Fig. 5. (a) Rupture surface (interface between Ti and Pd zone): the hexagonal base and the fingers profile at the corner are observed; (b) Conical shape of the nut. The fingers would have to open outwards due to the action of the cone but they foot down against the base of the nut. The marks of the fingers are clearly visible.

The failure mode of the abutment hex is a low cycle high load and therefore oligocyclic mode. This failure mode is not included in the classification of modes of failure from literature. Probably there were two causes for the rupture of the connection hex:

- *assembly*, it is necessary to verify that the abutment fingers are in the proper position. If they foot down against the base of the nut the correct position is not verified;
- *design*, the angle of the cone was too small and did not allow for the correct opening of the fingers.

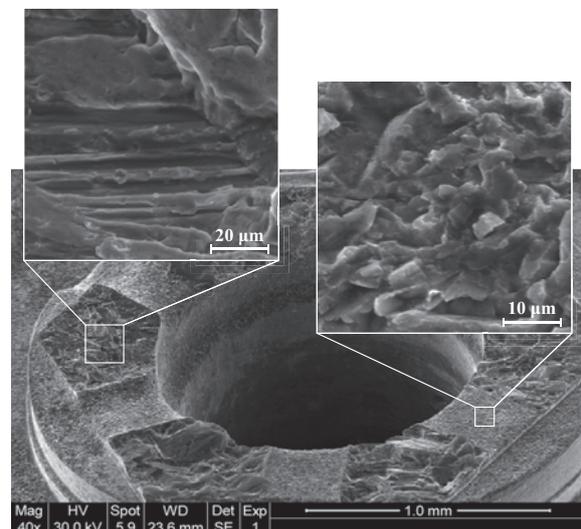
Fig. 6. Rupture surface: the enlargement evidences the presence of fatigue features that implies low cycle high load advancement line.

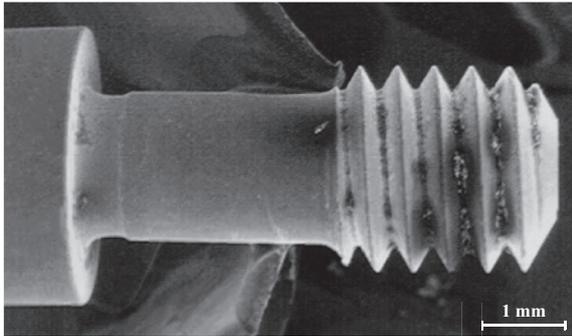
Chronic implant screw loosening remains a problem in restorative practices [15]. Figure 7 shows a SEM image of a screw whose loosening of retention caused the removal of the

Fig. 7. SEM image of the gold screw; no tracks of Ti (bushing material) and no damages are observed on the screw thread.

abutment. No tracks of Ti (bushing material) were observed on the screw except in the area of beat between the screw and the bushing. No damages were observed on the screw thread.

It appears however that a tightening moment equal to the one suggested (320 N·mm) guarantees only few percentage of the optimal preload value. Therefore, the effective application of these tightening values does not intervene in the actual moment of blocking of the screw. This is in agreement with the observations carried out at SEM on the condition of the screw threading and with the data reported by some authors [15-17].

The observation of the retention screw after loosening did not reveal any damage of the thread. The joint failure was probably due to a lower joint preload. Studies have shown that a low preload causes significant micromotion between implant and abutment and may result in screw loosening in addition to biological complications [17]. The preload is obtained by applying a torque control, and the value of the torque is strictly related to the geometry of the implant, the material properties and material interactions, such as friction coefficient.
