A structural analysis of the Modena Cathedral / Baraccani, S.; Silvestri, S.; Gaspoarini, G.; Palermo, M.; Trombetti, T.; Silvestri, E.; Lancellotta, R.; Capra, A.. - In: INTERNATIONAL JOURNAL OF ARCHITECTURAL HERITAGE. - ISSN 1558-3066. - 10:2-3(2016), pp. 235-253. [10.1080/15583058.2015.1113344]

A structural analysis of the Modena Cathedral

THE STRUCTURAL ANALYSIS OF THE MODENA CATHEDRAL

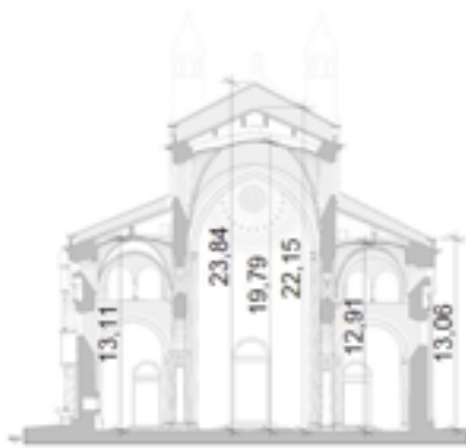
Figure 2. a) A 3D view of the Modena Cathedral (Google Earth); b) Cross-section of the Cathedral of Modena

The in-plan geometry is approximately 25 m wide (in the transversal direction) times 66 m long (in the longitudinal direction), for an area of roughly 1650 m². The maximum roof height is approximately 24 m (Figure 2). The Cathedral has a Latin cross plant with three naves, a false transept and the chancel (the area of the liturgical altar) in an elevated position, due to the presence of a crypt containing the corpse of the city's patron, Saint Geminianus.

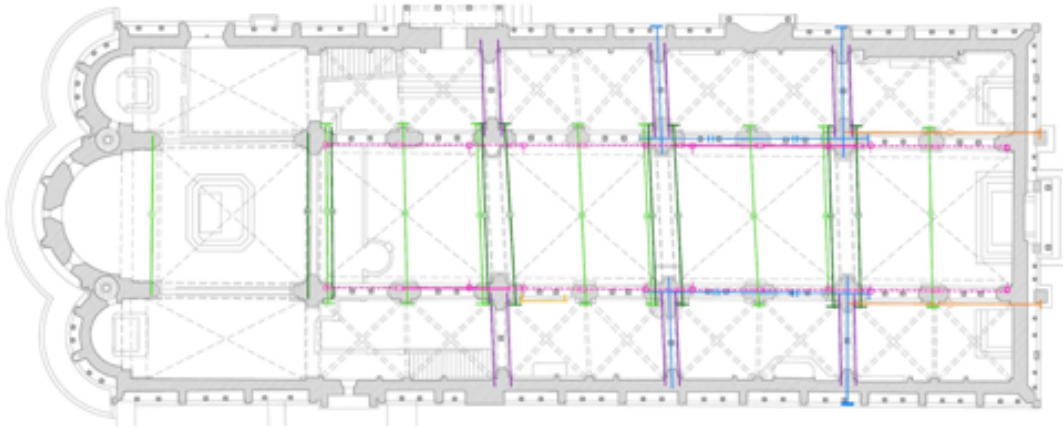
Figure 5. Survey of the tie-rods installed on the Cathedral during the years and respective photographers.

Several interventions after the end of the construction (end of XXII century) were carried out during the years. According to most critics, the roof system, initially made of wooden trusses system arranged in the transversal direction, was rebuilt starting from the 1413. The orientation of the principal beams were changed when the vaults of the naves were constructed. Probably during this phase, the wooden beams have been renewed. This intervention probably caused further deformations of the longitudinal walls. Later, other interventions were necessary to retrofit the Cathedral after the earthquakes occurred in the 1501, 1505 1671 and 1832. The main interventions affected the vaults, the arches, the façade and the portions of walls adjacent to the Ghirlandina tower (Dondi 1896). In the following years, additional strengthening interventions were performed, such as refilling the main cracks, repairing the roof (new wood structures connected to the masonry wall trough tie-rods) and better connecting the walls through iron tie-rods in the naves at different heights (Figure 5).

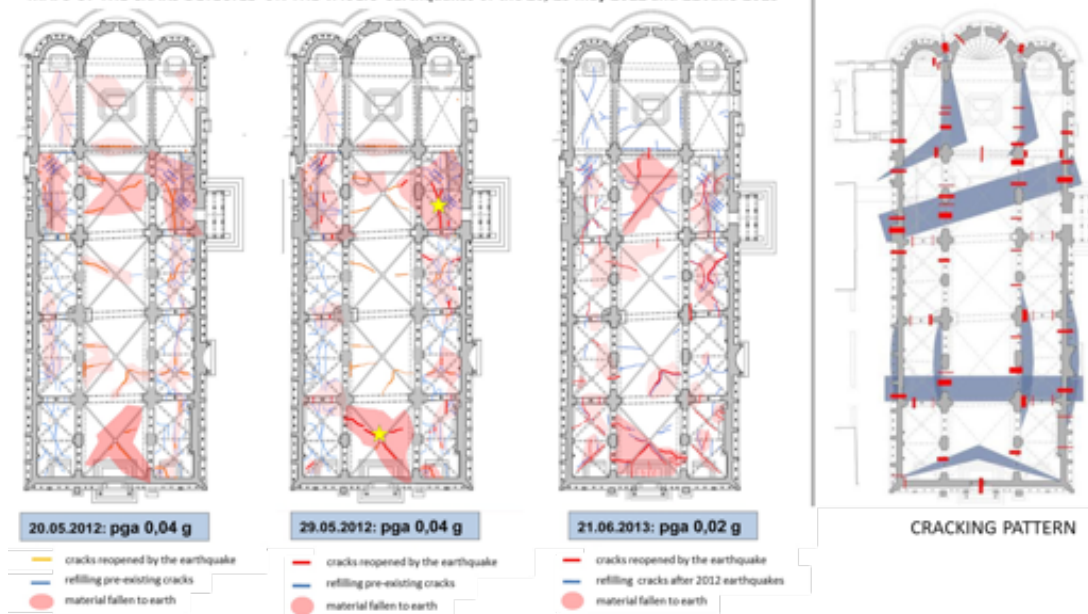
Figure 7. a) Maps of the cracks detected on the vaults after the earthquakes of the 20 and 29 May 2012 and 21 June 2013 and comparison with the crack pattern and b) photographs on the damage caused by recent earthquakes.

During the survey after the 2012 Emilia Earthquake, new cracks appeared in the intrados of the main vaults. Moreover, also an evolution of some existing cracks has been observed (Figure 7).

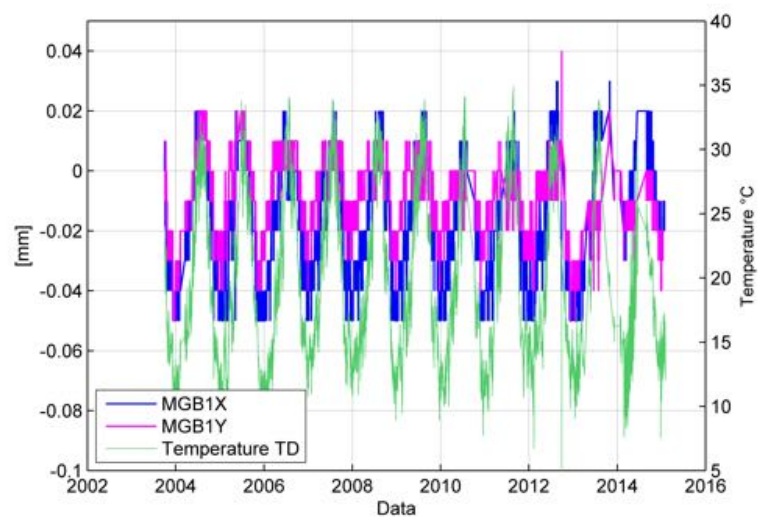
Figure 9. a) Trend recorded by the biaxial joint meter MGB1 and the temperature TD, b) Trend recorded by the biaxial joint meter MGB2

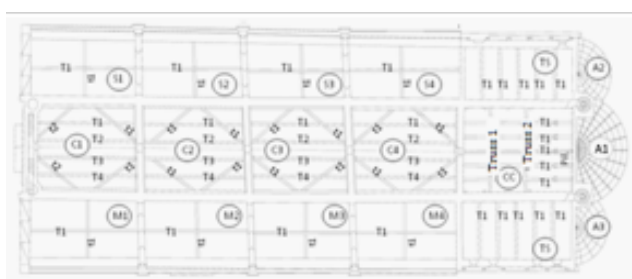
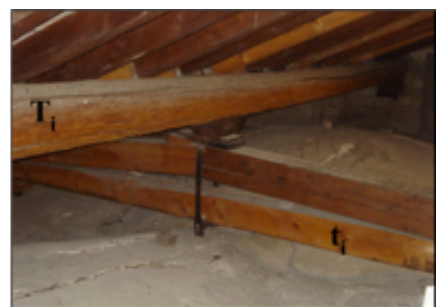
Figure 12. a) Structural roof elements and b) Main beams (T_i) and trusses system (t_i)

The actual roof geometrical configuration is made of principal beams arranged in the longitudinal direction, which rest on secondary beams or transversal trusses systems (indicated as T_i and t_i respectively, in Figure 12).

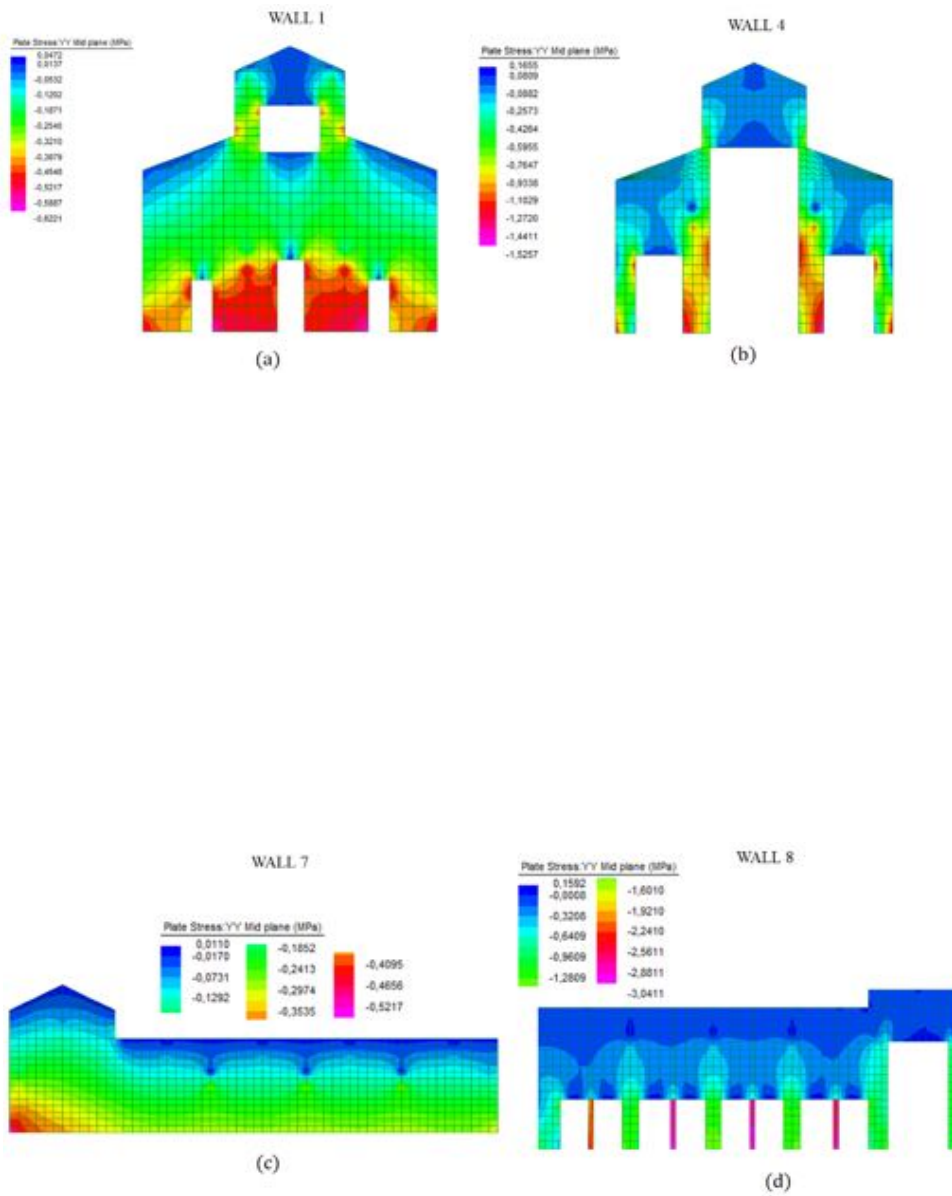
Figure 15. Contour maps of the normal stresses at the base of some walls obtained with two-dimensional FE models: (a) Wall 1; (b) Wall 4; (c) Wall 7; (d) Wall 8;

First, the results of the simple hand-made schematizations in terms of stress levels at the base (Figure 14) are compared with those of the ideal perfectly vertical FE models (Figure 15). Then the influence of the actual geometrical configuration is accounted for.

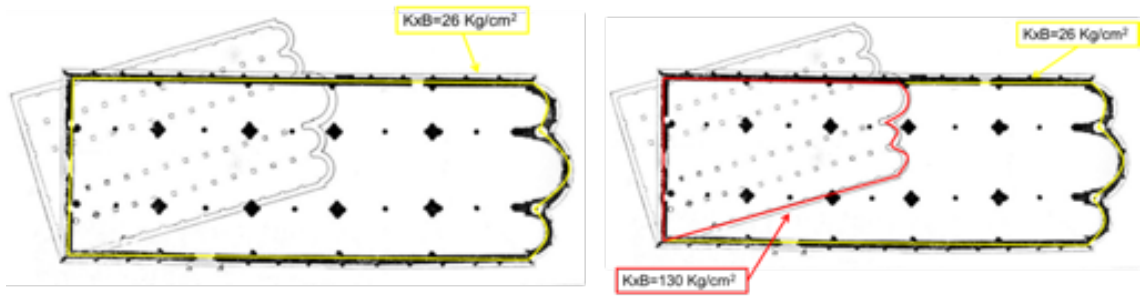
Figure 18- (a) Uniform distribution of Winkler's constant (W1) and (b) Non Uniform distribution of Winkler's constant (W2).

- Fixed base condition (F): soil is assumed to be rigid;
- Roller (R): the soil is assumed to be rigid in the vertical direction and with negligible lateral stiffness;
- Winkler 1 (W1): the soil is assumed to have a constant vertical stiffness (see figure 18(a)) while the lateral stiffness is assumed to be proportional to the applied axial load
- Winkler 2 (W2): two different vertical stiffness are used to account for the presence of the ancient cathedral of the XI century (see figure 18 (b)), while the lateral stiffness is assumed to be proportional to the applied axial load.
