# A structural analysis of the Modena Cathedral

## **THE STRUCTURAL ANALYSIS OF THE MODENA CATHEDRAL**

**KEY WORDS:** historic monuments, integrated knowledge, structural behaviour, limit schematizations, finite element models.

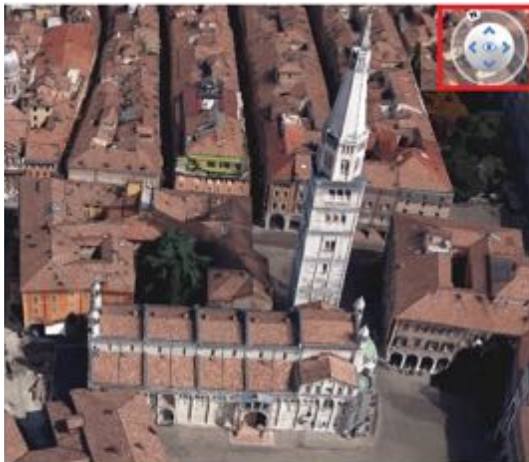
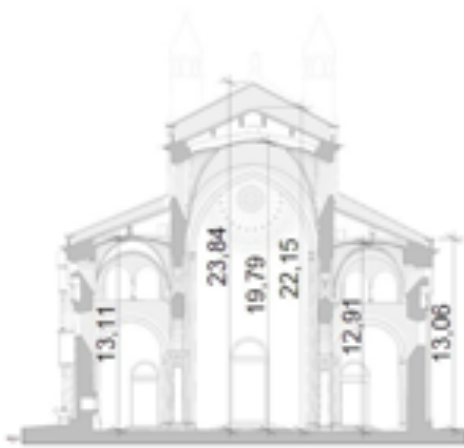
Figure 2. a) A 3D view of the Modena Cathedral (Google Earth); b) Cross-section of the Cathedral of Modena

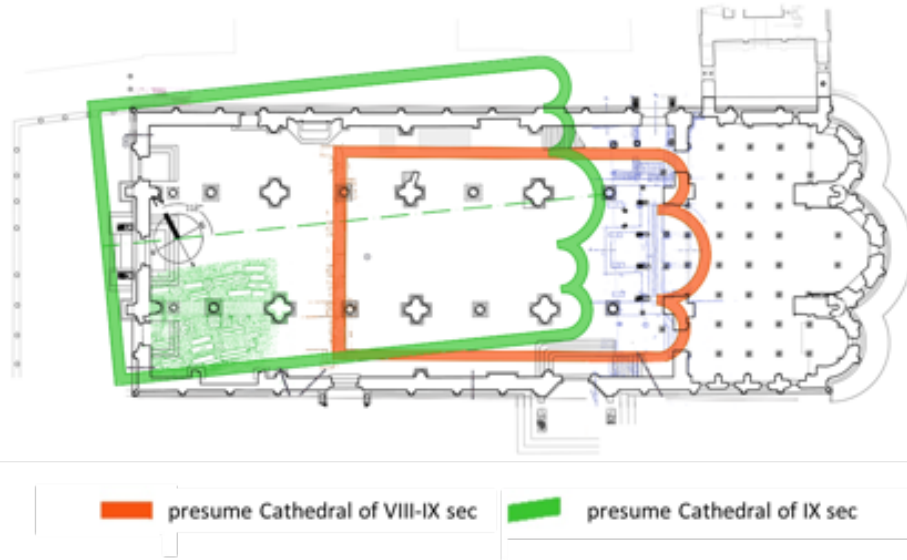
Figure 3. The pre-existing cathedrals

Three cathedrals were built on the necropolis containing the tomb of St. Geminiano (the founder of the church of Modena), before the current one (Labate 2007). The tombstone is the only remaining evidence of the first cathedral. A second cathedral was erected in the same place around the VIII-IX century. The remains indicate that the church had a length of around 32 m and width of 18 m. The presence of polylobate pillars (Bertoni 1914), discovered during past excavations, allow supposing the existence of another cathedral, presumably built around the XI century (Figure 3) (Frankl 1927).

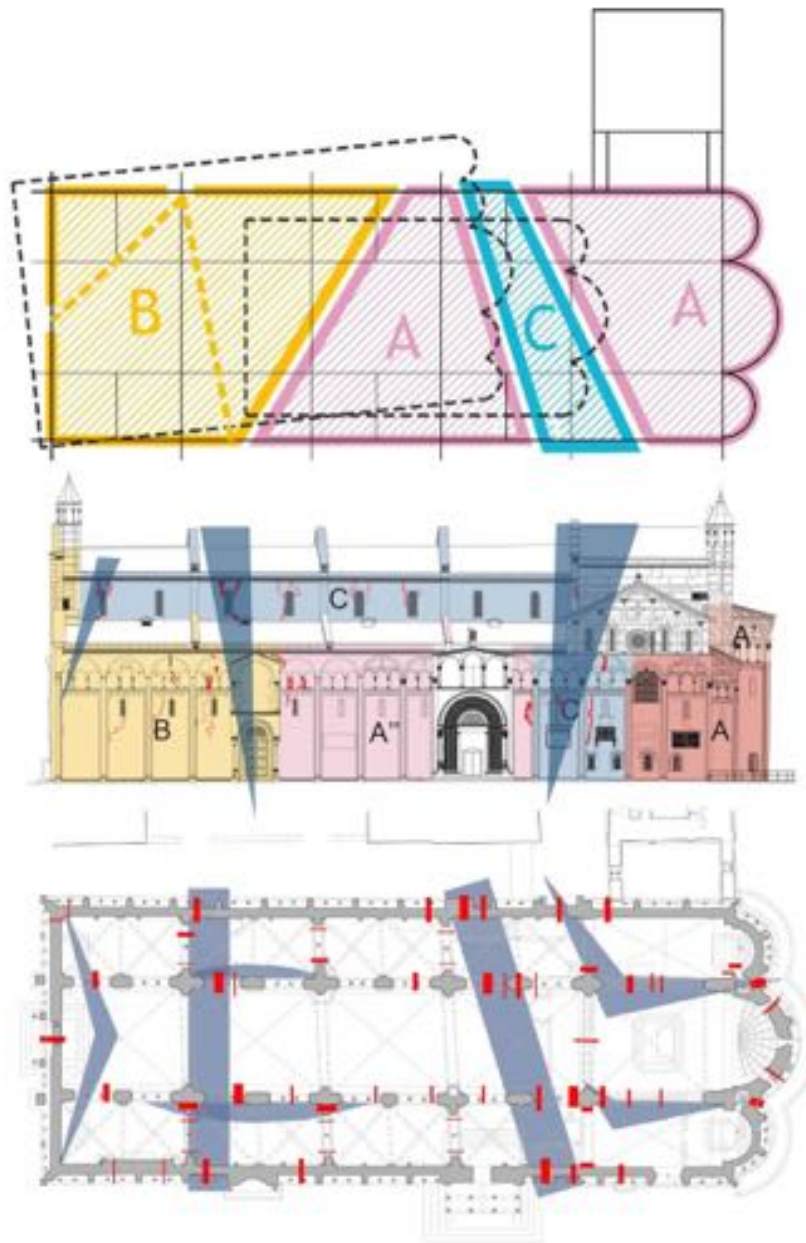
Figure 4. Relationship between the construction phases and the cracking pattern

was interrupted in order to maintain the portions of the pre-existing cathedral (phase C). According to more recent historical studies (Silvestri 2013), the construction did not proceed in parallel from the two sides, namely the main façade and the apsis, but started from the apses to end with the main façade (phases A and B). In light of this alternative hypothesis, the phase C was necessary to repair some damages due to early soil settlements manifested during the first two phases. Figure 4 graphically represent the three construction phases according to the last hypothesis.

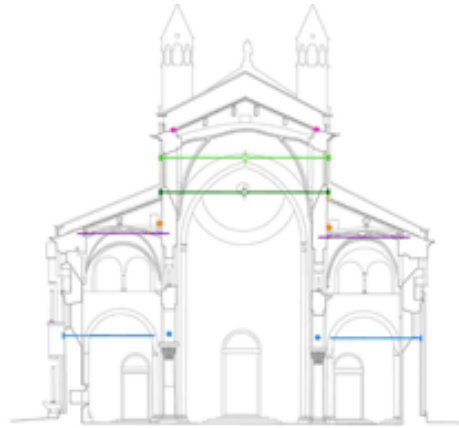
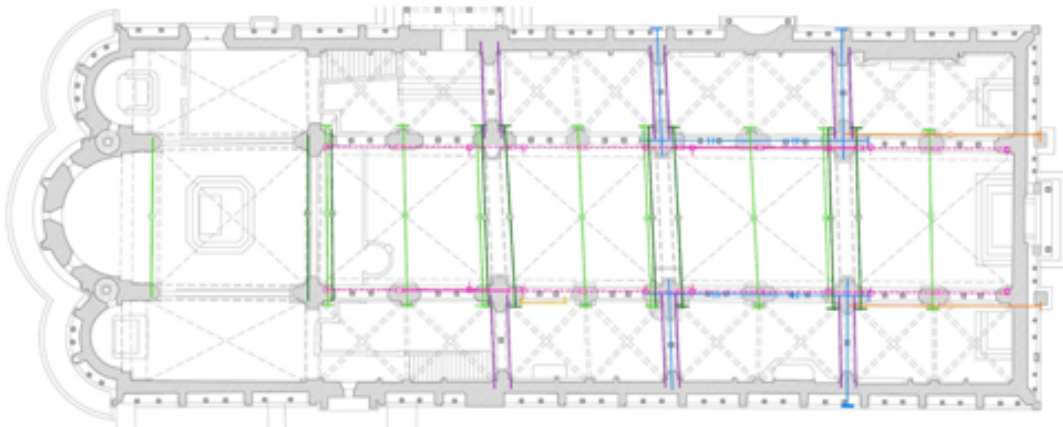
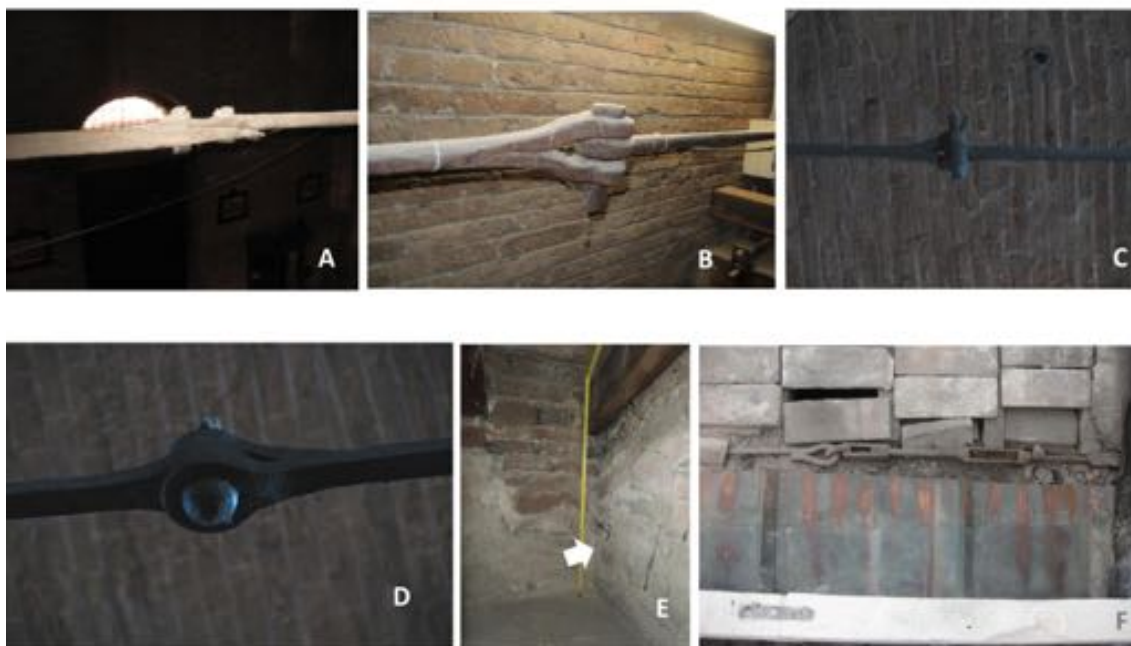
Figure 5. Survey of the tie-rods installed on the Cathedral during the years and respective photographers.

Several interventions after the end of the construction (end of XXII century) were carried out during the years. According to most critics, the roof system, initially made of wooden trusses system arranged in the transversal direction, was rebuilt starting from the 1413. The orientation of the principal beams were changed when the vaults of the naves were constructed. Probably during this phase, the wooden beams have been renewed. This intervention probably caused further deformations of the longitudinal walls. Later, other interventions were necessary to retrofit the Cathedral after the earthquakes occurred in the 1501, 1505 1671 and 1832. The main interventions affected the vaults, the arches, the façade and the portions of walls adjacent to the Ghirlandina tower (Dondi 1896). In the following years, additional strengthening interventions were performed, such as refilling the main cracks, repairing the roof (new wood structures connected to the masonry wall trough tie-rods) and better connecting the walls through iron tie-rods in the naves at different heights (Figure 5).

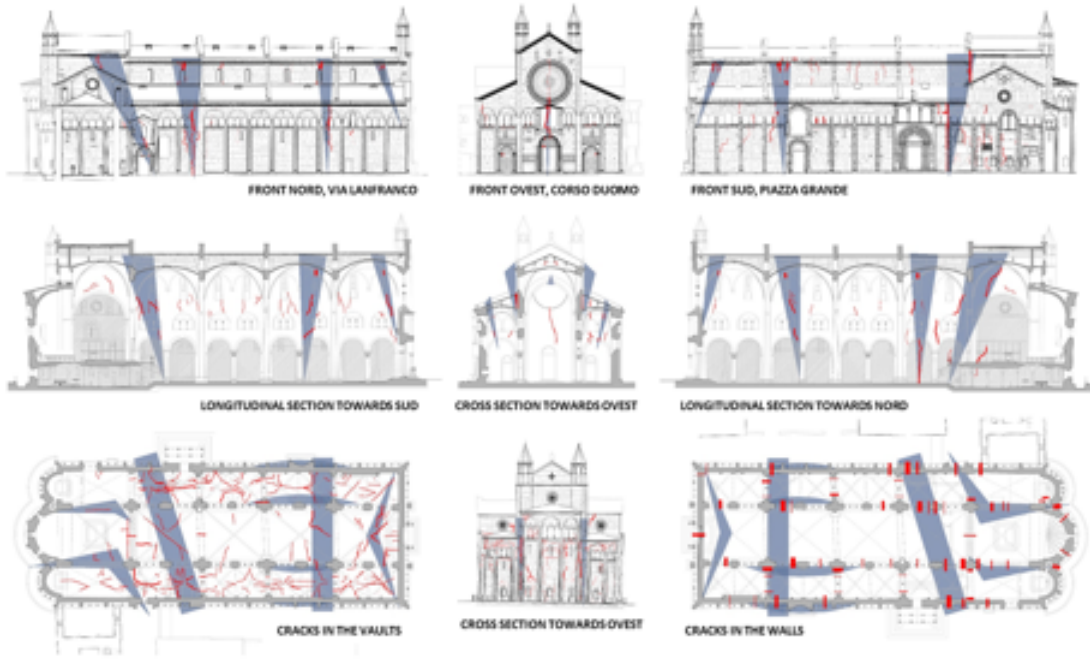
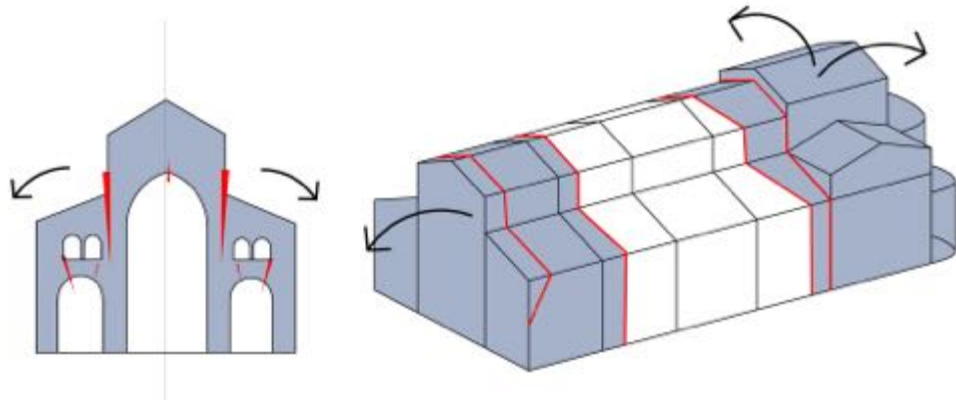
Figure 6. a) Crack pattern of the Cathedral of Modena and b) main failure mechanisms of the Cathedral on the longitudinal and transverse direction

The initial crack pattern (2010) has been identified not only to monitor the state of the main cracks but also to correlate their location within the construction phases and main interventions. The analyses of past studies also helped in the classification of the cracks. In particular, the correlation between the damage and the past interventions allow to identify probable causes and distinguish between stable cracks and still evolutionary situation. The major cracks are displayed in Figure 6. The main cracks are indicated in red, while grey areas indicates concentration of cracks, i.e. portions of potential high vulnerabilities. It can be noted:

- a large vertical crack is located in the main facade, just below the big rose window;
- a concentration of cracks has been identified in the connection between the walls, all along the portion of the building constructed during the phase C, in the fourth span from the west;
- another cracks concentration appears near the main facade, along a line parallel to the façade, in the second span from the west;
- vertical cracks along the main transversal walls and arches separating the central naves from the lateral naves;
- the grey areas are mainly located in the portion of the cathedral coinciding with the location of the old ones.

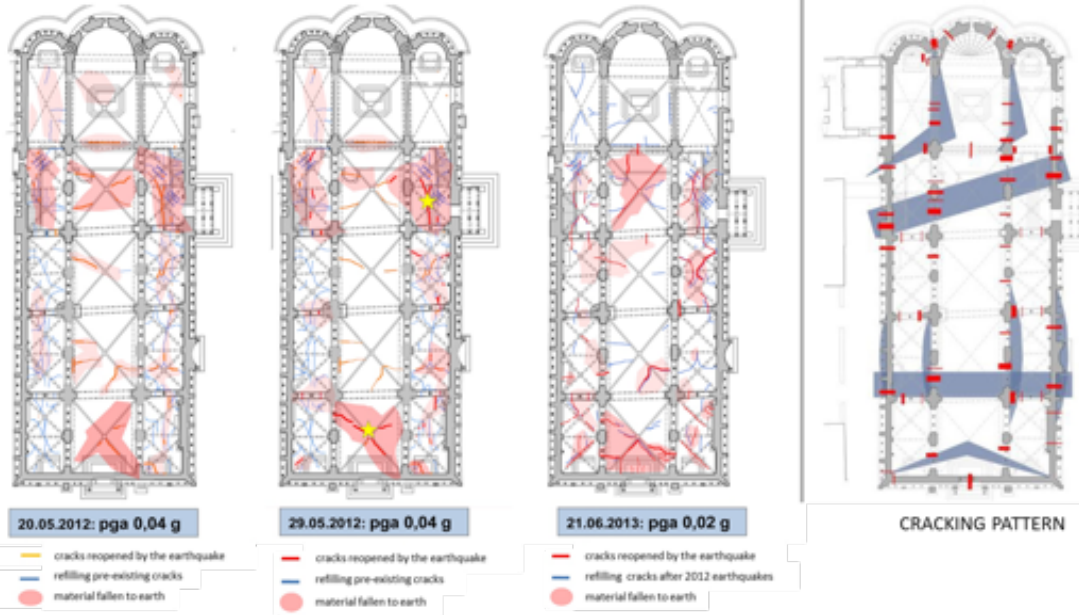
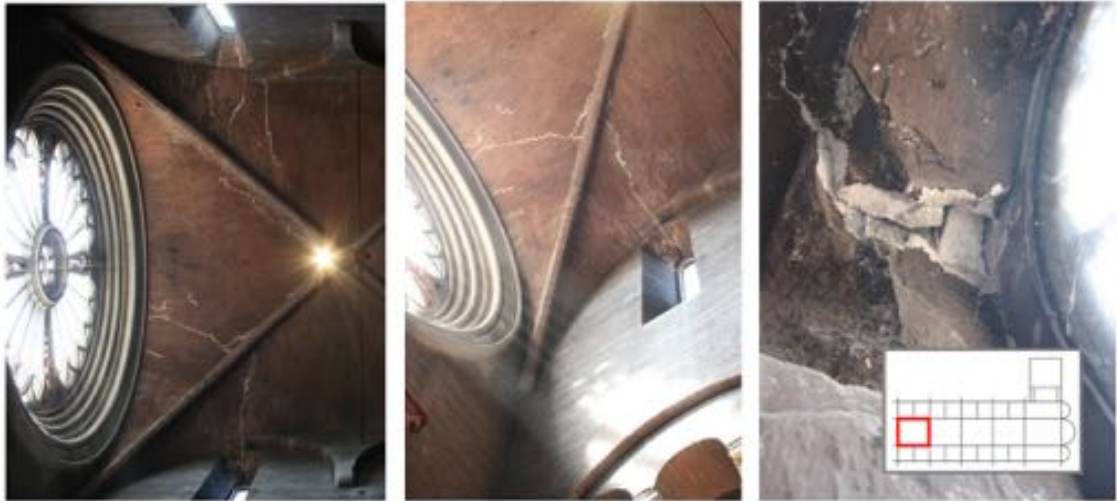
Figure 7. a) Maps of the cracks detected on the vaults after the earthquakes of the 20 and 29 May 2012 and 21 June 2013 and comparison with the crack pattern and b) photographs on the damage caused by recent earthquakes.

During the survey after the 2012 Emilia Earthquake, new cracks appeared in the intrados of the main vaults. Moreover, also an evolution of some existing cracks has been observed (Figure 7).

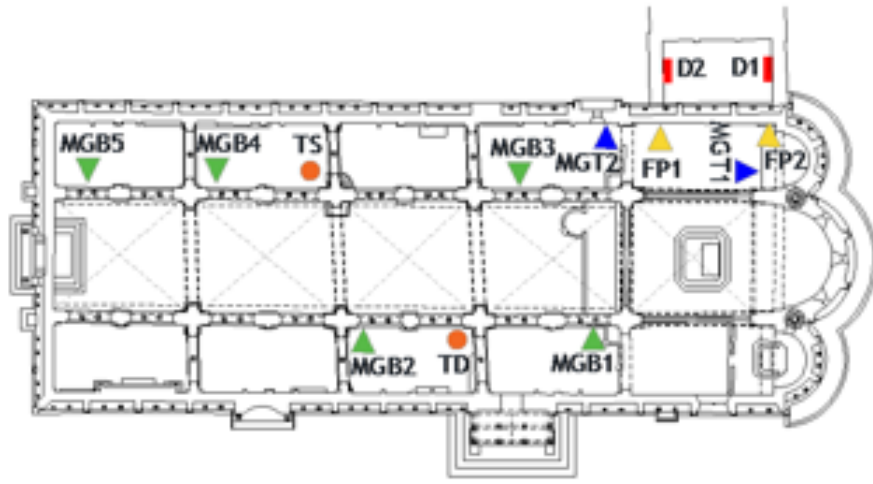
Figure 8. Location of the device installed on the Cathedral

The monitoring system installed in the Cathedral is composed of biaxial and triaxial joint meters (MGB-MGT), inclinometers (FP), deformometers (D) and thermometers (T) to monitor the main cracks across the walls and vaults, the inclination of the external longitudinal walls, the relative displacements between the cathedral and the tower and the internal temperature, respectively (Baraccani et al. 2014). A plan view with the indication of all installed instruments is provided in figure 8. For instance, the record of a biaxial joint meter (MGB1) is displayed in Figure 9a together with the record of the thermometer. A strong correlation of the oscillations with the thermal excursions may be noted. For the sake of conciseness, only the most significant results as obtained from the 10 years of monitoring by the joint meter can be summarized as follows (see also Figure 10):

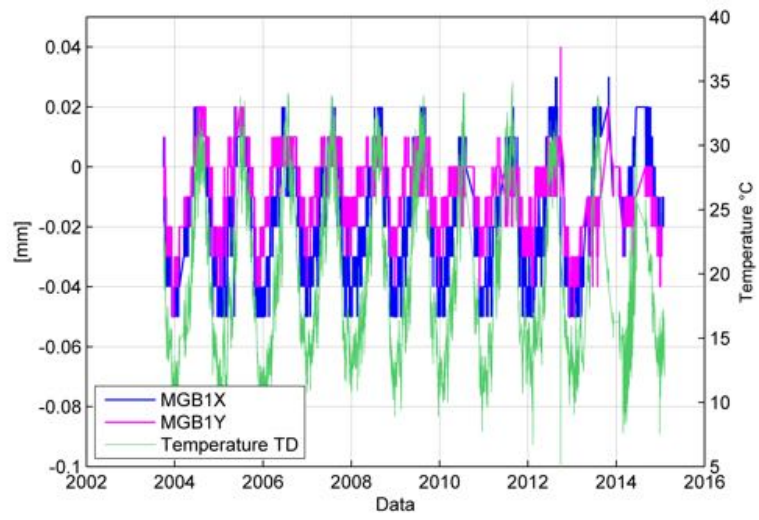
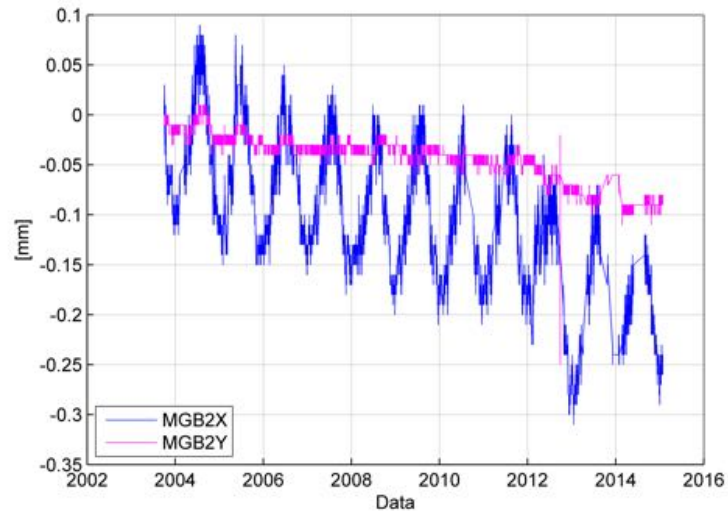
Figure 9. a) Trend recorded by the biaxial joint meter MGB1 and the temperature TD, b) Trend recorded by the biaxial joint meter MGB2

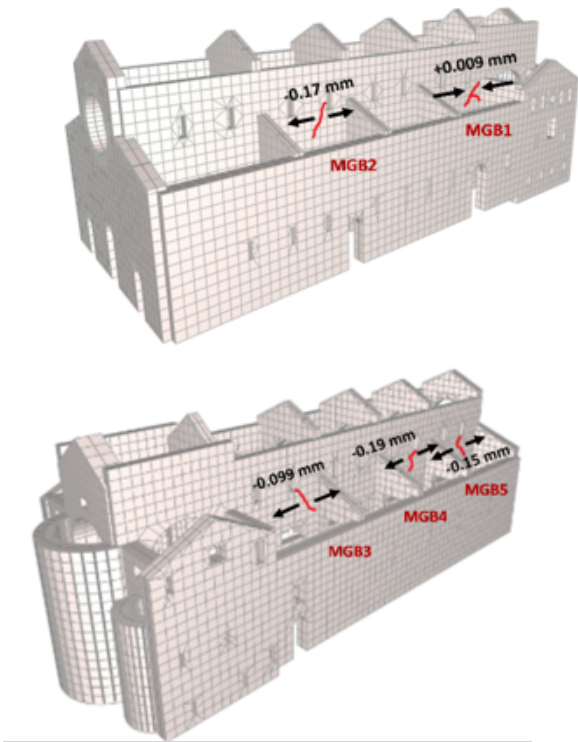
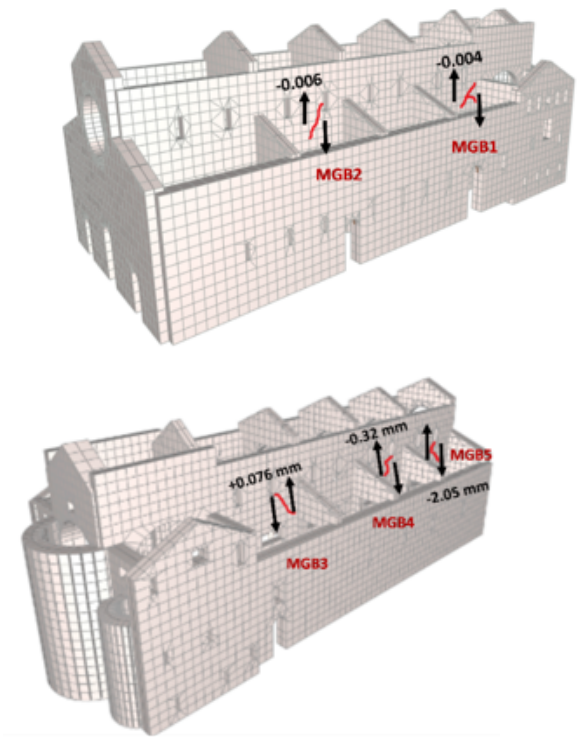
Figure 10- a) Amplitude variations in the X direction of the cracks observed by MGB1-2-3-4-5, b) Movements in the Y direction of the cracks observed by MGB1-2-3-4-5

- the average daily oscillation is around  $1\cdot7\cdot10^{-3}$  mm;
- the average annual oscillation is around  $1\cdot40\cdot10^{-2}$  mm;
- in general a quite stationary response is observed, with the exception of few instruments (such as MGB2, see Figure 9b), which show a slightly increasing trend (average annual rate around  $10^{-2}$  mm/year).

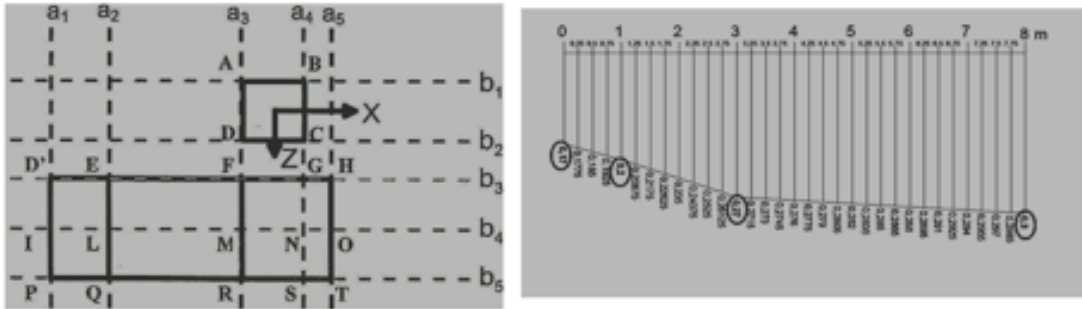
Figure 11. Imposed vertical differential displacements at the base due to the interaction between the Cathedral and the Ghirlandina Tower

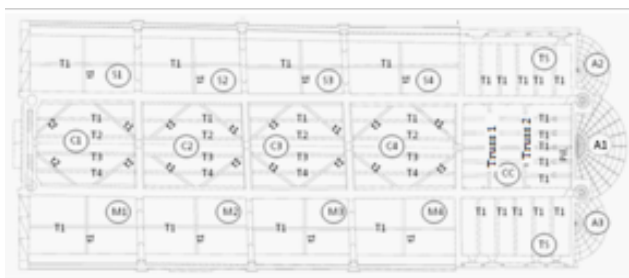
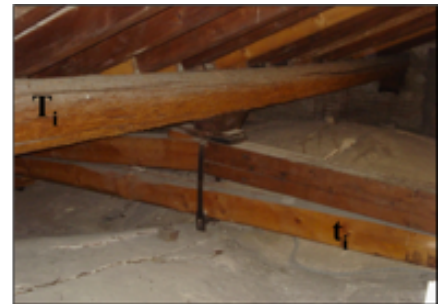
Figure 12. a) Structural roof elements and b) Main beams ( $T_i$ ) and trusses system ( $t_i$ )

The actual roof geometrical configuration is made of principal beams arranged in the longitudinal direction, which rest on secondary beams or transversal trusses systems (indicated as  $T_i$  and  $t_i$  respectively, in Figure 12).

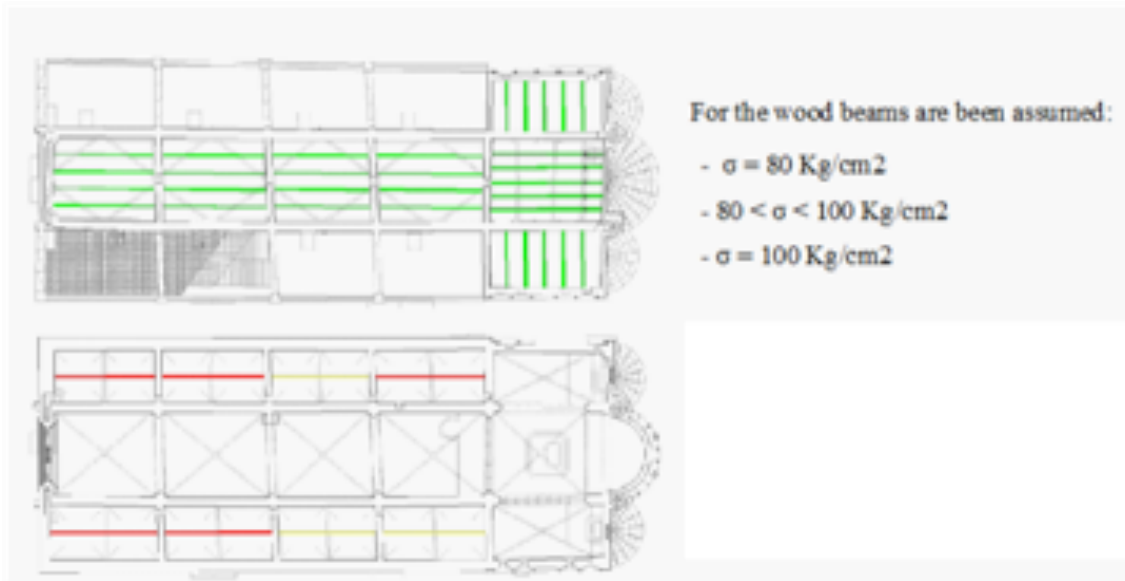
Figure 13. Stress level of the roof elements

Maximum normal stresses for the main beams due to self-weight only are around: 50 kg/cm<sup>2</sup> for the central nave, 80 kg/cm<sup>2</sup> for the area of transept, 100 kg/cm<sup>2</sup> for the aisles. The addition of the snow load lead to an increase in the maximum stresses of about 35% leading to maximum stresses close to material strengths. In detail, Figure 13 shows the stress levels (in a colour scale) of the roof beams. The stress levels in the secondary elements (trusses) are of the order of 10-15 kg/cm<sup>2</sup>, well below material strengths. It is worth to note that, due to the absence of specific tests performed on the wood elements, the assumed strength is conservative.

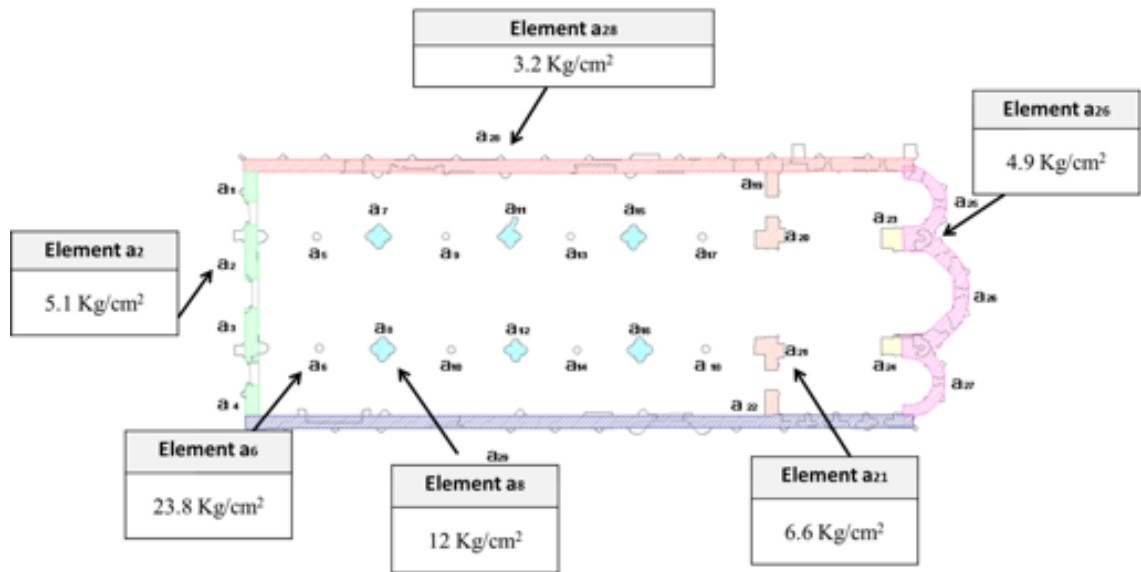
Figure 14. Reference values of the stress level at the base of the principal structural elements.

First, the results of the simple hand-made schematizations in terms of stress levels at the base (Figure 14) are compared with those of the ideal perfectly vertical FE models (Figure 15). Then the influence of the actual geometrical configuration is accounted for.

In the case of full masonry, the normal stresses due to only self-weights only are between 3-8 kg/cm<sup>2</sup> for the exterior walls and between 10-14 kg/cm<sup>2</sup> for the masonry pillars. Assuming an “a sacco” masonry (the contribution of the internal fill in terms of strength is neglected), the normal stresses due to the self-weights only doubled, when compared to the limit case of the full masonry.

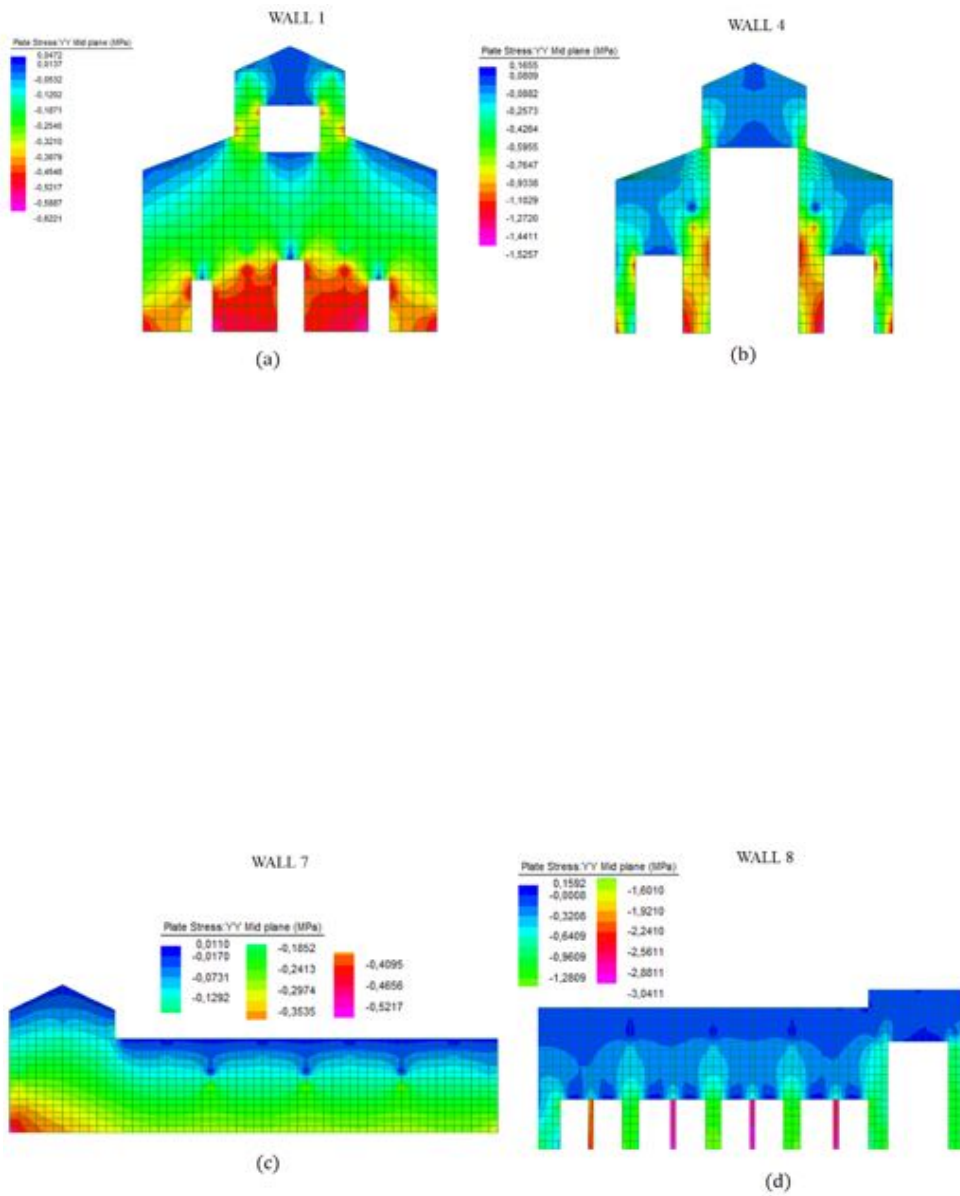
Figure 15. Contour maps of the normal stresses at the base of some walls obtained with two-dimensional FE models: (a) Wall 1; (b) Wall 4; (c) Wall 7; (d) Wall 8;

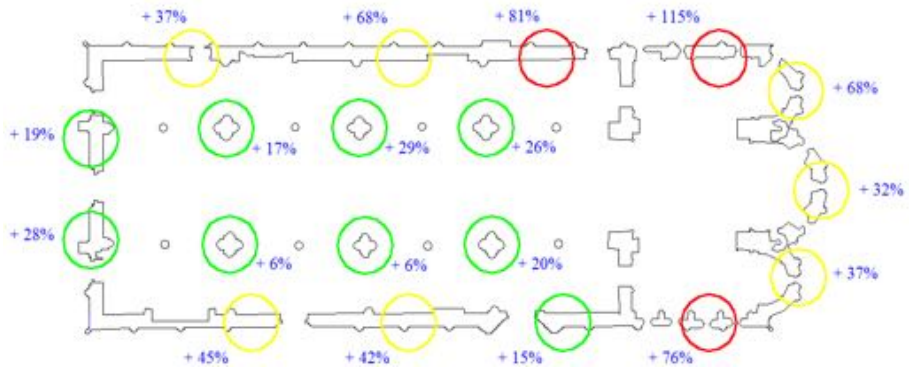
Figure 16. Increments of the stress at the base of the walls due to the inclination of the vertical elements.

To account for the walls overhanging, in a simplified way, the thrusts transmitted by the internal arches have been calculated and applied at the top of the walls to estimate the increase in the normal stresses. Figure 16 provides a schematic plan indicating the percentage increment of the normal stresses at the base of the walls and pillars due to their inclination. The green color represents increments below 30%; the yellow color increments between 30% and 70%, while the red color represents increments larger than 70%. The ranges of the normal stresses at the base of the walls and pillars by also including the effect of walls inclinations are provided in the plan schematization displayed in Figure 17. Maximum stresses are around 15 kg/cm<sup>2</sup> for the masonry walls and 90 kg/cm<sup>2</sup> for the stone pillars. All values are well below material strenghts.

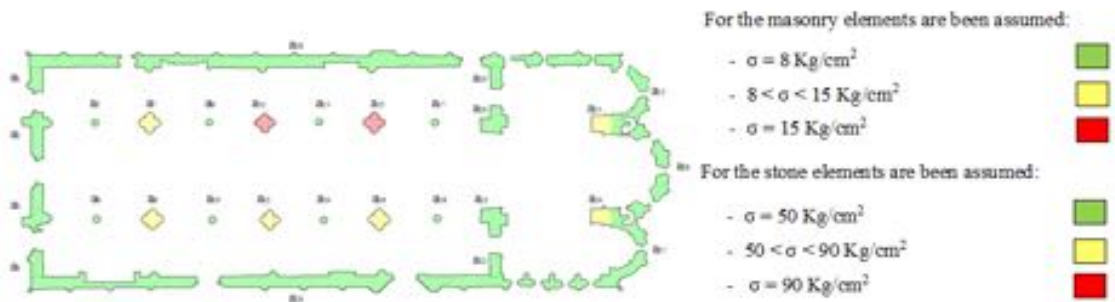
Figure 17. Level of stress at the base of the vertical elements including the effects of the inclinations.

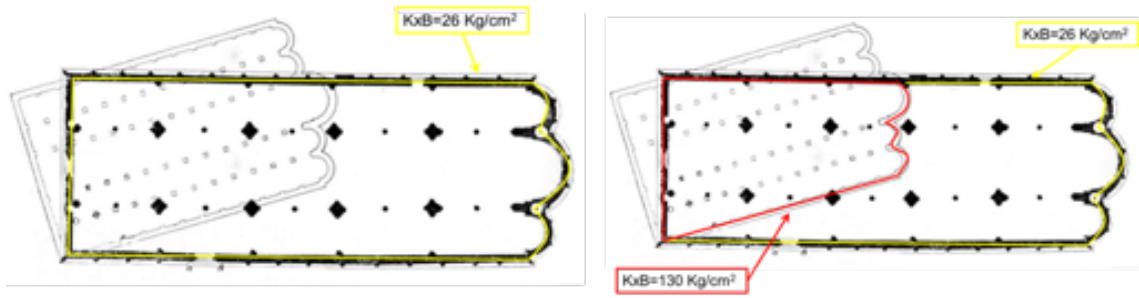
Figure 18- (a) Uniform distribution of Winkler's constant (W1) and (b) Non Uniform distribution of Winkler's constant (W2).

- Fixed base condition (F): soil is assumed to be rigid;
- Roller (R): the soil is assumed to be rigid in the vertical direction and with negligible lateral stiffness;
- Winkler 1 (W1): the soil is assumed to have a constant vertical stiffness (see figure 18(a)) while the lateral stiffness is assumed to be proportional to the applied axial load
- Winkler 2 (W2): two different vertical stiffness are used to account for the presence of the ancient cathedral of the XI century (see figure 18 (b)), while the lateral stiffness is assumed to be proportional to the applied axial load.

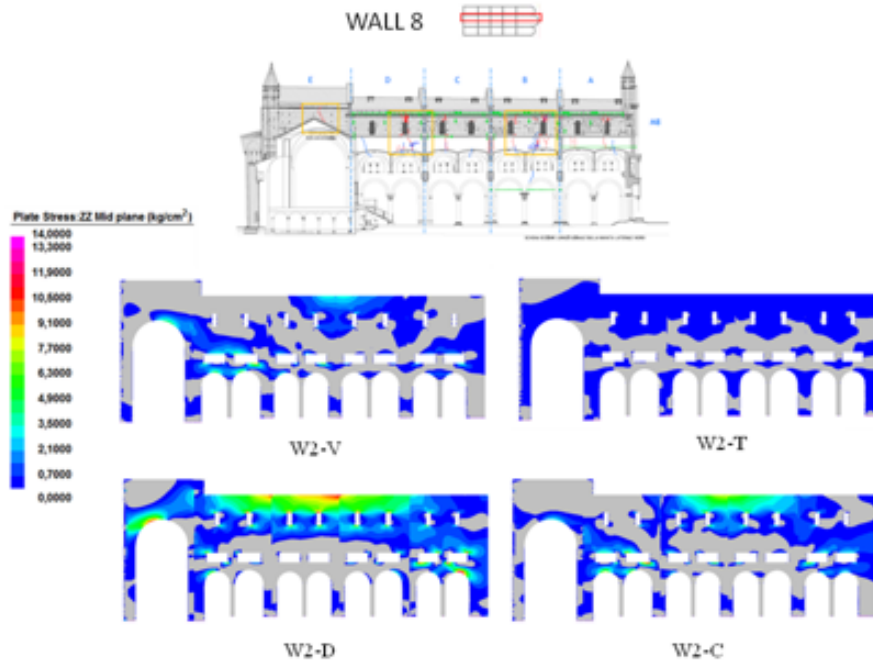
Figure 19. Stress of the wall 8 obtained from the W2 model with the different load cases and compared with the observed cracking patterns.

The stress state for a specific longitudinal wall and transversal wall as obtained from the UD-C and the W2 restrain considering all the single load cases is summarized in Figures 19 and 20. It can be noted that the locations of the peaks of the tensile stresses are in good agreement with the location of the main cracks.

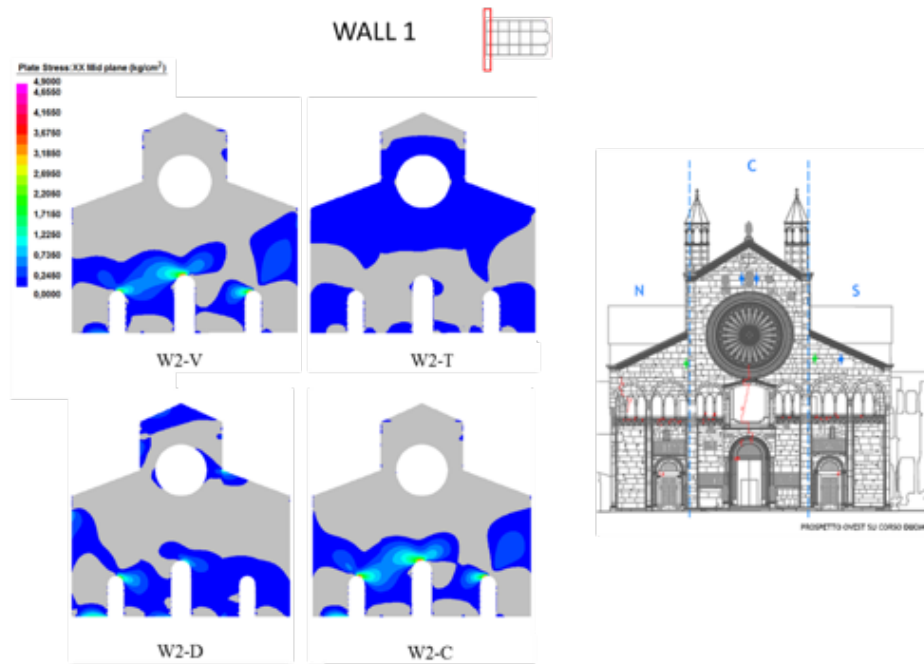
Figure 20. Stress of the wall 1 obtained from the W2 model with the different load cases and compared with the observed cracking patterns.

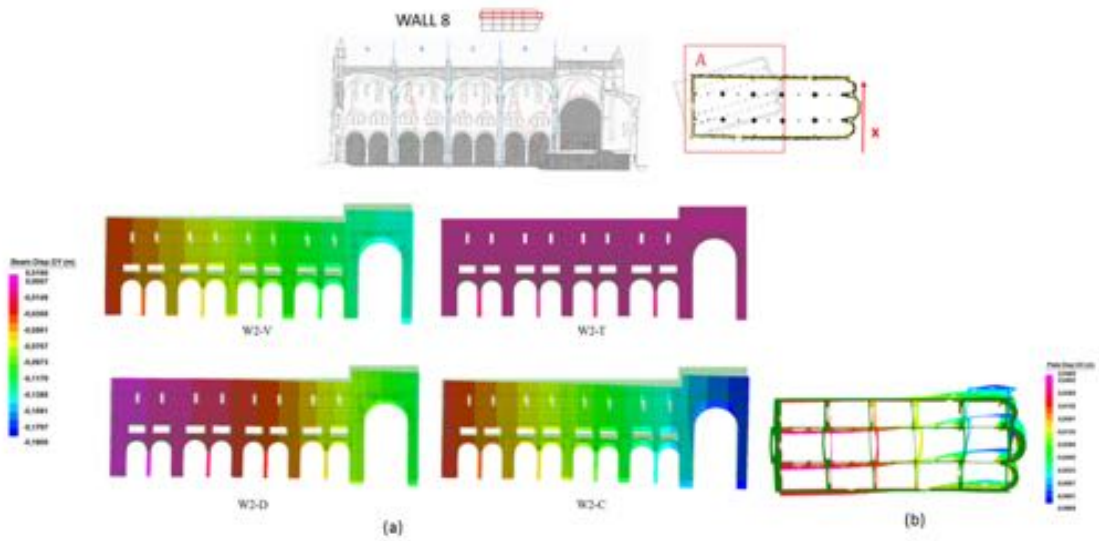
Figure 21. (a) in-plane deformed shape for the wall 8; (b) out-of-plane deformed shape (x direction) for all walls.

The in plane and out-of-plane deformed shapes for a specific longitudinal wall are represented in Figure 21 and compared with the results of the 3D laser scanning. The deformed shapes are consistent with the 3D laser scanning indicating that: (i) the presence of the ancient ruins of the pre-existing churches reduces the deformations within the zone A (as indicated in figure 21(a)); (ii) the interaction between the Cathedral and the Ghirlandina Tower causes significant out of plane displacements (Figure 21(b)) of the longitudinal walls, especially for those walls closer to the tower. These out-of-plane- displacements are quite larger than those caused by the arches thrust.

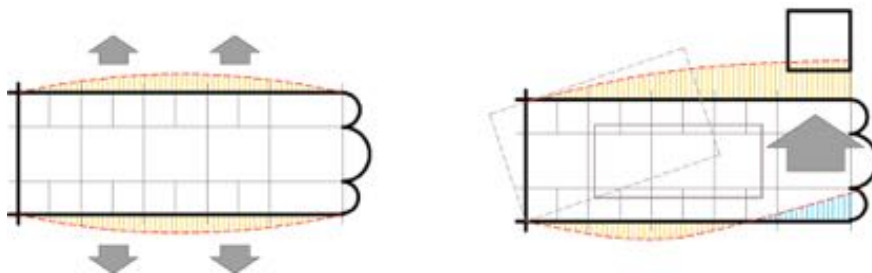
Figure 22- Original sketch of the main global movements of the Cathedral.
