A new methodological approach to assess the stability of discontinuous rocky cliffs using in-situ surveys supported by UAV-based techniques and 3-D finite element model: a case study

Fazio N.L.¹, Perrotti M.¹, Andriani G.F.², Mancini F.³, Rossi P.³, Castagnetti C.³, Lollino P.¹

ABSTRACT

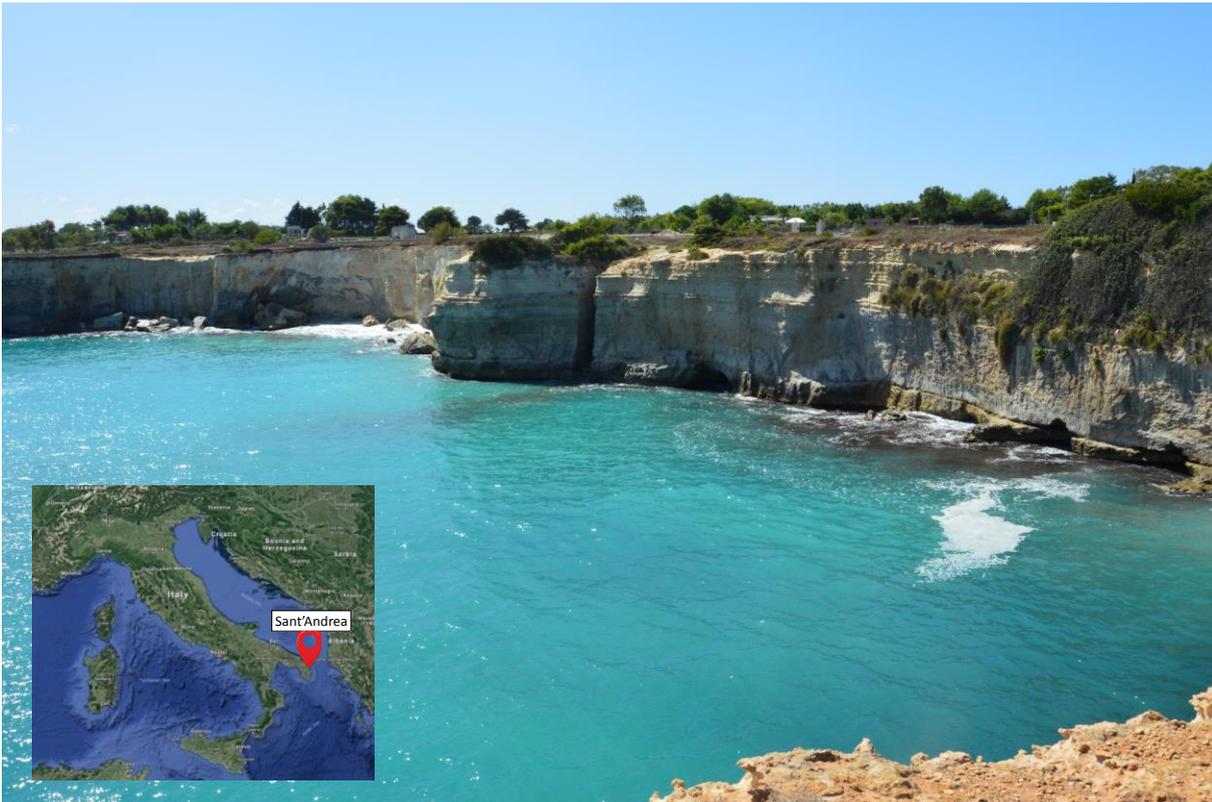
Figure 1. Frontal view of the sea cliff at Sant'Andrea (Melendugno, Apulia - southern Italy).

As a test case study, a 600 m long sea cliff along the southern Adriatic Sea (Fig.1; Sant'Andrea, Melendugno, Apulia - Italy) was surveyed by UAV photogrammetry and, later on, a 3-D finite element model was setup on a specific cliff sector. The study area is represented by a plunging cliff, where in-situ surveys were performed only in the cliff lateral areas and on the platform at the top of the cliff. This is a common situation along the coastline rocky cliffs, so that UAV can represent the unique instrument to acquire information about joint features. Hence, a 3D surface from UAV photogrammetry that fits the requirements for the geomechanical modeling has been developed and the main

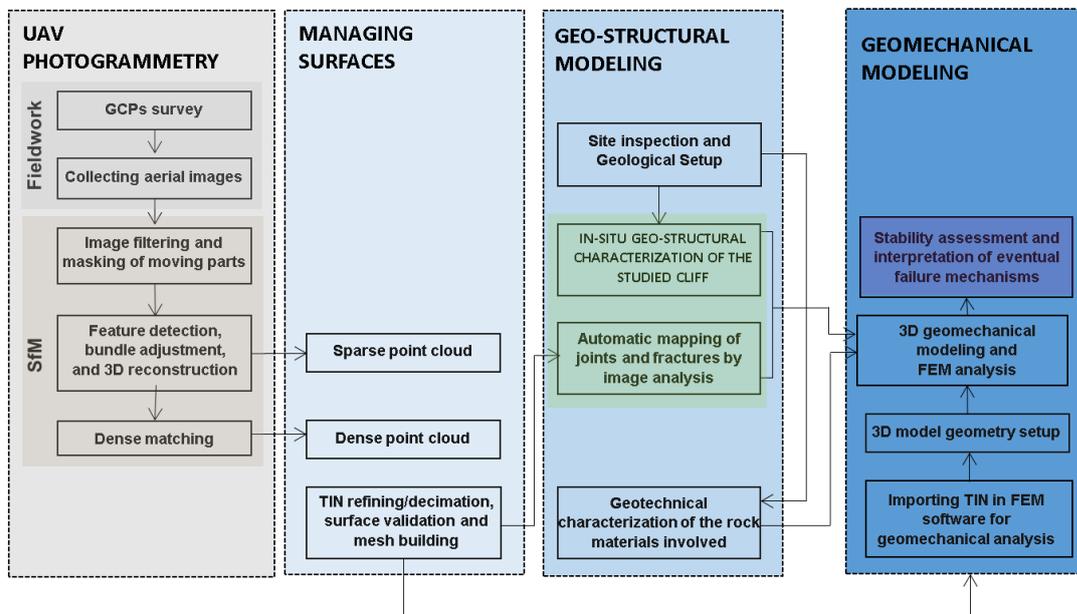
Figure 2. Workflow of the methodology adopted in the stability analysis of the cliff.

Accordingly, in this section a comprehensive methodology for the assessment of the stability of a coastal cliff is proposed, as follows (Fig. 2):

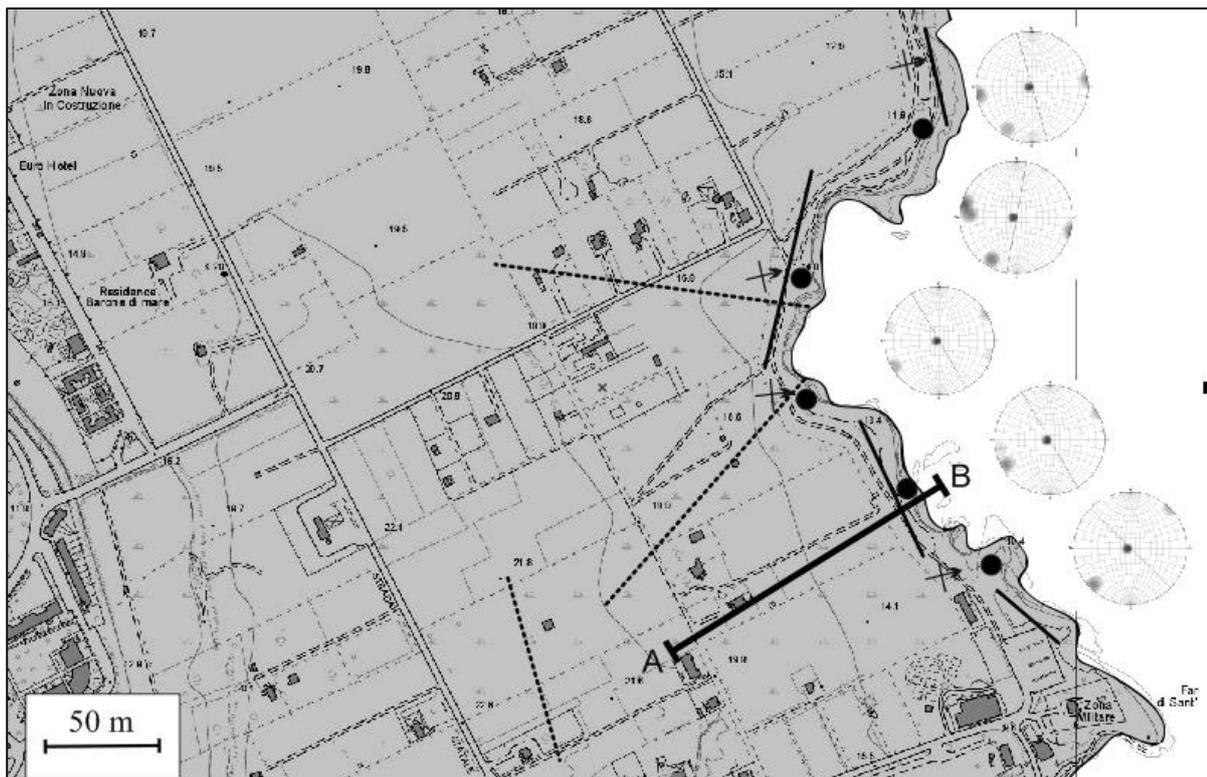
Fig. 3. Lithologic map of the study area with stereonet (lithologic cross-section in Fig. 5).

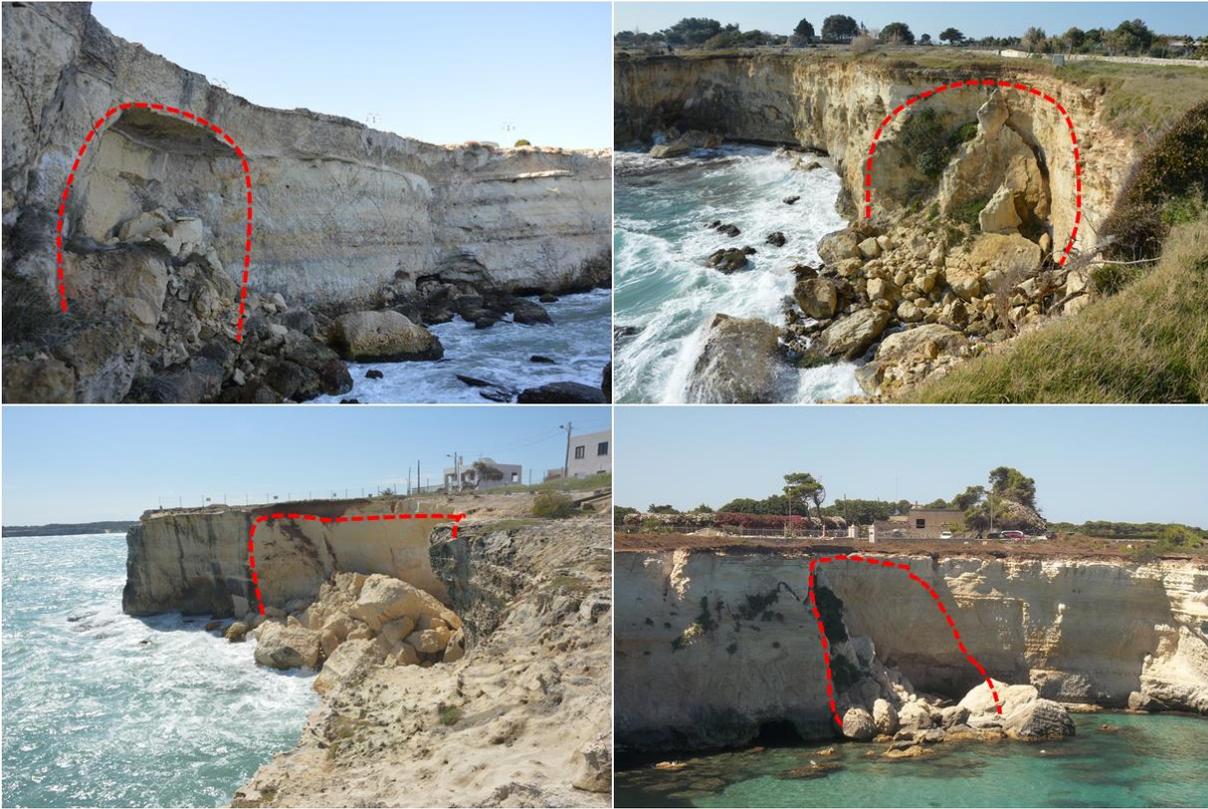
Figure 4. Rock blocks detached from the sea cliff, caps, inlets, arches and stacks in the area of Sant' Andrea.

shaped on Pliocene and Quaternary sediments. In particular, the coastal stretch examined is situated in a tectonically uplifting area with a generally indented development and a series of caps and inlets, arches, stacks and a small bay where an ephemeral water channel slightly incised reach the sea (Fig. 4).

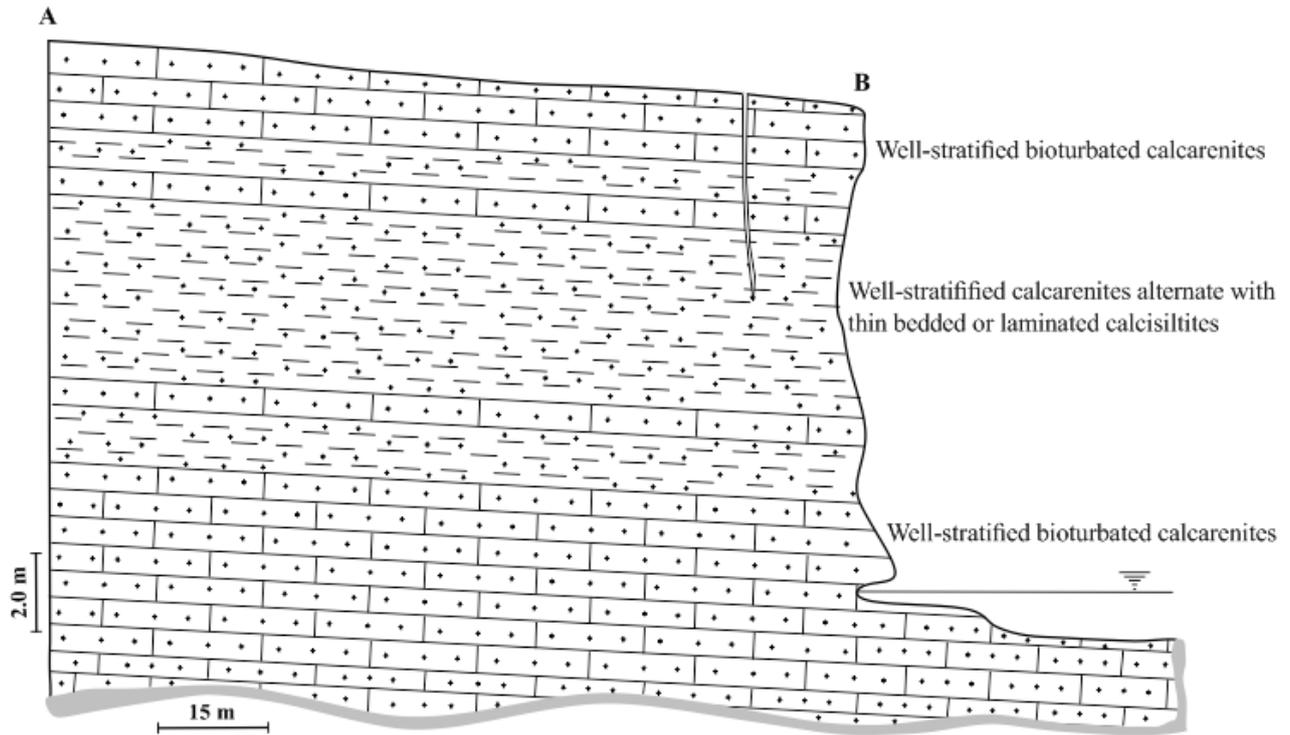
Figure 5. Lithological cross-section of the Sant'Andrea cliff (A-B section trace in Figure 3).

The rock materials cropping out along the cliff at Sant'Andrea belongs to two different lithofacies according to the stratigraphic sequence of calcisiltites and biocalcarenes as described in the previous section (Fig. 5). Each lithofacies constitutes de facto a geotechnical unit, quite different from the other in terms of physical properties and mechanical behavior, strongly conditioned by depositional fabric and diagenetic processes, but not for chemical and mineralogical composition because they are both carbonate-rich units. This implies heterogeneity in the rock masses along the cliff under the influence of differentiated erosion and weathering processes due to textural and structural features. In fact, the calcisiltites exhibit more susceptibility to erosion and degradation, both at the meso-scale and the macro-scale, than calcarenites and at places the instability mechanisms are just controlled by the contrast in shear strength and stiffness between the two units.

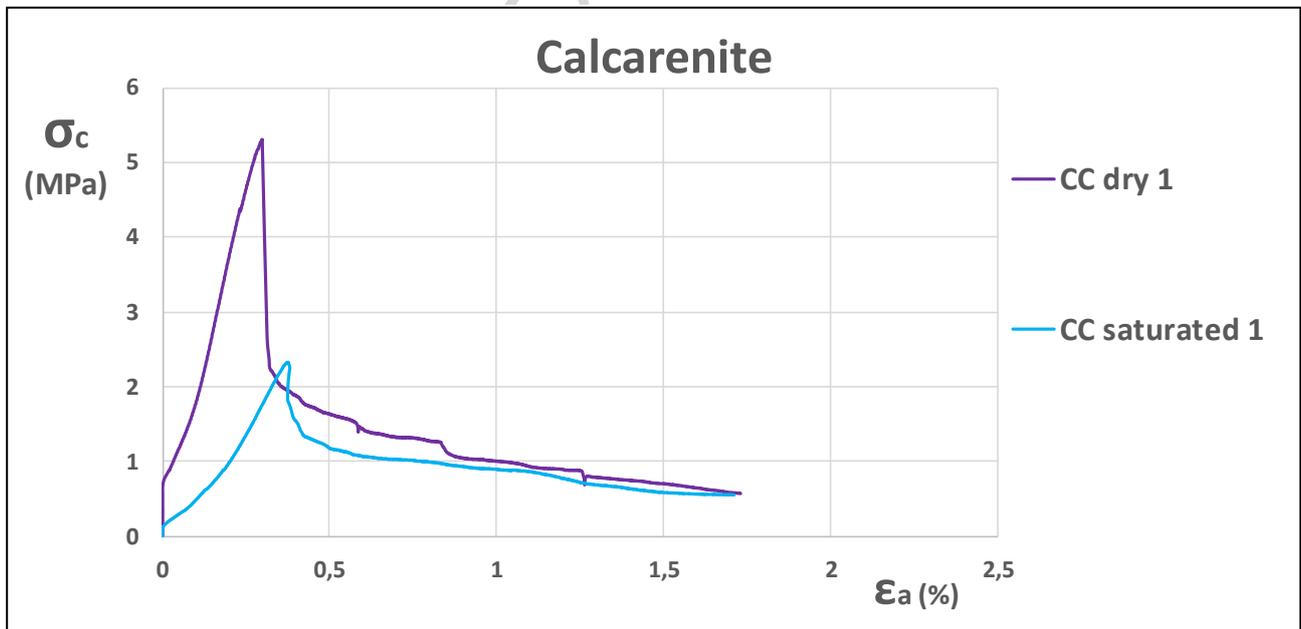
Figure 6. UCS stress-strain curves for the calcarenite samples obtained from the same rock block.

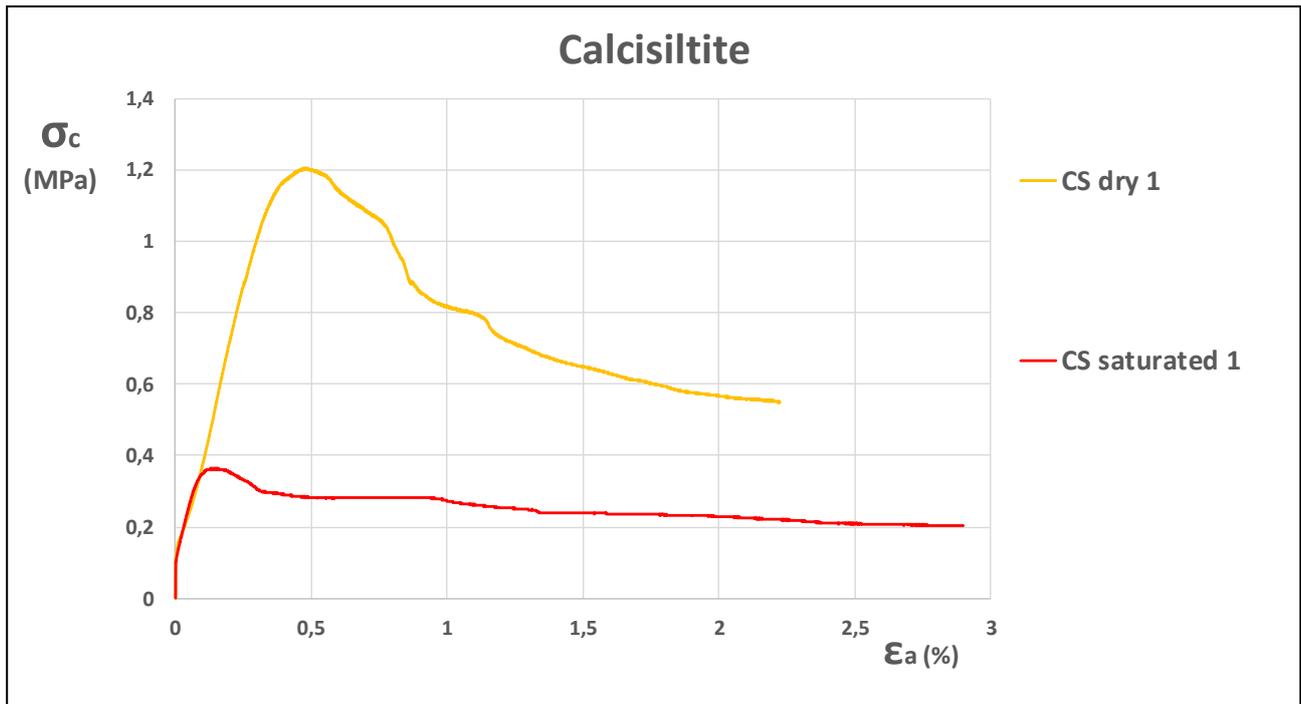
Figure 7. UCS stress-strain curves for the calcisiltite samples obtained from the same rock block.

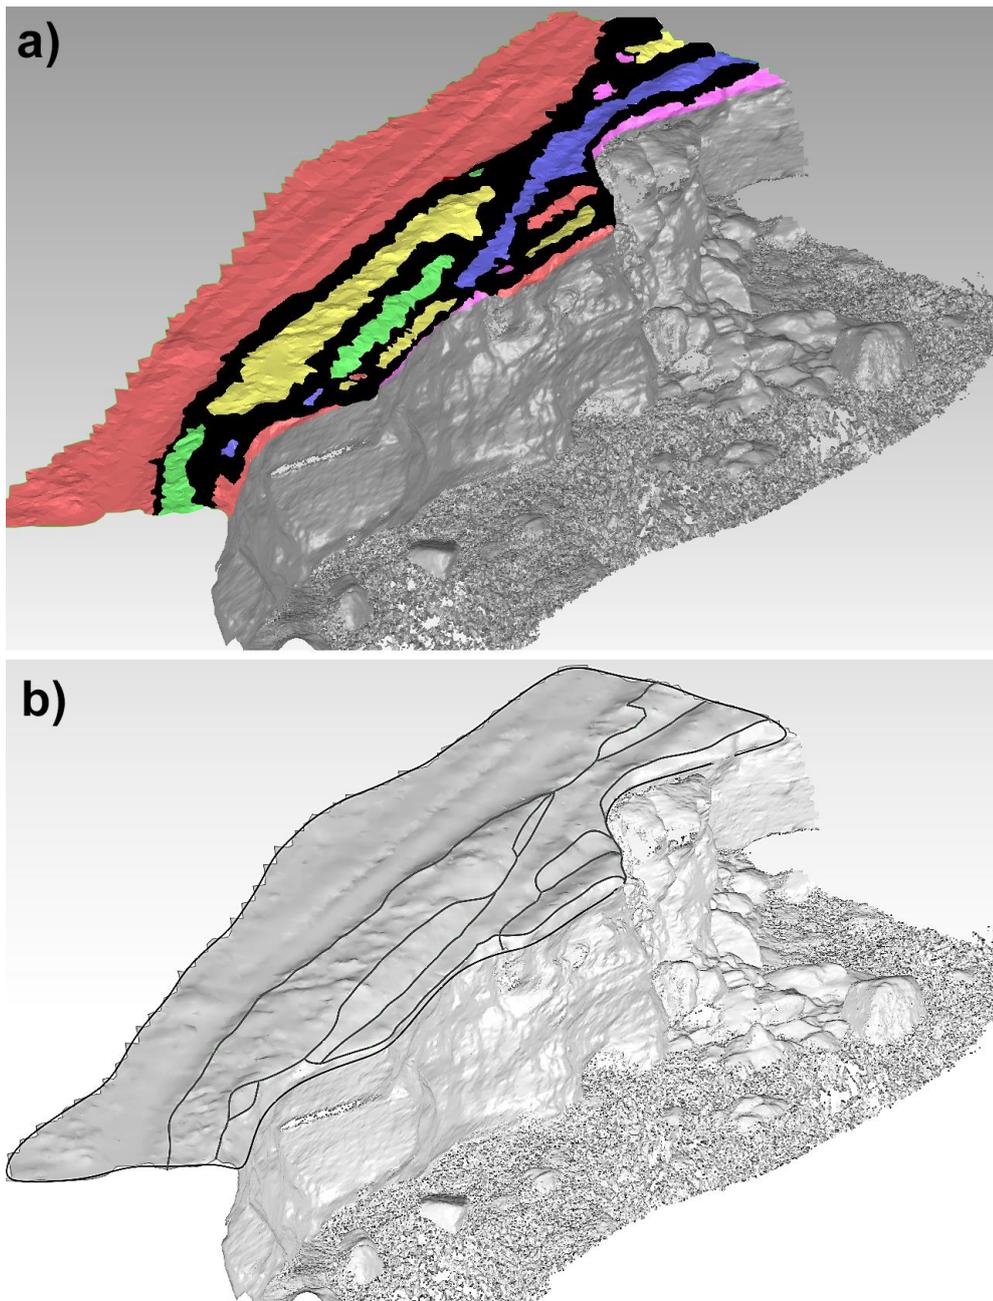
Figure 8. a) Extract regions utility: extraction of flat regions (colored areas) and separators (red strips); b) Contour utility, generation of contour lines.

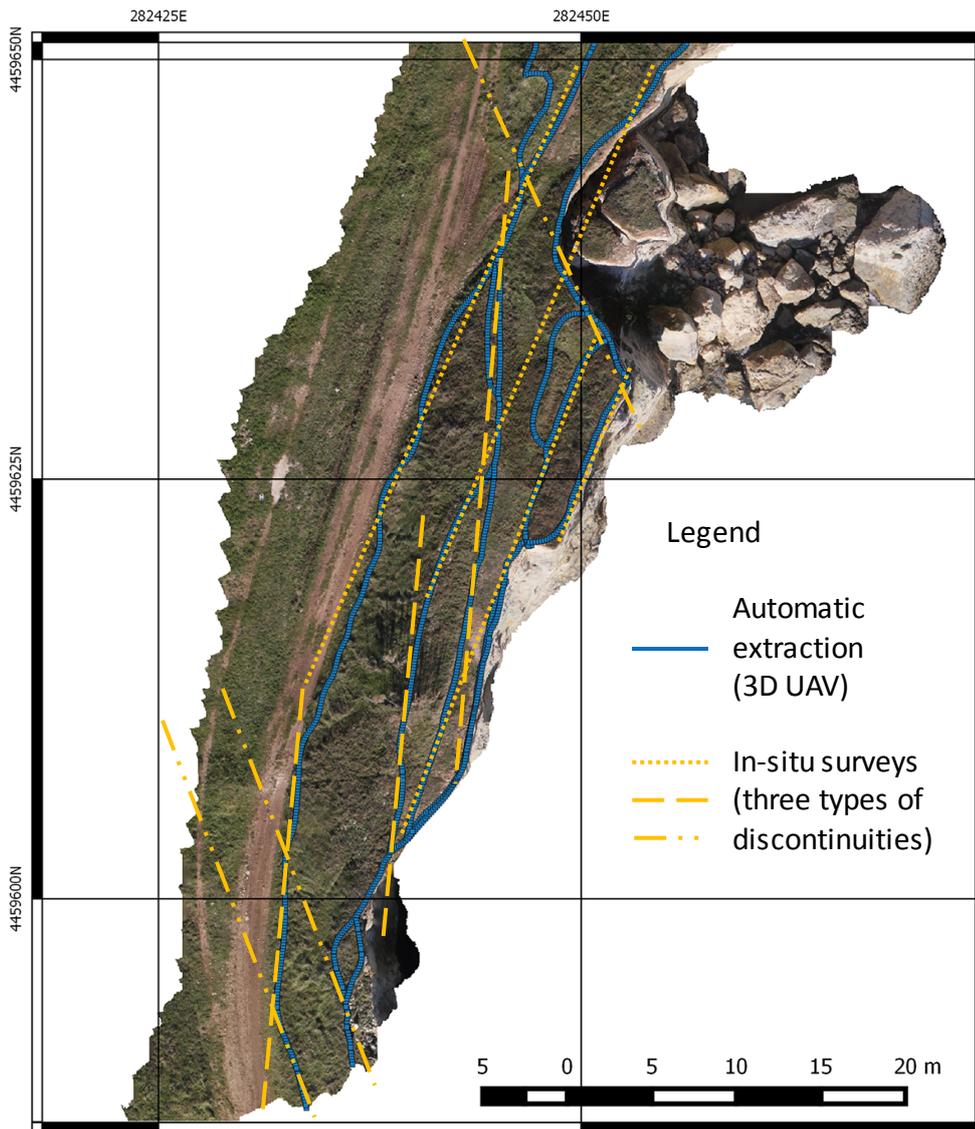
Figure 9. Map of detected discontinuity lines. Discontinuities automatically detected through 3D UAV model (blue), discontinuities derived by a field surveys (yellow).

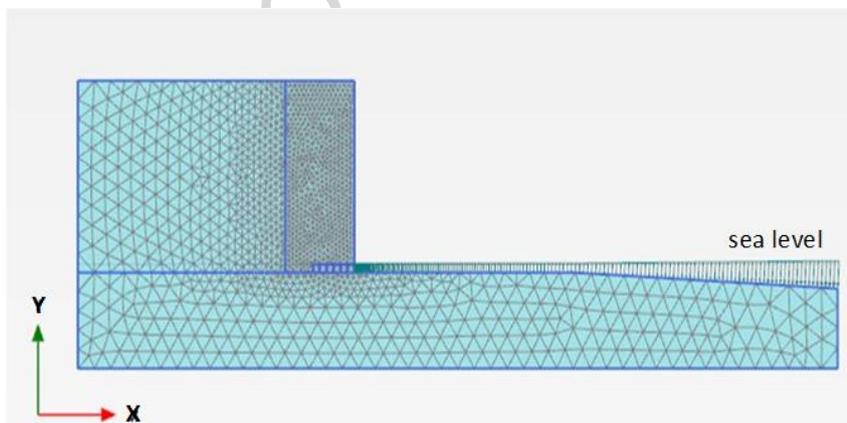
Figure 10. 2-D model with sea erosion at the foot (no joint interface activated): Numerical model with discretization mesh

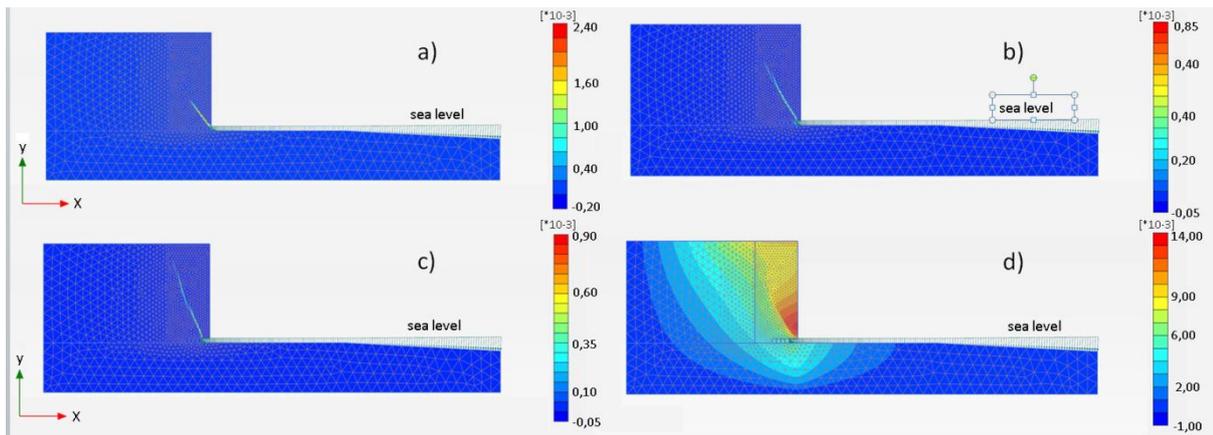
Figure 11. 2-D model with sea erosion at the foot (no joint interface activated) and reduced rock mechanical properties due to weathering: a) deviatoric strain γ_s without erosion at the cliff foot; b) deviatoric strain γ_s with erosion depth at the cliff foot of 1m; c) deviatoric strain γ_s with erosion depth at the cliff foot of 3m; d) total displacements u_x with erosion depth at the cliff foot of 3m.

When reduced rock mechanical properties are introduced in terms of a lowering of both the cohesion and the tensile strength values ($c' = 50$ kPa and $\sigma_t = 50$ kPa) in order to simulate the effects of rock weathering along the cliff, even with a 1-m depth erosion at the foot, the numerical model does not converge. In this case, a failure mechanism indicated by an oblique shear band starting from the end of the erosion depth and evolving towards the top of the cliff, at a distance of about 5-6 m from the crest, is calculated (Figure 11).

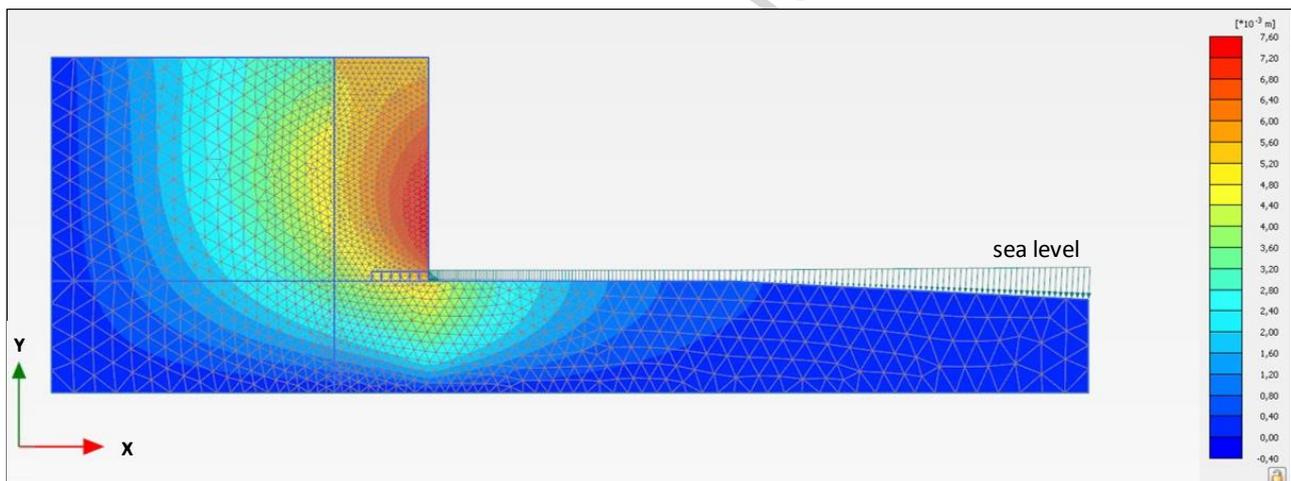
Figure 12. 2-D model without sea erosion at the foot and joint interface activated (no rock weathering): total displacements u_x .

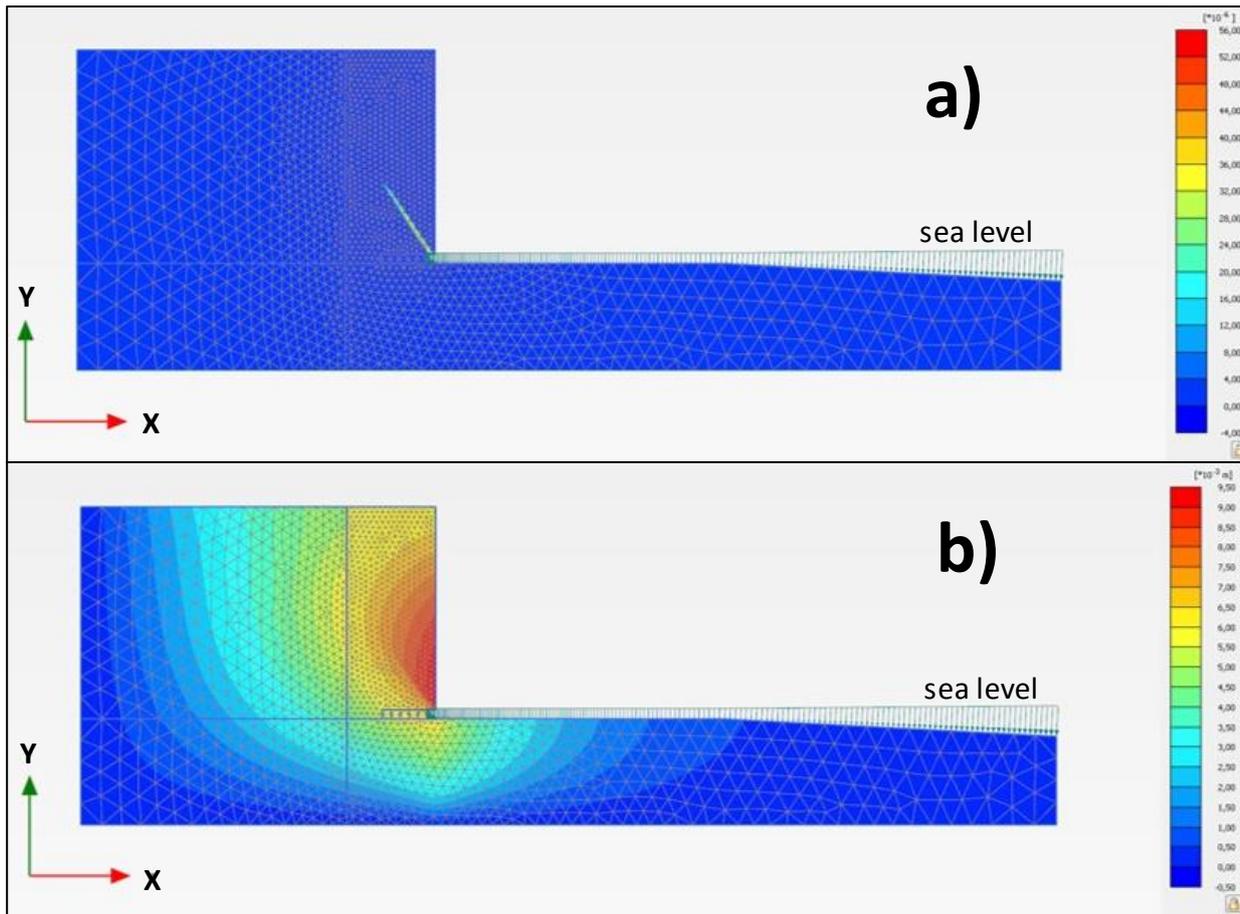
Figure 13. 2-D model with sea erosion at the foot, slightly cemented joint interface activated and reduced rock mechanical properties due to weathering: a) deviatoric strain γ_s ; b) total displacements u_x .

the vertical joint is characterized by $c' = 0$ kPa, $\phi' = 30^\circ$ and $\sigma_t = 0$ kPa, the numerical model does not converge, even with no erosion at the foot and assigning unweathered mechanical properties of the rock, and a failure mechanism involving the cliff portion up to the interface is observed (Figure 19). Instead, when a slight cementation degree of the joint is assumed ($c' = 10$ kPa, $\phi' = 30^\circ$ and $\sigma_t = 10$ kPa) and no weathering is considered for the intact rock, no failure process is observed, unless an erosion depth of 1 m is simulated in the model. Finally, adding the simulation of rock weathering (rock mechanical degradation), under the same previous assumptions, the model indicates a failure mechanism connecting the end of the erosion depth to the interface joint, already when an erosion depth of 0.5 m is simulated (Figure 13).

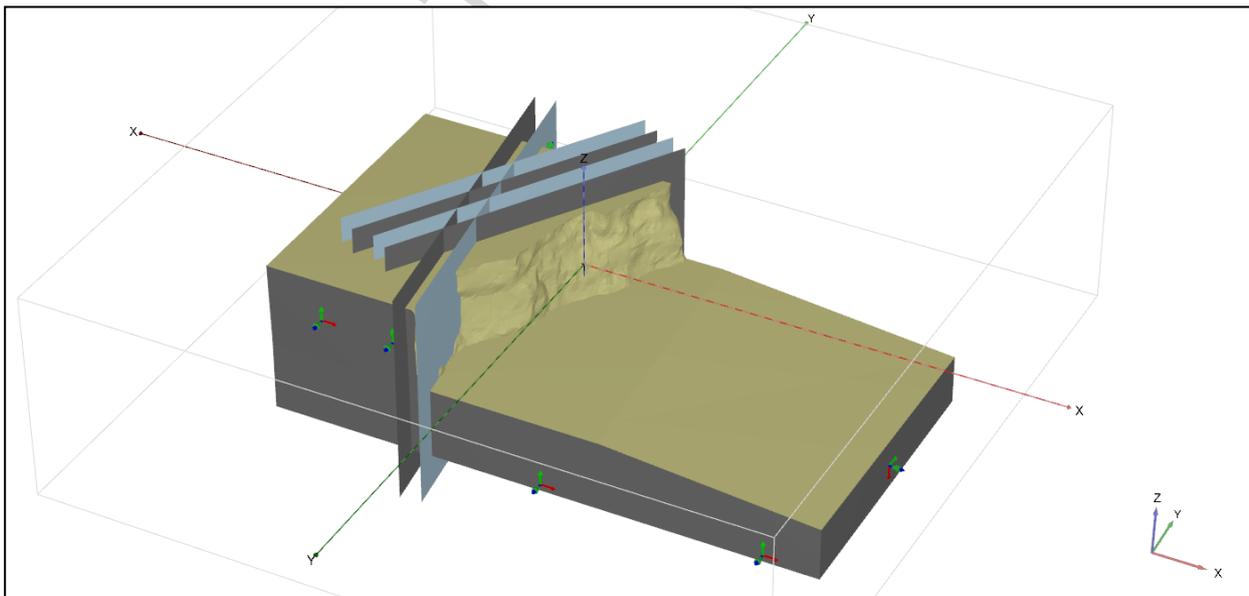
Figure 14. Three-dimensional solid forming the whole analysis domain and indications of the joint interfaces.

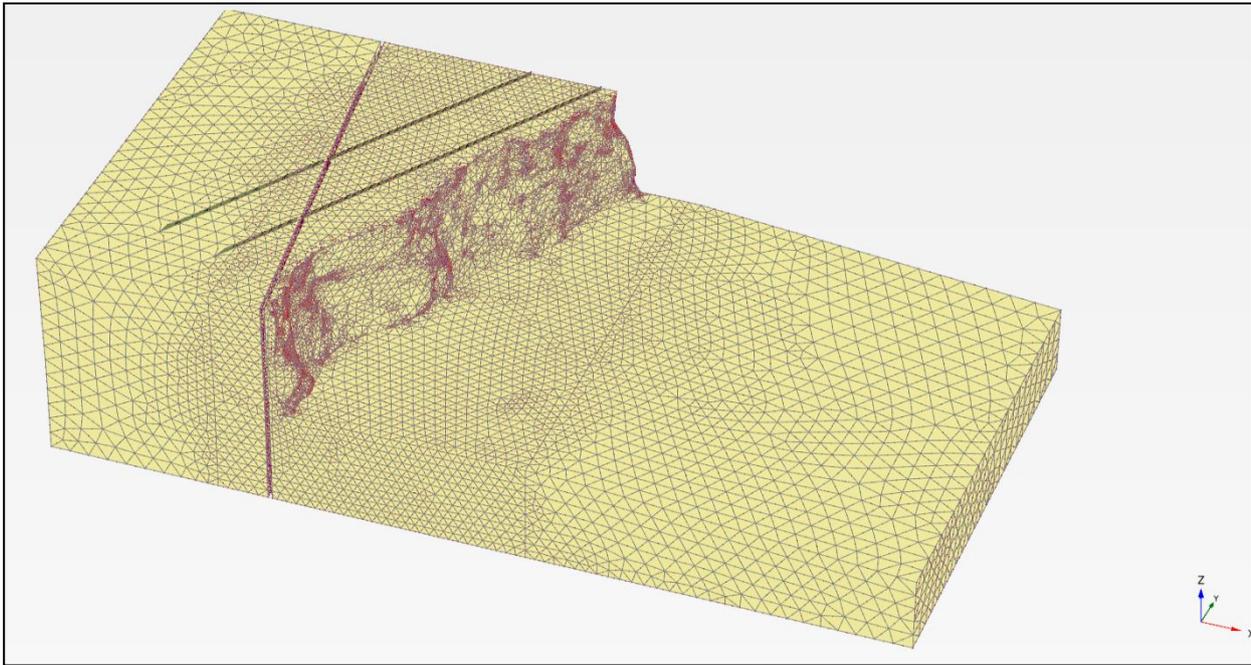
Figure 15. Three-dimensional finite element discretization mesh.

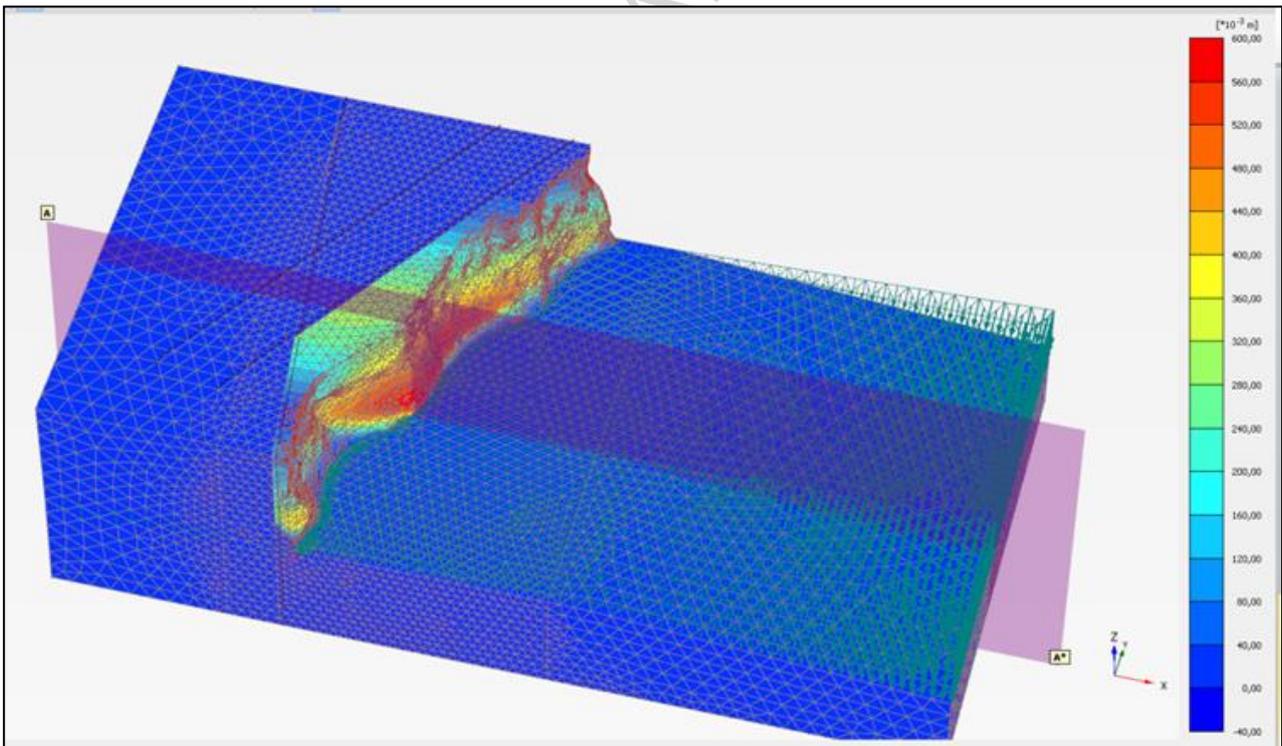
Figure 16. Horizontal displacements calculated

both the vertical displacements (Fig. 16) and the horizontal displacements (Fig. 17) appear to be concentrated in this cliff portion delimited by the interfaces. Even with high values of the intact rock cohesion, the cliff becomes unstable, so that a clear role of the uncemented joints in the control of the cliff stability is observed. These results are not consistent with those obtained by the simulations proposed by Mancini et al. (2017), where continuity conditions are instead supposed for the whole rock mass. Figure 17 shows that the larger horizontal displacements are seen in the lower part of the cliff portion protruding in the sea, characterized by no lateral confinement, whereas Figure 16 indicates that the larger vertical displacements are calculated in the upper part of the same rock portion. The same results are more clearly observed in the vertical cross-section shown in Figures 18 and 19. In fact, both the figures show that the failure mechanism develops from the toe of the cliff according to a steep failure surface and then reaches the existing rear joint, thus connecting with the top of the cliff. This numerical mechanism of rock portion detachment from the cliff is compatible with the collapses that have been observed in the surrounding areas of the cliff.

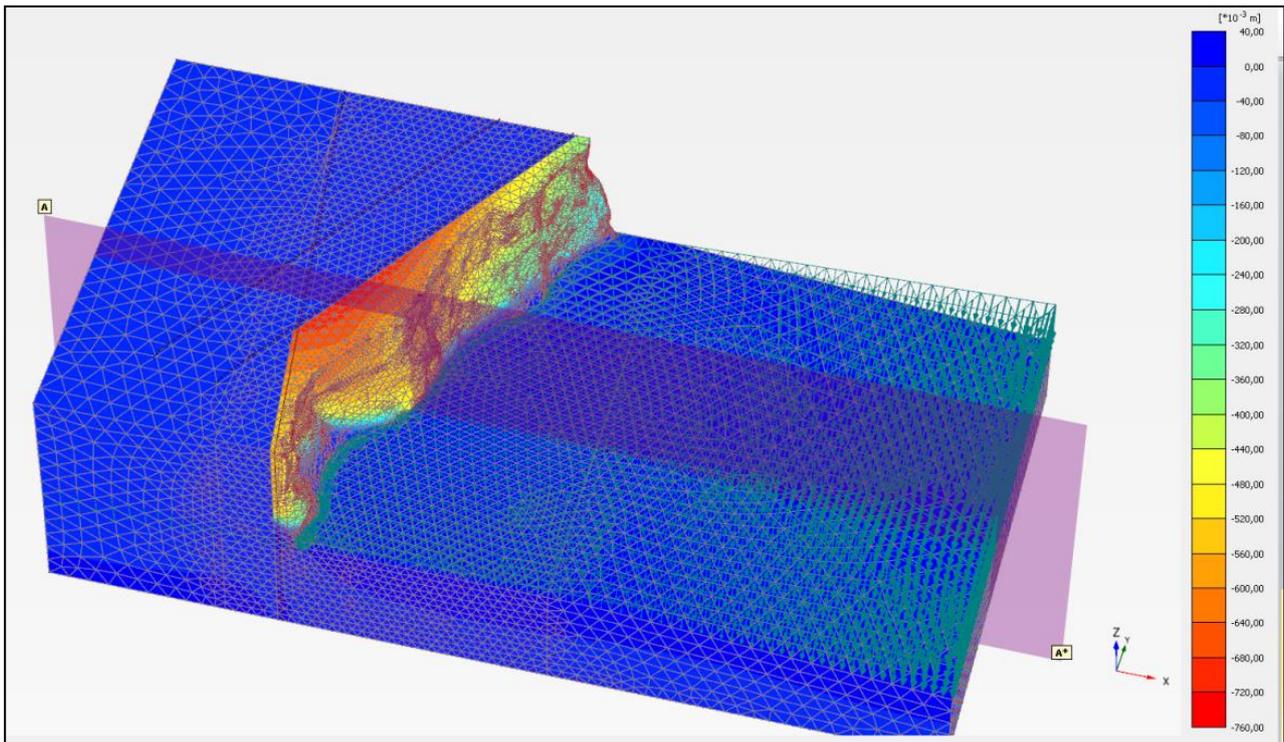
Figure 17. Vertical displacements calculated

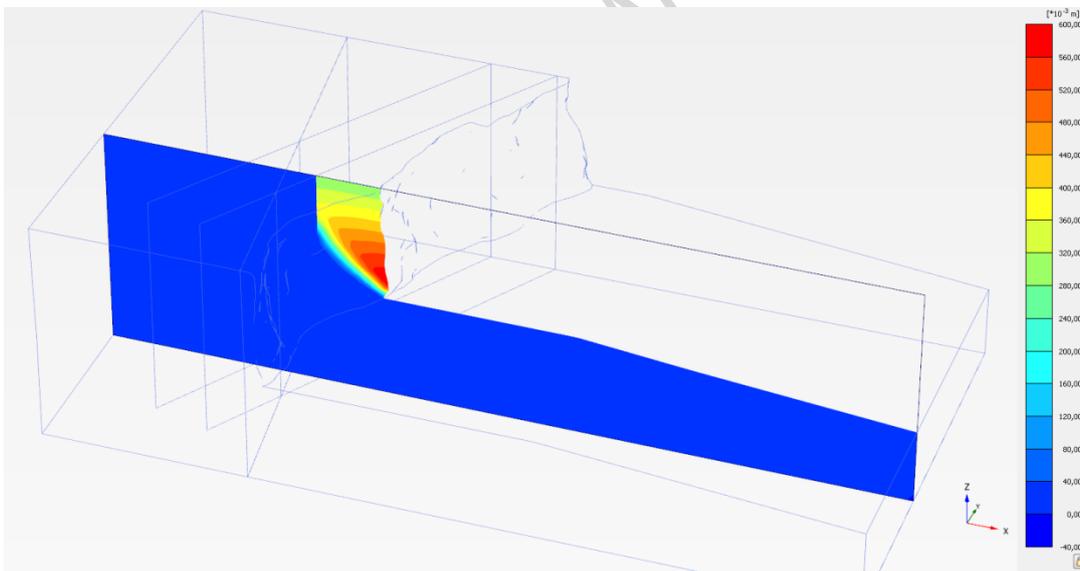
Figure 18. Horizontal displacements calculated for cross-section A-A*

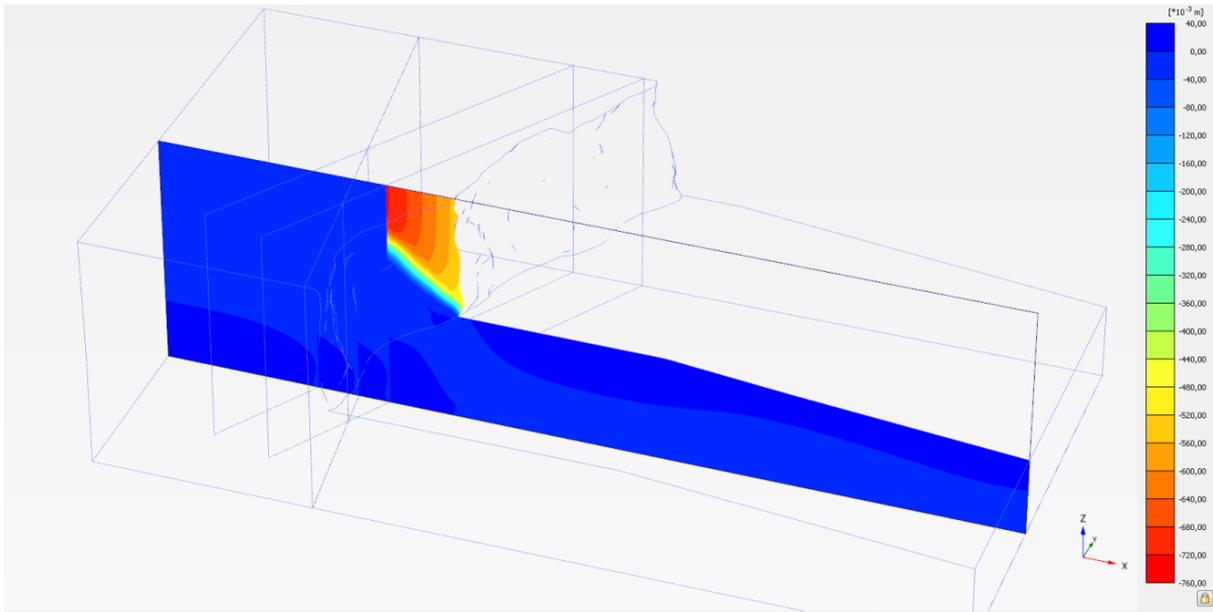
Figure 19. Vertical displacements calculated for cross-section A-A*
