## LESSONS LEARNT FROM THE SGORIGRAD AND STAVA DISASTERS

### Sgorigrad – Stava: identical disasters

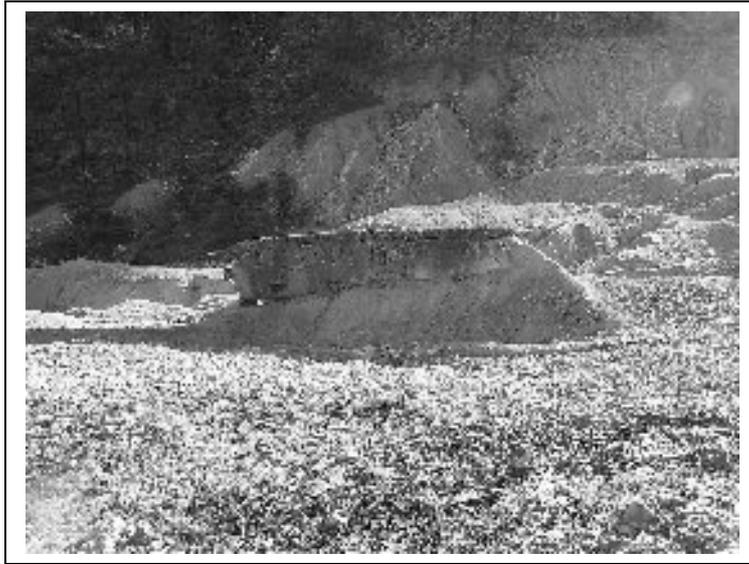
Fig. 1 – The remains of an overflow tower and mine waste where the Sgorigrad tailings dam stood

In 1958 the Placalnica mine in the Western Balkan Mountains, opened in 1902, was equipped with a flotation plant, built on the mountain slope, in order to extract minerals containing zinc, lead and, to a lesser degree, copper and silver. In order to decant and store the residual waste produced by the flotation process, a tailings dam was constructed in a lateral valley overhanging the village of Sgorigrad. The tailings thus produced were conveyed to the basin by means of a pipeline. The stream running on the valley floor was dammed with an embankment and its water was pumped back upstream of the tailings basin. In 1966 the basin attained the approximate height of 60-70 m. The retaining embankment for damming the torrent, the overflow towers and segments of the pipes are still visible today, together with small amounts of decanted mud, which remained in place [1] (Fig. 1).

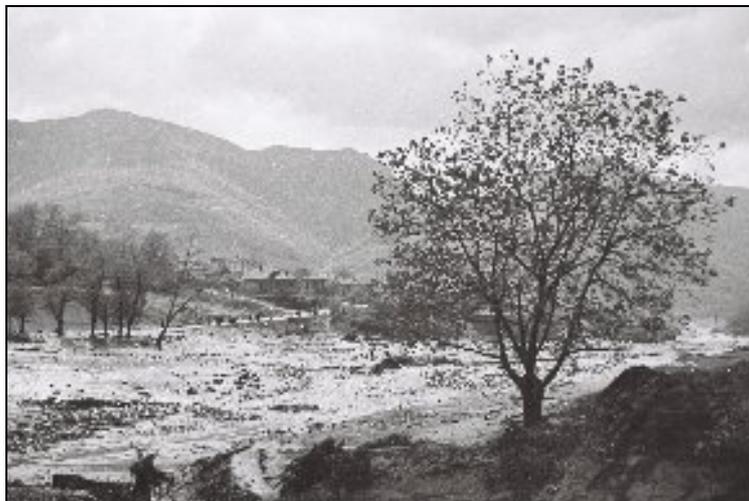
Fig. 2 – The area of Sgorigrad after the tailings dam failure (May 1966)

Failure took place on 1<sup>st</sup> May at 11:15 hours. A 220,000 m<sup>3</sup> flowslide, in some places over 3 m high, ran a distance exceeding 6 km, causing considerable material and environmental destruction (Fig. 2).

The mudflow destroyed most of the village of Sgorigrad, and eventually reached the town of Vratza. Rescue operations and recovery of casualties lasted several weeks. The corpses of the victims were taken to Vratza's stadium and their identification was a particularly difficult task [3]. The fact that the dam's collapse occurred around midday of 1<sup>st</sup> May probably limited the number of casualties. However, this number was still rather high as most of the inhabitants of Sgorigrad were in the town centre taking part in the celebrations of Workers' Day. Officially, the number of lives lost was declared as 107 [4]. Over 2,000 persons were injured, 576 families were affected, 156 houses were destroyed together with Vratza's Zoological Garden.

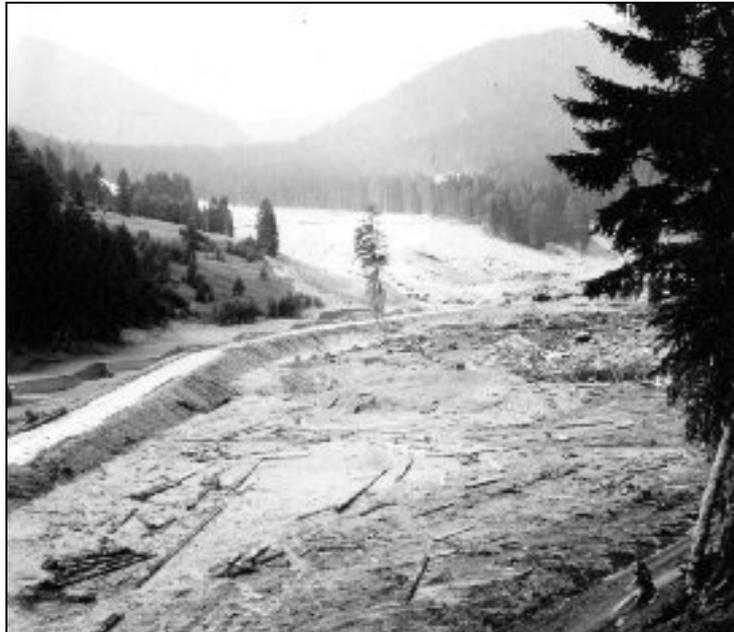
Fig. 3 – The Stava Valley completely devastated by the flowslide (July 1985)

At 12:23 hours of 19<sup>th</sup> July 1985 the dam of the upper basin failed and collapsed onto the lower basin, which also failed. The flowslide composed of water and sand from the dams and the whitish silts they had contained descended downstream at a velocity of nearly 90 km/h [5], sweeping away people, buildings, trees and whatever it met in its path as far as the main valley floor.

Along its path the flowslide caused the death of 268 people, the complete destruction of 3 hotels, 53 houses, 6 industrial buildings and 8 bridges whereas some more buildings were seriously damaged. A layer of mud,

some 20 to 40 cm thick, covered an area of some 435,000 m<sup>2</sup> over a length of 4.2 km. Some 180,000 m<sup>3</sup> of waste material spilled out of the tailings dams, to which another 45,000 m<sup>3</sup> of debris should be added resulting from erosional processes, destruction of buildings and uprooting of hundreds of trees (Fig. 3). The area where the dams stood and the path of the mud flow were completely reclaimed some years after failure.
