IMPREGNATED CARBON FABRIC REINFORCED CEMENTITIOUS MATRIX COMPOSITE FOR REHABILITATION OF THE FINALE EMILIA HOSPITAL ROOFS: A CASE STUDY

Andrea Nobili, Ph.D., P.E.[1] and Federico O. Falope, P.E.[2]

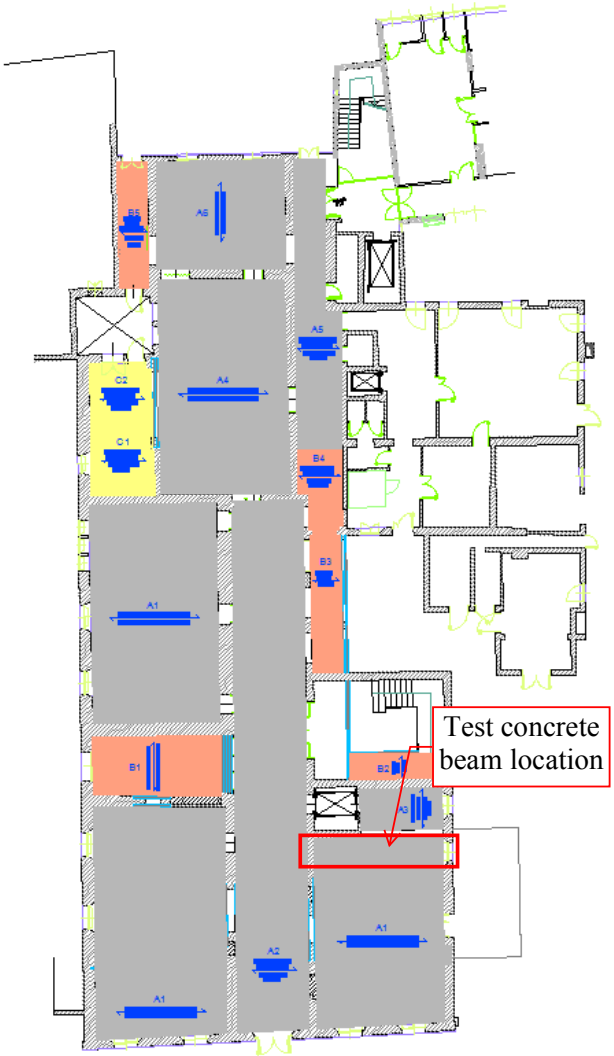
A preliminary analysis of the main building found more than ten different types of roofs, for the largest part constituted by concrete beams with hollow blocks in between, with different slab thickness and orientation (Fig.1). A roof typical cross-section is shown in Fig.2. An impregnated CFRCM composite is considered to be bonded at the intrados of the concrete beams taken from the Finale Emilia hospital roof. The composite material is applied according to the following steps:

FIG. 1. Roof system at ground floor for the hospital main building (H1)

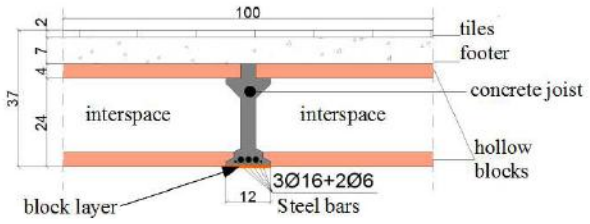
FIG. 2. Roof typical cross-section (dimensions in mm)

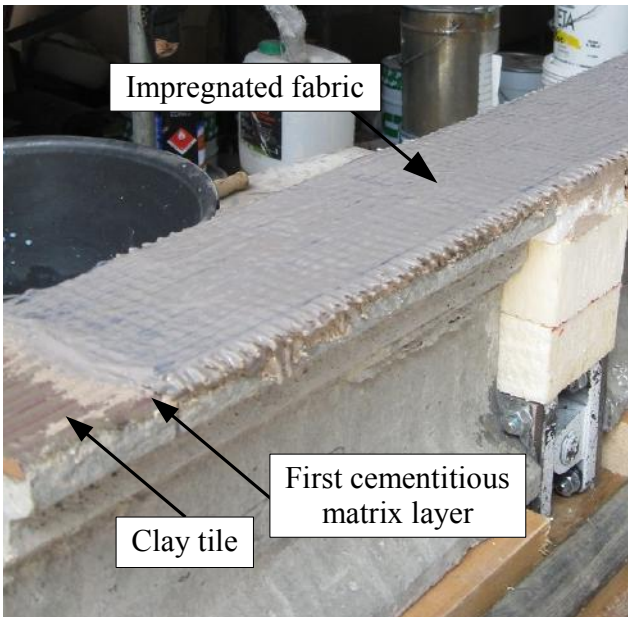
FIG. 4. The roof concrete beam is placed upside down for lamination (clay tile on top, steel hinge for the beam test at the bottom)

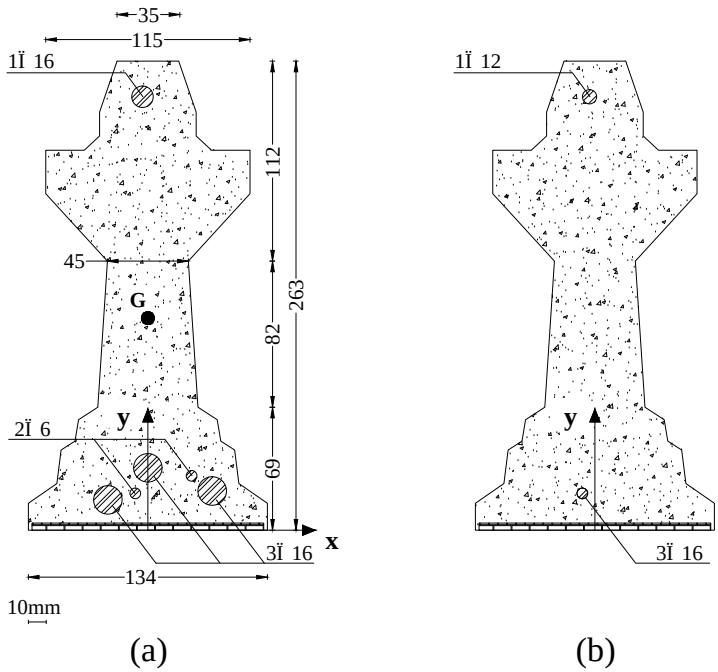
In order to avoid weakening an already poorly performing structure, only a single 8-m-long beam could be taken from the hospital roof (the original location of this beam is shown in Fig.1). For transportation convenience, the beam was cut into 5 pieces, between 1.2 to 1.4 m long. The roof beam is fitted with a variable-along-the-length longitudinal steel bar reinforcement, which roughly follows the bending moment diagram. Rebar surface is not patterned. The mid-span longitudinal reinforcement is given by $3\varnothing16 + 2\varnothing6$ mm and by $1\varnothing16$ mm, respectively for lower and upper section reinforcement (see Fig.5). Conversely, the

beam end longitudinal reinforcement features 1⌀6 mm (lower) and 1⌀12 mm (upper section). Table 3 gathers the cross-section inertial properties. It should be emphasized that the longitudinal rebar distribution is incompatible with modern seismic design, for no provision is taken against bending moment sign inversion. The beam pieces were further cut into a total of 15 400-mm-long portions, each endowed with a different amount of longitudinal steel rebars according to its location in the original joist. Transverse reinforcement is very weak and only 1⌀6/500 mm steel bar could be detected through pachometer testing. According to the Italian Building Code (2008, §4.1.2.1.3.2), the theoretical ultimate shear strength amounts to

FIG. 5. Concrete beam mid-span (a) and beam end (b) cross-sections (clay tile at the bottom) and reference system

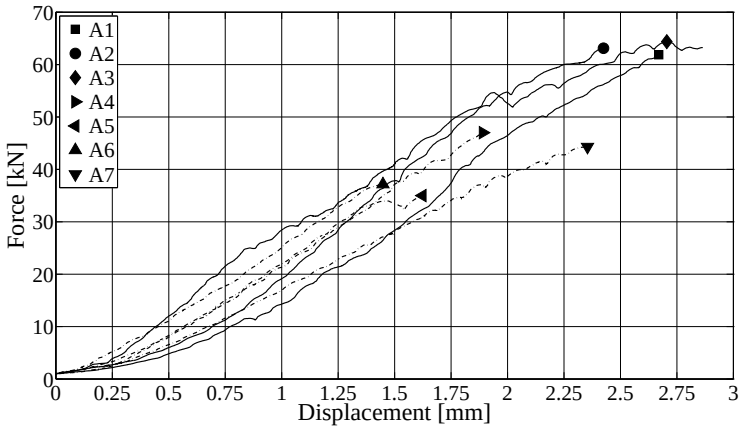
where Γ_{fd} is the specific fracture energy which depends on the ultimate slip s_u (see also D'Ambrisi et al. 2013 for a suitable choice of s_u for FRCM materials) and parameters are given in Table 4. Clearly, for maximum performance, the bonded length l_b should exceed l_e. Indeed, a bonded length $l_b = 300$ mm was considered with no special anchoring device (e.g. U-wrapped fabric, transverse bars, abrasive blasting of the substrate surface etc.). The bending test was carried out under displacement control at 1 mm/min knife speed. Fig.7 gathers the results of the beam test while Fig.8 presents the failure mechanism for each specimen. Failure in specimens A1–A3, treated according to Cycle A, is either due to cohesive fracture in the thin tile layer, also known as intermediate debonding, or to tensile failure in the concrete (for a brief description of the different fracture mechanisms see CNR DT200 (2004)). Indeed, specimen A2 displayed clear evidence of tensile failure in the concrete near the hinge, which was accompanied by mixed cohesive fracture at the laminate interface.

Conversely, delamination of the fabric with fracture taking place at the fabric/matrix interface is always met in specimens A4–A7, prepared according to Cycle B. The difference in the failure mechanism reflects itself in a sharp difference among the ultimate loads, which exceed 60 kN for Cycle A as opposed to well below 50 kN for Cycle B. It is observed that

FIG. 7. Beam test results - solid curves belong to Cycle A, dashed curves to Cycle B

FIG. 8. Failure modes: cohesive fracture (specimen A1 and A3), tensile failure in the concrete (A2), delamination (A4,A5,A7)
