Evidence of an emerging levee failure mechanism causing disastrous floods in Italy

Stefano Orlandini¹, Giovanni Moretti¹, and John D. Albertson²

Orlandini, S., G. Moretti, and J. D. Albertson (2015), Evidence of an emerging levee failure mechanism causing disastrous floods in Italy, *Water Resour. Res.*, 51, 7995–8011, doi:10.1002/2015WR017426.

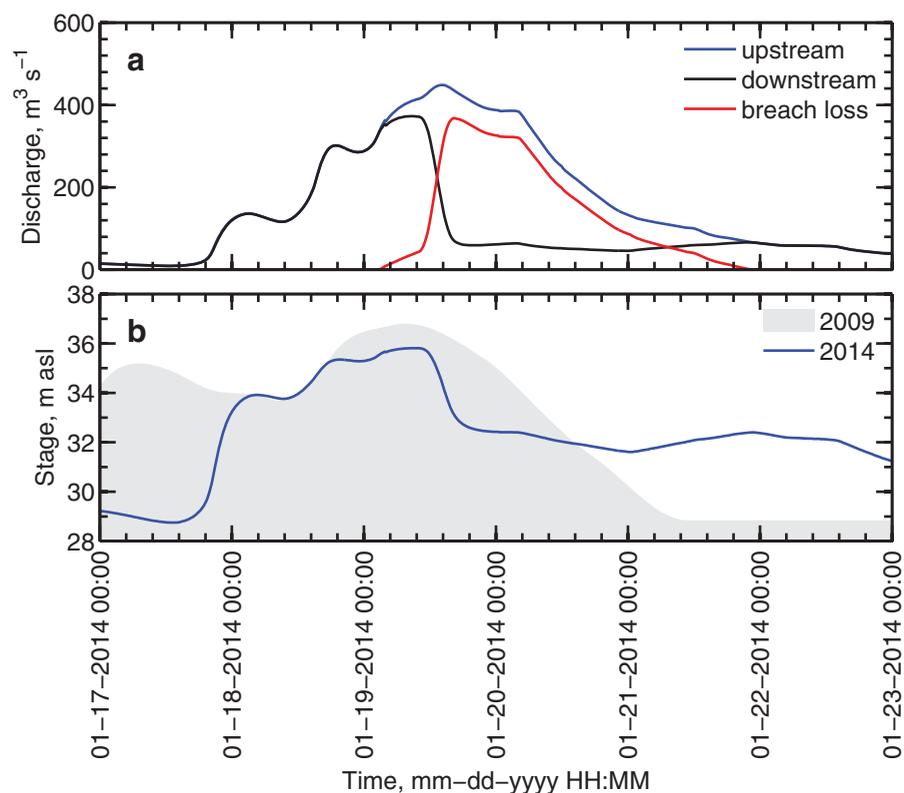
The flood hydrographs from December 2013 and January 2014 at the cross section of the failed levee were reconstructed by developing a level pool routing model and a dynamic wave model (section A1). Reconstructed flow discharge and river stage for the period 17–22 January 2014 are reported in Figures 3a and 3b, respectively. The breach flow loss was computed by incorporating into the dynamic wave model an explicit description of the breach evolution, obtained from photographs taken during the event (Figure 4). The combined use of observations and models yielded the results reported in Figure 3, revealing that (1) the maximum stage reached by the river flow in January 2014 was about 1.5 m below the top of the levee and (2) the magnitude of the peak river stage and the duration of high river stages along the Secchia River in January 2014 were smaller than the corresponding quantities observed in previous events such as, for instance, those observed in December 2009 (Figure 3b).

Figure 3. Reconstructed flow discharges (Figure 3a) and river stages (Figure 3b) at the cross section of the Secchia River at San Matteo where the levee failure occurred. A longer simulation period (from 22 December 2013 at 0:00 to 3 February 2014 at 24:00) than that reported in Figures 3a and 3b was considered to provide a sound analysis of the hydraulic response of the levee to the river stage forcing. The flood hydrograph occurred in December 2009 (from 23 December 2009 at 14:00 to 28 December 2009 at 14:00) is reported in the background of Figure 3b to enable a visual comparison.
