Article

Effect of Mechanical Pretreatments on Damage Mechanisms and Fracture Toughness in CFRP/Epoxy Joints

Keywords: CFRP; adhesive bonding; fracture toughness; R-curve

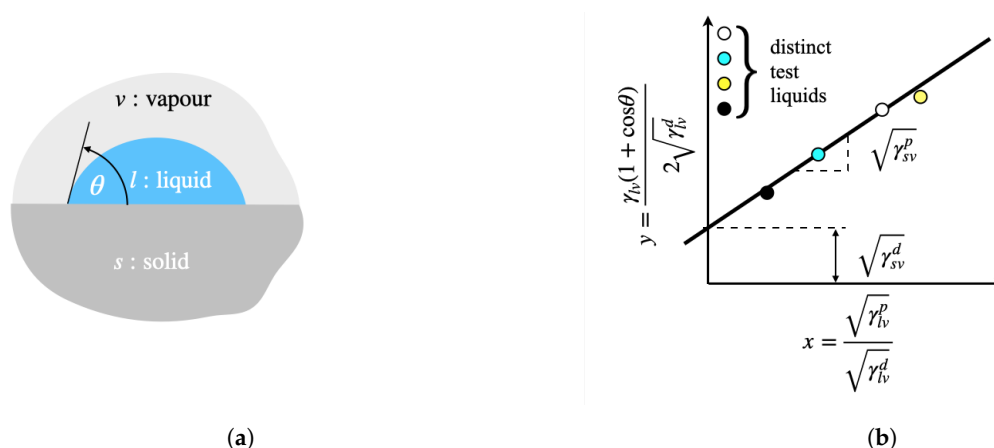
Figure 1. (a) Liquid drop resting at equilibrium on a solid surface. (b) Schematic Owens–Wendt plot for determining the surface free energy of a solid.

where θ is the contact angle, which can be determined using a variety of techniques, such as the sessile drop method shown in Figure 1a. Besides, γ_{lv} is the surface energy of the test liquid, and γ_{lv}^d and γ_{lv}^p are the corresponding dispersive and the polar components. Similarly, γ_{sv}^d and γ_{sv}^p are the dispersive and the polar component of the solid surface energy that represent the unknown that needs to be determined, since the solid surface energy is given by $\gamma_{sv} = \gamma_{sv}^d + \gamma_{sv}^p$. By recognizing that Equation (3) is in the form $y = mx + q$, where

it is possible to determine γ_{sv} by using different liquids with known polar (γ_{lv}^p) and dispersive (γ_{lv}^d) surface free energies and measuring the corresponding contact angle on the target surface to generate (x, y) data points. Indeed, the gradient and the intercept of the best-fit line will thus provide the polar (γ_{sv}^p) and dispersive (γ_{sv}^d) components of the solid surface energy, as schematically illustrated in Figure 1b.

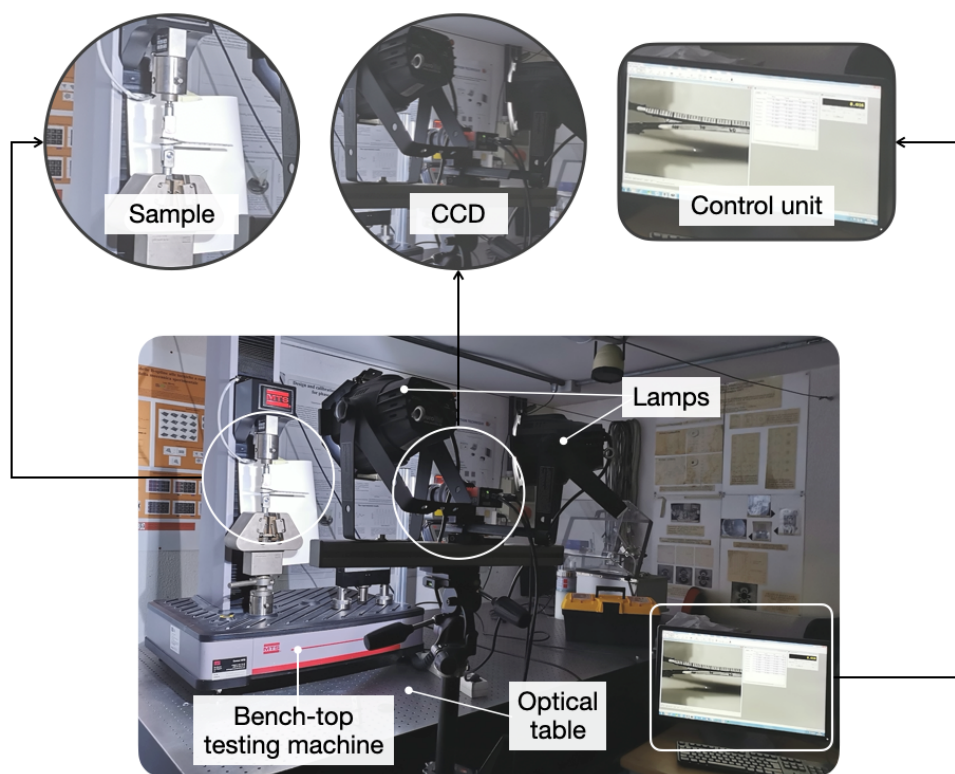
Figure 2. Experimental setup employed in mechanical testing of double cantilever beam (DCB) adhesive joints.

carried out using a bench-top electromechanical testing machine equipped with a 5-kN loading cell (MTS Criterion Model 42, MTS Systems Corporation, MN, USA). A cross-head displacement equal to 2 mm/min was used and the peel load was introduced by means of loading pins that were inserted into aluminum blocks adhesive bonded to the CFRP substrates (see Appendix B). An overview of the setup employed for the measurements is reported in Figure 2.

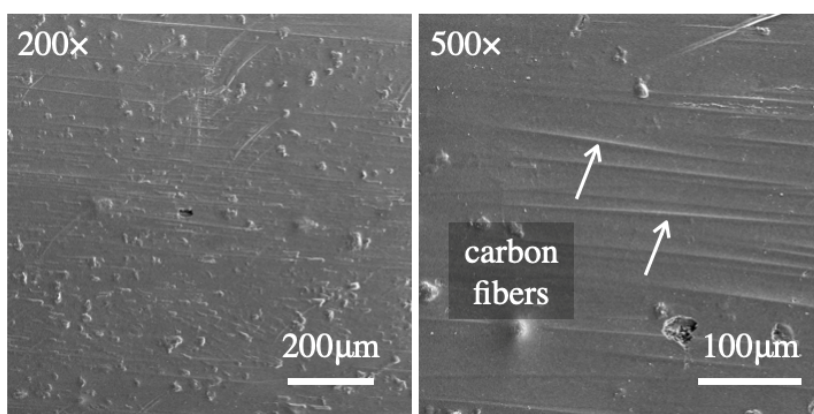
Figure 3. Scanning electron microscopy (SEM) images of the as-received CFRP surface after consolidation in the hot press.

The as-received (AR) material in pristine conditions is shown in the SEM images of Figure 3. Carbon fibers surfacing the outermost layer of the laminate are also highlighted. The peculiar morphology is attributed to the relatively thin surface matrix layer and the use of a PTFE mold-release film.

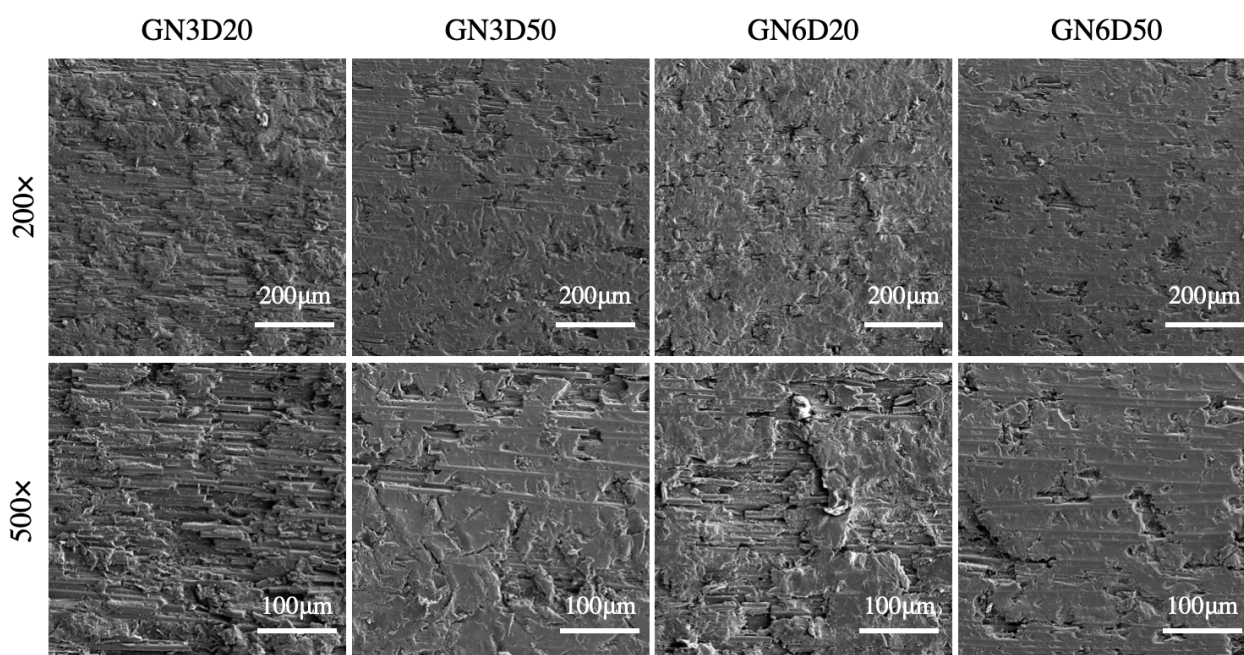
Figure 4. Scanning electron microscopy (SEM) images of CFRP surfaces grit-blasted using glass particles.

SEM images of grit-blasted (GB) CFRP surfaces are reported in Figure 4. The images indicate that the morphology and removal rate of the epoxy matrix are more sensitive to the gun-to-surface distance (D) rather than the number of passes (N). Indeed, by reducing D , more matrix was removed from the CFRP surface with a consequent increase of exposed carbon fibers.

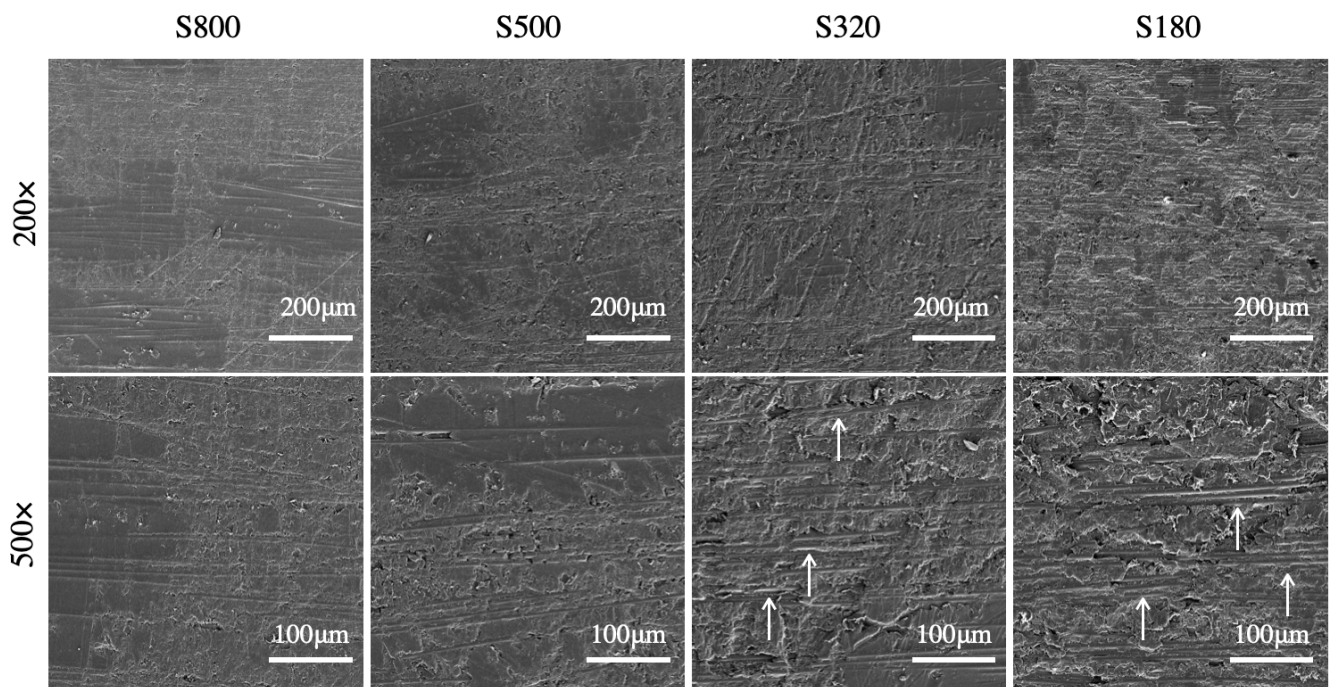
Figure 5. Scanning electron microscopy (SEM) images of CFRP surfaces sanded with silicon carbide papers of various grit sizes.

Sanding with emery paper was carried out using four distinct grit sizes and the corresponding SEM images are compared in Figure 5. The finer grits led to several surface areas with little or no changes in morphology. With 320 and 180 grits, the sanding treatment provided a more even surface modification. In a few locations across the treated area, such as those highlighted by the arrows in Figure 5, we did observe exposed carbon fibers mainly flattened by the sanding process and therefore still embedded in the epoxy. Overall, the surfaces had a high percentage of the polymer matrix. Surface profiles were extracted in the directions parallel (x -) and perpendicular (y -) to the direction of the fibers, and representative results are reported in Figure 6. The roughness-sampling-length employed for the measurements is equal to 4 mm. The baseline (AR and DG) surfaces exhibit a relatively smooth profile but with occasional peaks and valleys (i.e., millimeter range), likely due to scratches and defects induced during manufacturing and subsequent handling

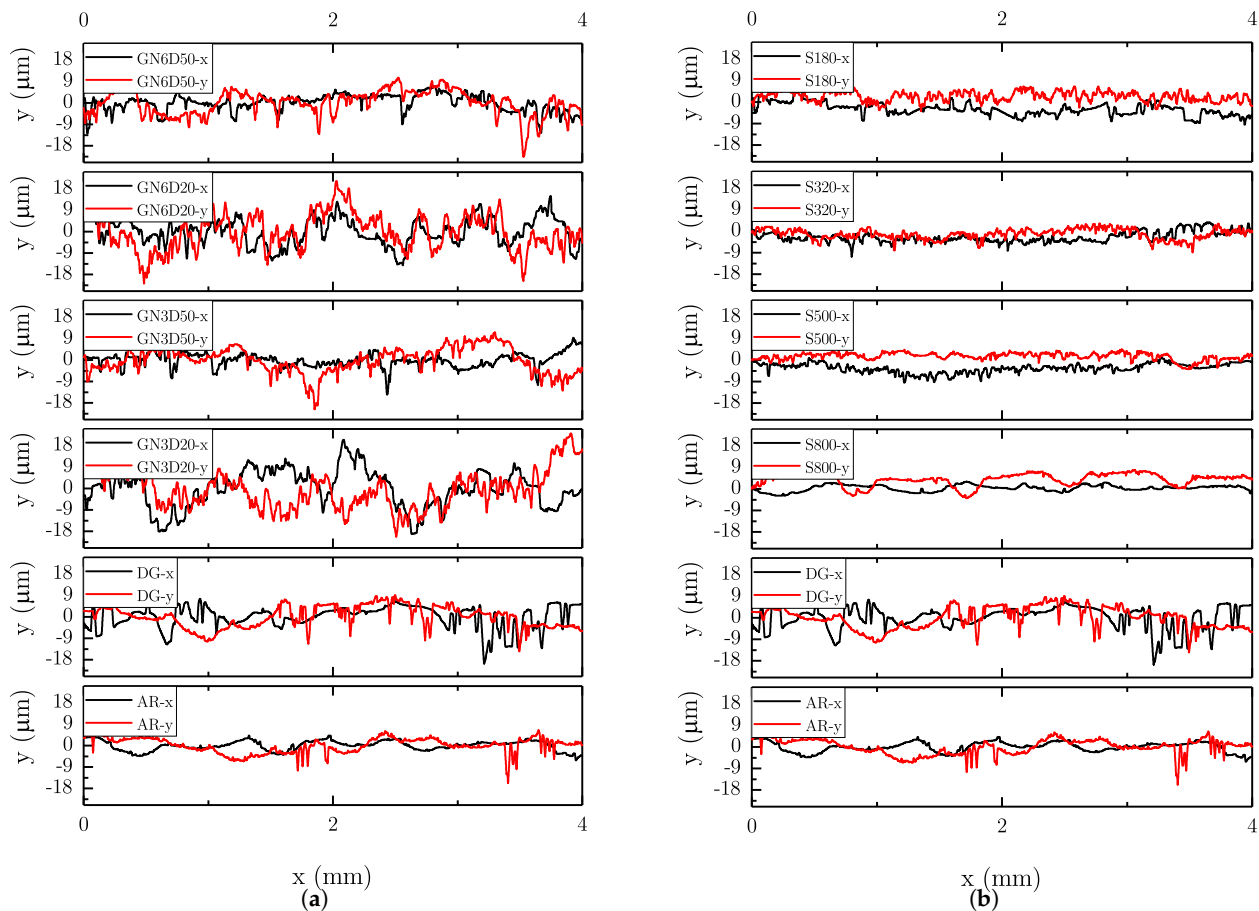
Figure 6. Surface profiles of CFRP plates: (a) grit-blasted and (b) sanded surfaces.

of the plates (see Figure 3). The surface profiles of sandblasted samples feature high-frequency microroughness. In addition, when the sample-to-gun distance was reduced ($D = 20$ mm), a random waviness (macroroughness) was also observed. The profile did not display such additional macroroughness when increasing the distance to $D = 50$ mm. The observed topography is probably due to the removal rate of epoxy matrix and random exposure of carbon fibers associated to $D = 20$ mm. By changing the number of passes from $N = 3$ to 6, we did observe significant differences in the measured profiles, as also shown in previous SEM images. As expected, the surface profile of sanded samples, which are reported in Figure 6b, are relatively smooth with respect to the baseline surfaces. The treatments further flattened surface asperities, with a significant decrease in surface roughness with respect to both baseline and grit-blasted surfaces.

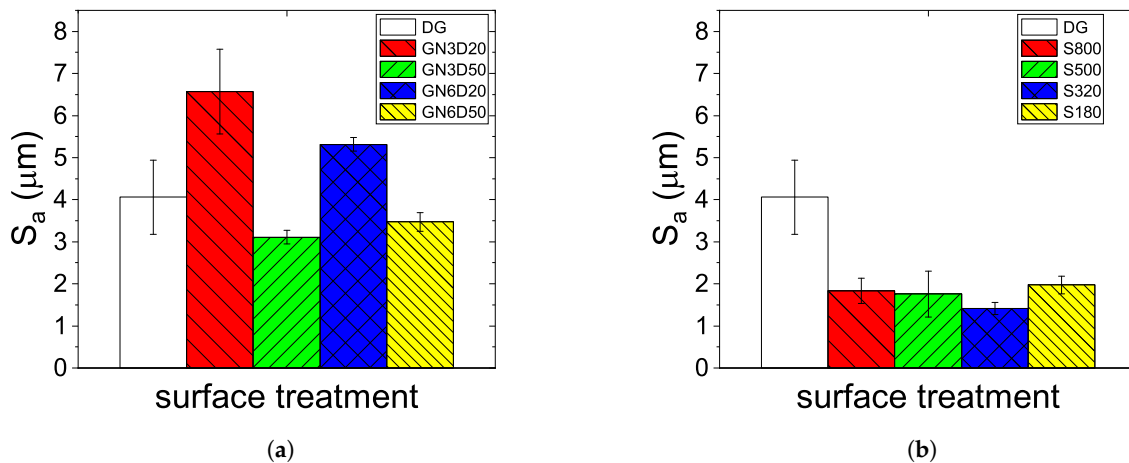
Figure 7. Surface roughness of CFRP plates: (a) grit-blasted and (b) sanded surfaces.

Surface roughness (S_a) was extracted from the above measurements and is reported in Figure 7. For the sandblasted surfaces, consistently with SEM and profilometry observations, S_a was more sensitive to the gun-to-surface distance (D) rather than to the number of passes (N). However, by increasing N , reduced scatter in repeated measurements was observed. Concerning sanding, the treatment flattened surface asperities and always decreased the roughness below the values obtained with grit-blasting. The use of different emery papers did not affect S_a to a great extent, since the values were very similar. However, as noted above, the use of 320 and 180 emery papers led to the exposure of carbon fibers.

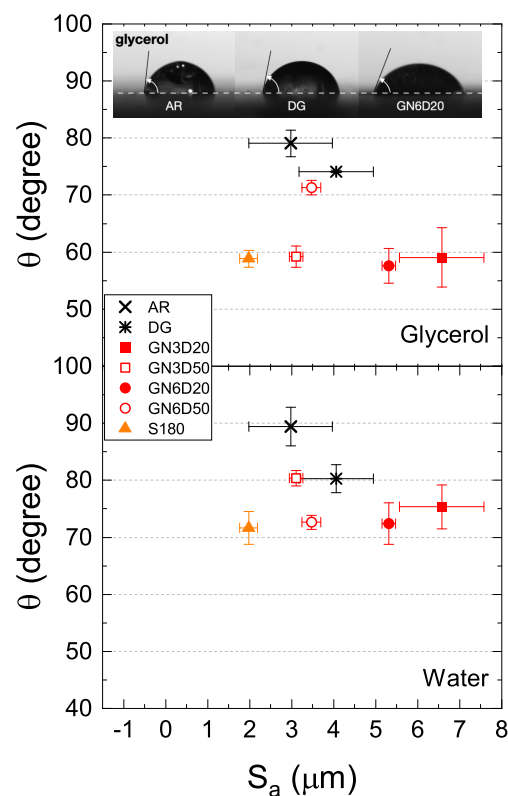
Figure 8. Contact angle as a function of average surface roughness obtained using glycerol and deionized water probe liquids. The insert shows drops of glycerol placed on as-received (AR), degreased (DG), and grit-blasted (GN6D20) samples.

Surface wettability was surveyed to expand the analysis and better understand the effects of the mechanical treatments. The results of contact angle measurements obtained using both glycerol and distilled water are reported in Figure 8. The reported values were determined 60 s after drop dispensing in order to spread any capillarity effect. Notice that only the surface treatment S180 was withheld for the subsequent analysis of contact angle and determination of free energy. Indeed, the CFRP samples subjected to the sanding treatments described above were preliminarily scrutinized using the water-break-free test. The samples were submerged and withdrawn rapidly from a bath of distilled water. It was

noted that, except for S180, the water formed water beads (or small droplets) randomly across the surface because of improper wetting. The determined values of contact angles for the GB surfaces were consistently lower than those recorded on AR and DG. However, if compared to other combinations of processing parameters, the grit-blasting treatment GN6D20 featured a reduced scatter in repeated measurements. Despite the lower surface roughness, a similar wettability was observed for the sanded samples (S180), whose measurements were characterized by low variability.

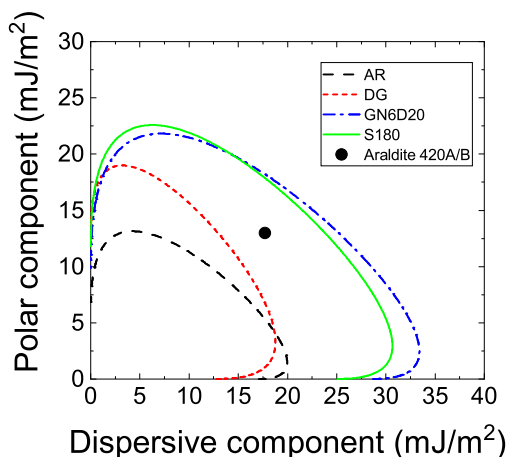
Figure 9. Surface wetting envelope diagrams of AR, DG, sanded (S180), and GN6D20 samples.

The solid surface energy and the wetting envelope diagrams were subsequently obtained using the methodology described earlier. The obtained diagrams for GN6D20 and S180 surfaces are compared with those related to AR and DG surfaces in Figure 9. The surface energy of the liquid adhesive, which was determined in our previous work [18], was also added to ascertain whether or not the liquid adhesive can spread on any of the given surfaces and establish the necessary intermolecular interaction needed to achieve a strong bond. Both GB and S treatments allowed for the increase in surface energy and the corresponding envelope diagrams fully embedded the liquid adhesive data point. It is interesting to note that the diagrams of GB and S surfaces are nearly identical. Since these surfaces are basically composed of a mixture of carbon fibers and epoxy matrix, it appeared that the CFRP texture had only a minor influence on the wetting behavior. Thus, the dominating factor is supposed to be surface composition. The result is consistent with the previous finding by Wetzel et al. [11] that assessed the influence of surface preparation (e.g., teflon foil, peel ply, and peel ply followed by atmospheric pressure plasma) and contamination on the fracture toughness of adhesive bonded CFRPs.

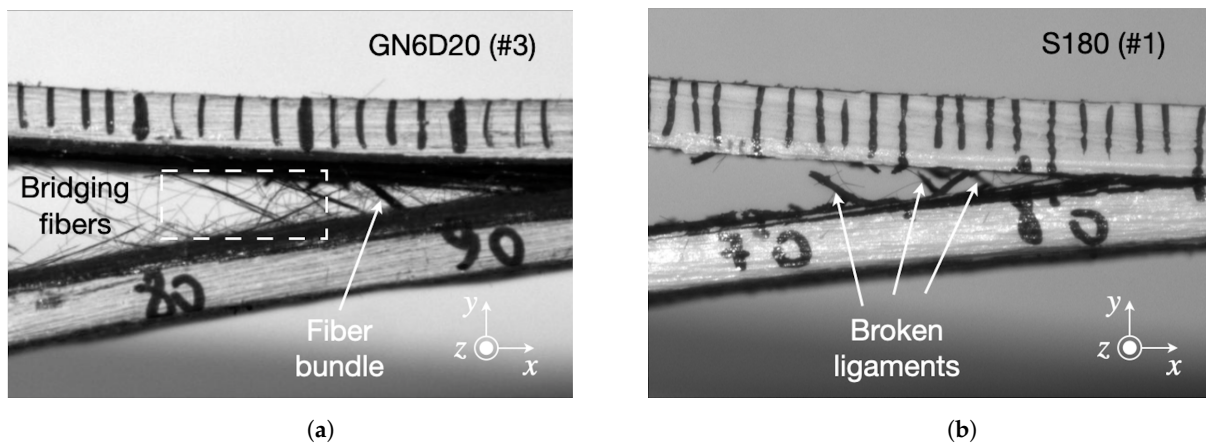
Figure 12. Typical mechanisms of damage recorded in (a) grit-blasted (GN6D20) and (b) sanded (S180) CFRP/epoxy joints recorded during the experiments.

During each DCB test, a region of interest surrounding the advancing crack front was recorded with the aid of a high-resolution camera to track damage in the course of fracture. The key features of the crack propagation process extracted from the images are given in Figure 12 and refer to the mechanical results shown in Figures 10 and 11. For grit-blasted interfaces, crack propagation occurred in conjunction with extensive fiber bridging and provided a significant reinforcing effect. As shown in Figure 12a, single fibers and fiber bundles are created and pulled out during the fracture process. In the sanded samples, we did not observe any significant fiber bridging effect but there was competition between crack propagation at the upper and lower interfaces, as also reported in a previous work on composite joints bonded with an adhesive film [12]. The peculiar mechanism of failure has led to the formation of small adhesive ligaments bridging the crack faces. Such ligaments, which are eventually broken in the crack wake, are highlighted in Figure 12b. It is worth noting that the authors have recently demonstrated a method that enables a highly controllable formation of adhesive ligaments through tailoring interfacial adhesion [27]. The occurrence of multiple ligaments was shown to provide a significant reinforcing effect in otherwise brittle adhesive bonded composite joints.

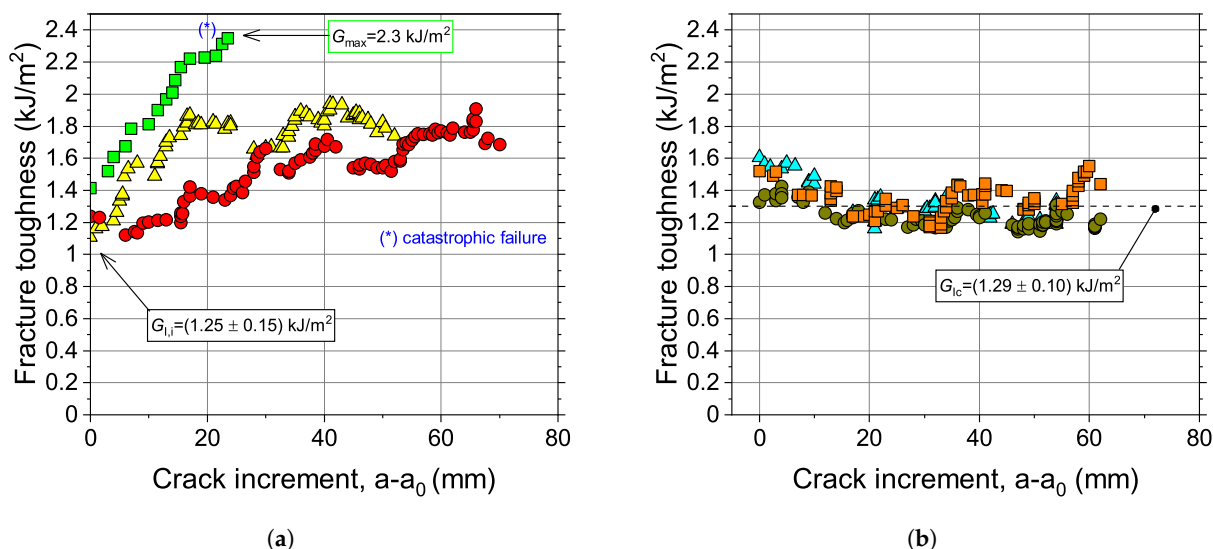
Figure 14. Fracture toughness versus crack increment for (a) grit-blasted and (b) sanded interfaces.

As shown in Figure 14a, the resistance curves obtained in repeated DCB tests with grit-blasted interfaces display a certain degree of variability. Although the initiation fracture toughness had a relatively consistent value, the propagation stage was characterized by a considerable degree of variation because of the different bridging extent. When large bundles accompanied fracture of the joint, the maximum toughness exceeded 2.3 kJ/m^2 , but the accumulated elastic energy within the DCB arms ultimately led to a catastrophic fracture. On the contrary, it is noted that sanded interfaces provided a consistent response across multiple tests and flat R-curves.

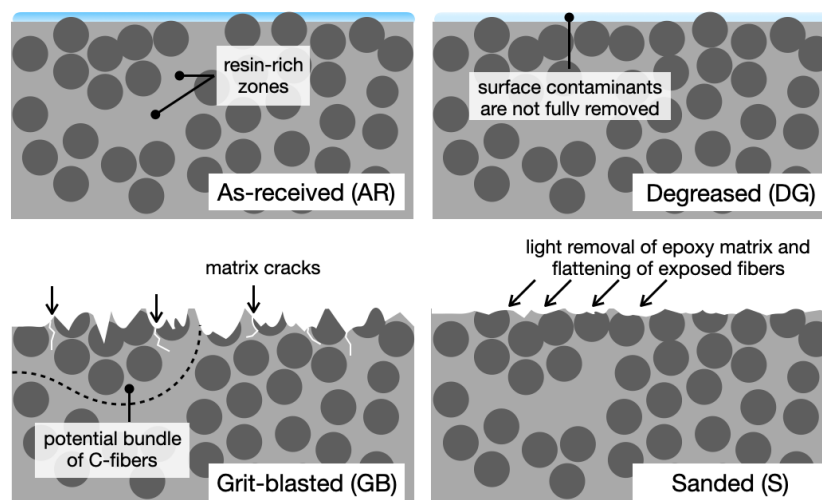
Figure 15. Schematic of the CFRP before and after different surface preparation methods.

The schematic of Figure 15 attempts an explanation for the observed mechanisms of failure. The initial surface (AR) is covered by contaminants that are eventually absorbed in the epoxy matrix. The use of a degreasing step (DG) is still unable to remove contaminations entirely. As our laminates feature a very thin layer of surface epoxy matrix, the GB process likely removed these contaminants. It still provided large areas with exposed loose fibers, including surface damage in the form of broken fibers and surface cracks (see Figure 4). As noted earlier, fiber dispersion within the ply and the resin-rich zone between plies plays a significant role in forming fiber bundles and on the occurrence of large-scale bridging [20]. We speculate that these surface cracks could eventually find a way through resin-rich regions of the CFRP material and promote the experimentally observed fiber bridging. Concerning sanding, the analysis of previous SEM images indicates that the treatment removed a thin outermost layer of epoxy matrix, leading to partial exposure of carbon fibers, partly flattened during the abrasion process. However, because bridging was not observed, it is concluded that the matrix/fiber interface was not compromised and the fibers were still anchored to the epoxy matrix.

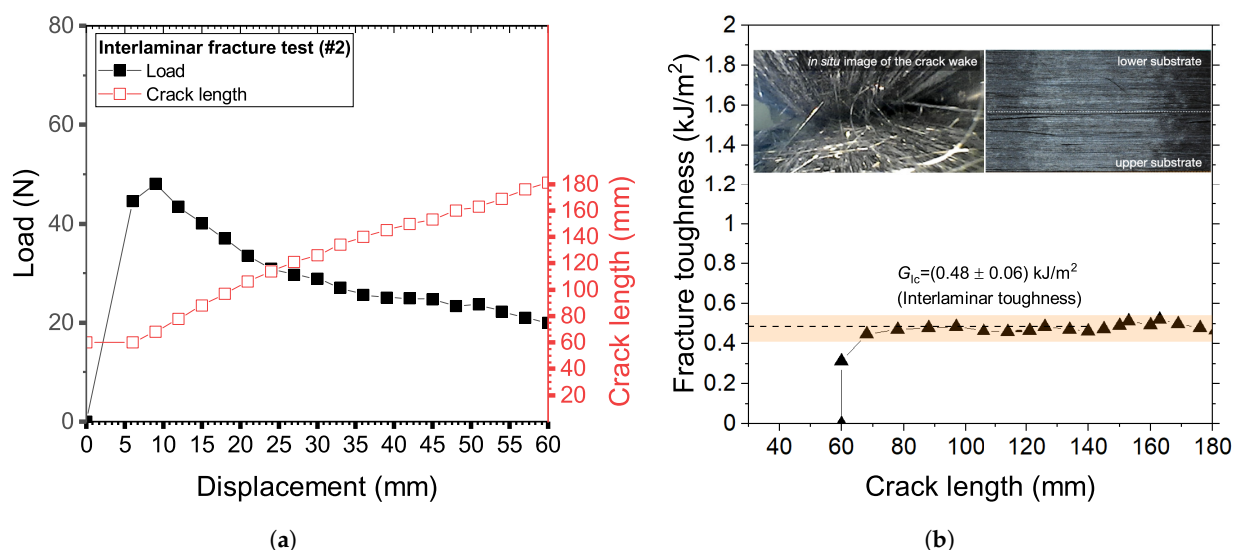
Figure A1. (a) Load-displacement and crack length displacement curves; (b) R-curve obtained in DCB interlaminar tests.

In this section, the results of the interlaminar fracture tests are briefly summarized. Unidirectional ($[0^\circ]_{16}$) laminates were fabricated using carbon fiber prepregs (HexPly T700/M21, Hexcel, Stamford, CT, USA). The fracture toughness was determined using the double cantilever beam configuration. Sample dimensions and execution of mechanical tests were based on recommendations reported in the ASTM D5528-13 [29]. The Compliance Calibration (CC) data reduction scheme was employed to determine the interlaminar toughness, and six samples were tested to ensure redundancy of the obtained results. Typical results are reported in Figure A1. In situ optical observations of the crack propagation were carried out using an industrial endoscope (CMOS Omnivision OV6946, Precision Optics Corporation Inc., MA, USA) with 400×400 pixels resolution. An image of the crack wake and an overview of the fractured surfaces are provided in the insert of Figure A1b. Repeated tests have shown a relatively stable crack growth and the occurrence of limited fiber bridging. This is also reflected by the flat resistance curve (R-Curve), whose plateau value reads $G_{Ic} = (0.48 \pm 0.06) \text{ kJ/m}^2$. A detailed account of these results is reported in [30].

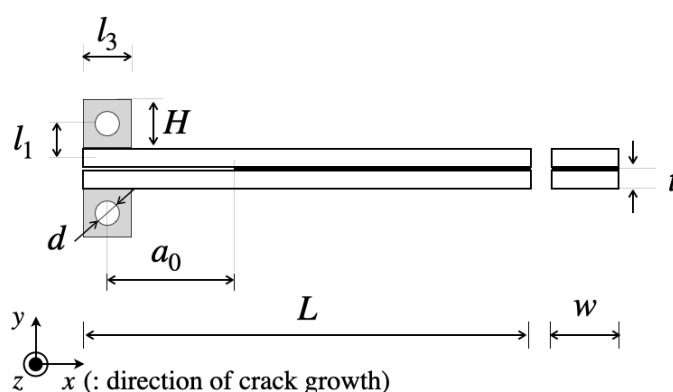
Figure A2. Schematic of the double cantilever beam adhesive joints comprising CFRPs adherents and bonded with an epoxy adhesive. Dimensions are not to scale.

Double cantilever beam (DCB) adhesive joints were fabricated to determine the fracture toughness. A schematic of the sample is reported in Figure A2. A starter-crack ($a_0 = 30 \text{ mm}$) was obtained employing an antisticking tape. Nylon wires were placed in the direction perpendicular to crack propagation (x -) to set the adhesive layer's thickness to about 0.2 mm . The adjoined composites substrates had length $L = 140 \text{ mm}$, width $w = 20 \text{ mm}$, and thickness $t = 2 \text{ mm}$. Initiation and propagation values of fracture toughness were determined using the experimental compliance method (ECM) and following the procedures described in [26]. The compliance is estimated by generating a $\log(C)$ versus $\log(a)$ diagram, where C and a are the specimen compliance and the crack length. The slope of the $\log(C)$ - $\log(a)$ curve, i.e., m , was employed to evaluate fracture toughness using the following equation:

where $l_1 = 16$ mm distance from the center of the loading pin to the mid-plane of CFRP arm; $l_2 = 20$ mm is the distance between the center of the pin-hole of the load-block and its edge, measured towards the tip of the starter crack.

Notice that the thickness of the blocks was $H = 30$ mm, and the width was a match with that of the substrates. The initiation fracture toughness obtained from the mode I precrack can be determined using the following approaches: (i) NL, i.e., onset of nonlinearity on the load-displacement curve; (ii) VIS, i.e., onset of a visually recognizable crack increment as observed from the edge of the specimen; (iii) MAX/5%, i.e., the point of intersection of a straight line with the P - δ curve, with the slope of the straight line 5% higher than the initial one.
