The unusual Ca' Bonettini landslide (Province of Modena, Italy) / Tosatti, Giovanni. - In: ATTI DELLA SOCIETÀ DEI NATURALISTI E MATEMATICI DI MODENA. - ISSN 0365-7027. - STAMPA. - 137:(2006), pp. 145-156.

## Giovanni Tosatti<sup>\*</sup>

# The "unusual" Ca' Bonettini landslide (Province of Modena, Italy)

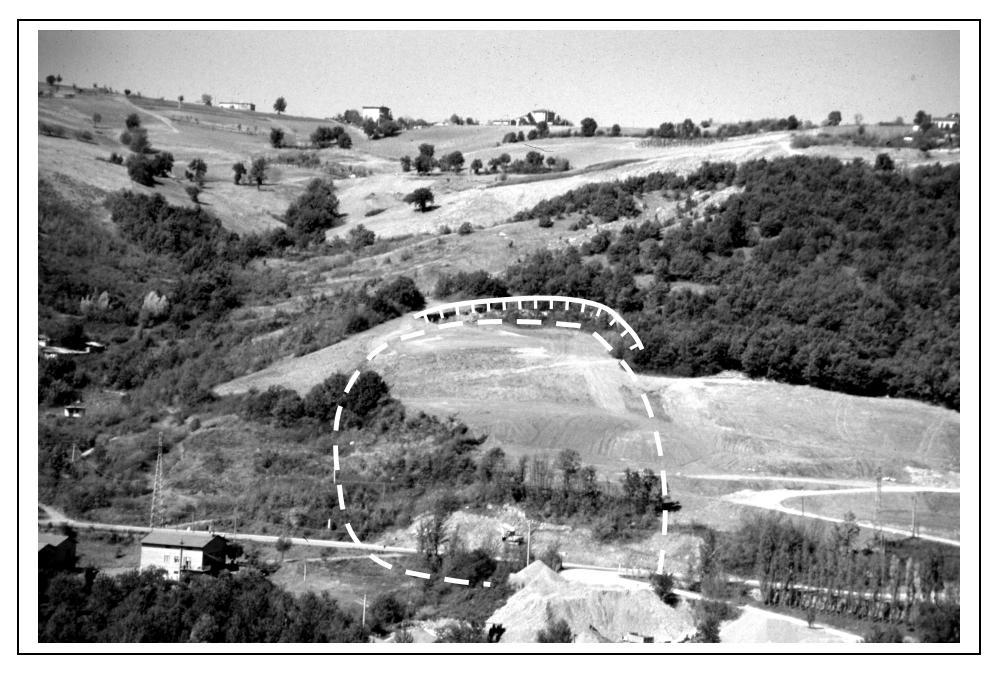
*Fig.* 1 – Panoramic view of the slope where the Ca' Bonettini landslide took place. Broken lines represent the landslide's crown and body (courtesy of D. Castaldini)

Early on 15<sup>th</sup> September 2003 a slope movement took place near Ca' Bonettini, a group of houses in the Municipality of Marano sul Panaro (Modena Apennine hills), on the left-hand side of the River Panaro valley (Fig. 1). According to seismological data, an earthquake, VII-VIII degree MCS, 5.2 magnitude, was recorded late on 14<sup>th</sup> September 2003 in the nearby Bologna Apennines.

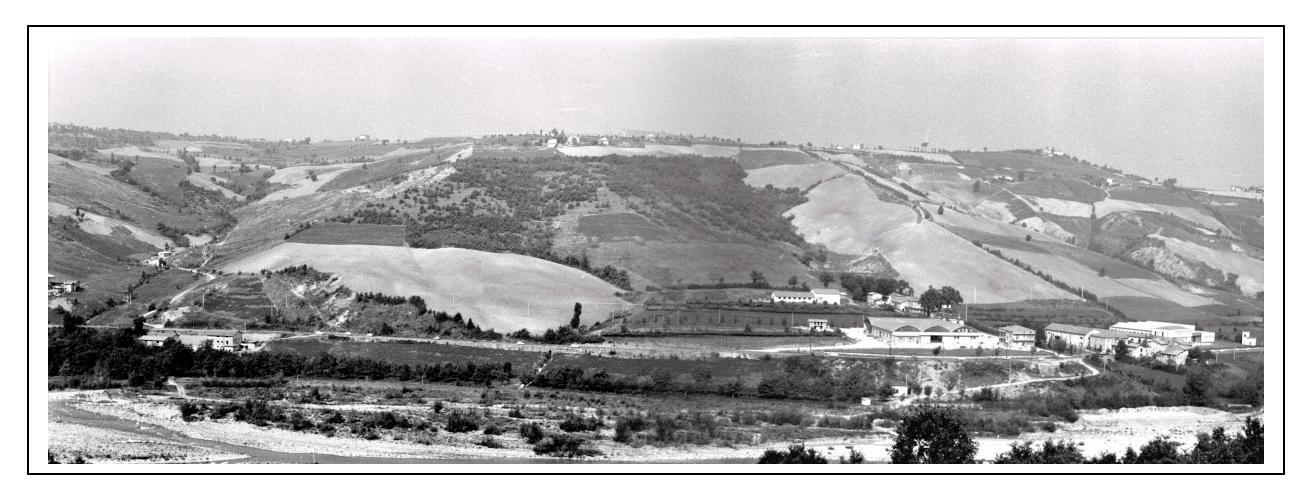
Fig. 2 – General view of the Ca' Bonettini slope on the left-hand side of the Panaro Valley showing dormant landslide bodies in September 1969 (courtesy of M. Pellegrini)

As confirmed by photographs and aerial images from the 1960s-70s, a dormant landslide body was already present along the slope where the Ca' Bonettini landslide of 15<sup>th</sup> September 2003 took place. In those years the slope's lower portion was cultivated whereas its upper part was partially covered by scanty vegetation (Fig. 2). Therefore, in accordance with the great majority of mass wasting processes occurring in the Northern Apennines, also this landslide is a reactivation of a previous movement of unknown origin, probably going back to thousands of years ago, at the end of the last Ice Age (10,000-9,000 yrs BP), when extremely severe

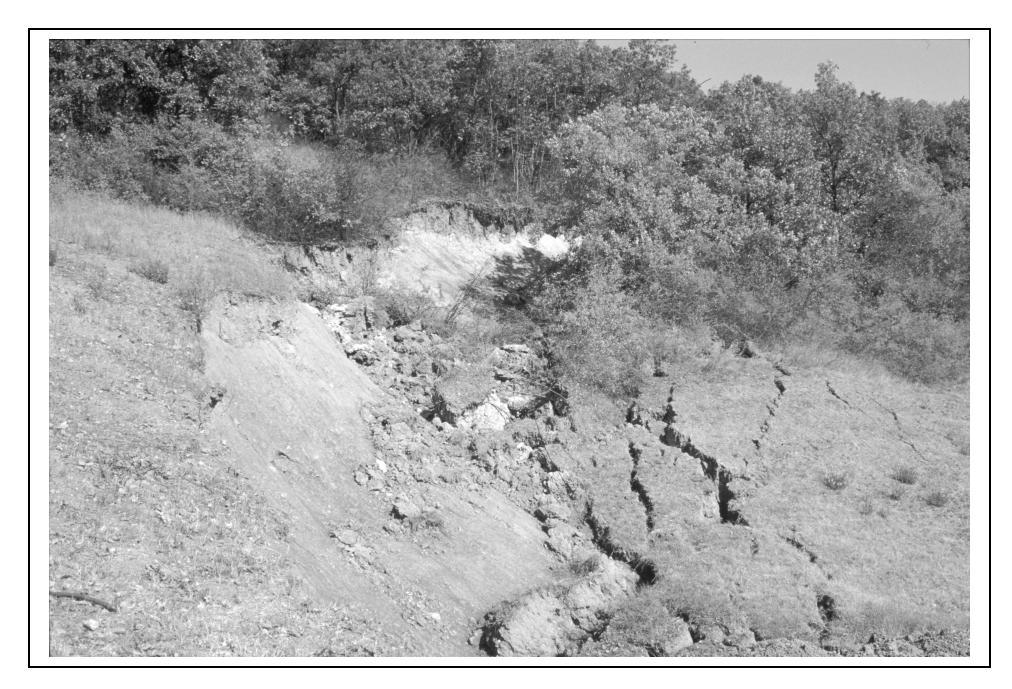
Fig. 3 – The source area of the Ca' Bonettini landslide: slip surfaces and open ground fissures (September 2003)

From a classification viewpoint, this landslide is defined as compound (rotational-translational) earth slides and, locally, earth flows (Cruden & Varnes, 1996) with slow to moderate displacement velocity (Fig. 3).

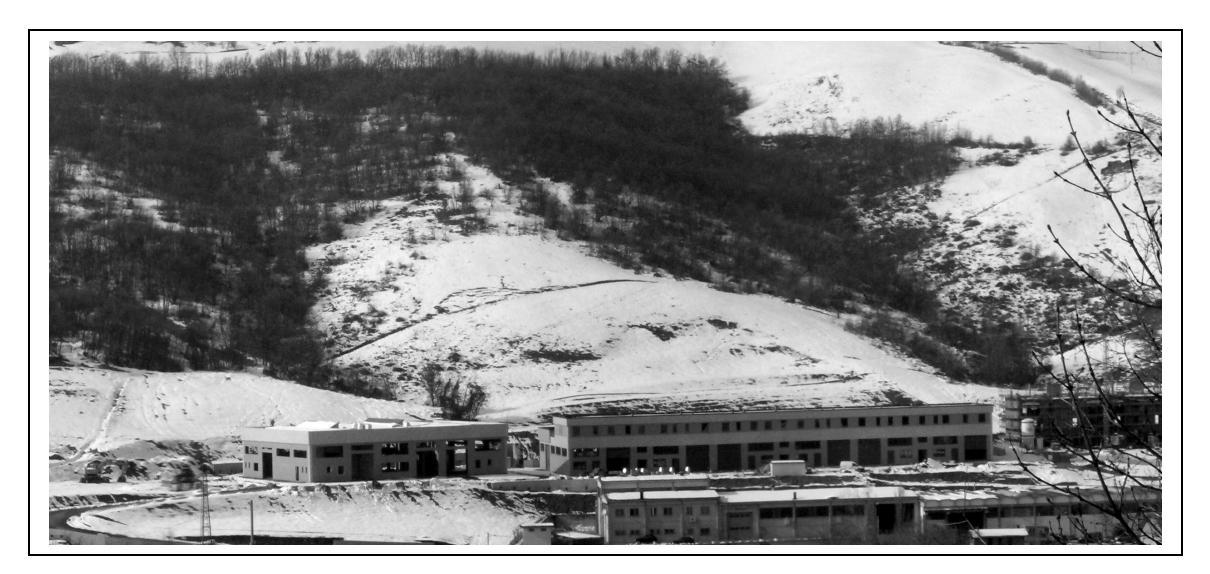
Fig. 4 – Industrial buildings recently constructed at the foot of the Ca' Bonettini landslide (March 2004)

Another predisposition cause for landsliding should also be considered. Since the mid-1960s the area near the foot of the Ca' Bonettini landslide body, in proximity to the valley floor, has been subject to human activities, mainly consisting of industrial and office buildings as witnessed by photographs taken in that period (cf. Fig. 2). Late in August 2003, just weeks before the landslide's first reactivation, building activities were extended towards the landslide foot with the construction of another two buildings, preceded by considerable morphological changes with the removal of large amounts of earth to make room for new constructions (Fig. 4). These works further reduced the stability of the slope, since it is well known that the removal of material from the zone of accumulation of a dormant landslide leads inevitably to a general decline of stability conditions.

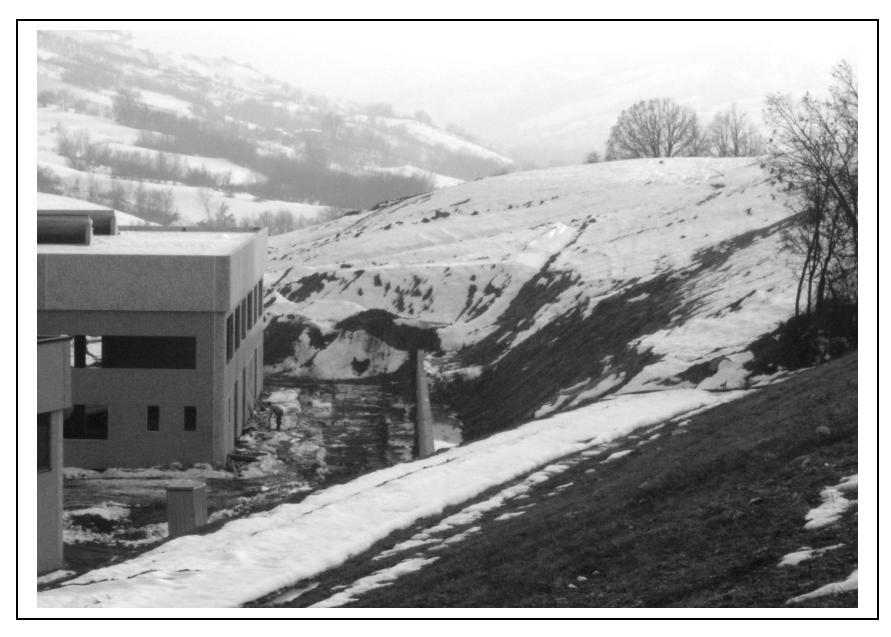
Fig. 5 – Slope cut at the foot of the Ca' Bonettini landslide and containment wall (March 2004)

After the first reactivation and the analysis of seismographic and other instrument data, it was clear that the causes of slope instability were to be found in the excavation and building activities carried out at the foot of the landslide. Therefore, a series of remedial measures was planned in order to increase stability and, at the same time, safeguard the new constructions directly threatened by the movement. The first consolidation works consisted in remodelling the landslide toe with the insertion of drain pipes to reduce pore water pressures, but it was soon obvious that these measures were not sufficient to reinstate the lost stability. Subsequently, a containment wall anchored to the ground by means of 50 m long piles, was constructed uphill of the new buildings (Fig. 5) and surface drains were placed all over the landslide body in order to reduce water absorption.
