Impregnated Carbon Fabric-Reinforced Cementitious Matrix Composite for Rehabilitation of the Finale Emilia Hospital Roofs: Case Study / Nobili, Andrea; Falope, FEDERICO OYEDEJI. - In: JOURNAL OF COMPOSITES FOR CONSTRUCTION. - ISSN 1090-0268. - STAMPA. - 21:4(2017), pp. 05017001-05017022. [10.1061/(ASCE)CC.1943-5614.0000780]

IMPREGNATED CARBON FABRIC REINFORCED CEMENTITIOUS MATRIX COMPOSITE FOR REHABILITATION OF THE FINALE EMILIA HOSPITAL ROOFS: A CASE STUDY

Andrea Nobili, Ph.D., P.E.¹ and Federico O. Falope, P.E.²

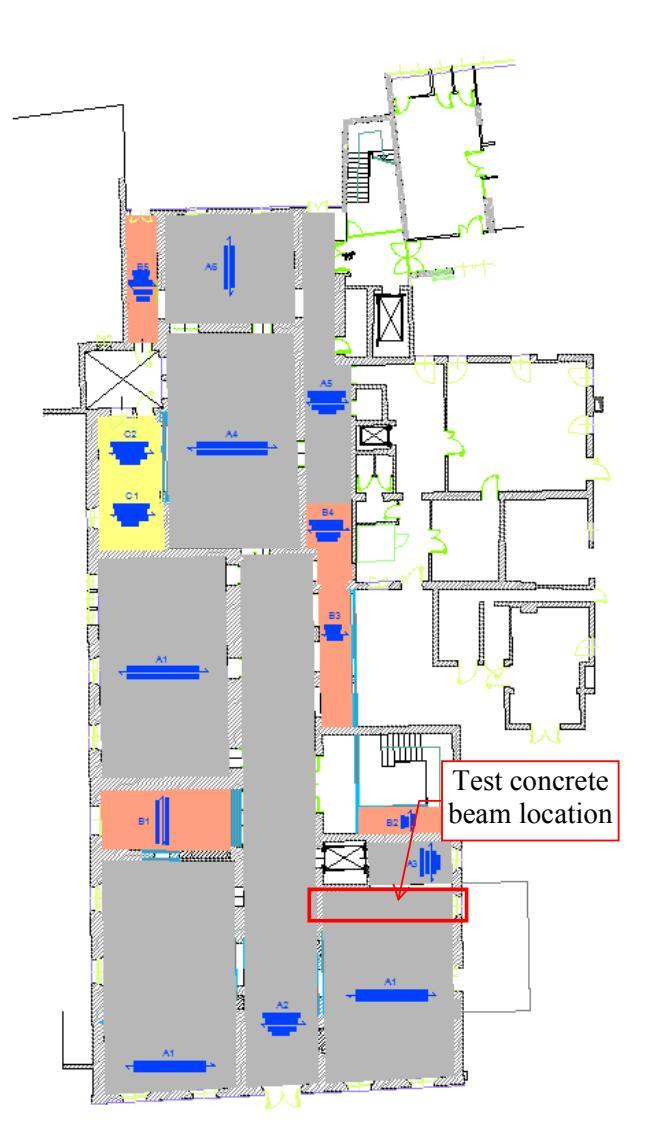
FIG. 1. Roof system at ground floor for the hospital main building (H1)

⁶⁵ A preliminary analysis of the main building found more than ten different types of roofs, ⁶⁶ for the largest part constituted by concrete beams with hollow blocks in between, with ⁶⁷ different slab thickness and orientation (Fig.1). A roof typical cross-section is shown in ⁶⁸ Fig.2. An impregnated CFRCM composite is considered to be bonded at the intrados of ⁶⁹ the concrete beams taken from the Finale Emilia hospital roof. The composite material is ⁷⁰ applied according to the following steps:

In order to avoid weakening an already poorly performing structure, only a single 8-mlong beam could be taken from the hospital roof (the original location of this beam is shown in Fig.1). For transportation convenience, the beam was cut into 5 pieces, between 1.2 to 1.4 m long. The roof beam is fitted with a variable-along-the-length longitudinal steel bar reinforcement, which roughly follows the bending moment diagram. Rebar surface is not patterned. The mid-span longitudinal reinforcement is given by $3\emptyset 16 + 2\emptyset 6$ mm and by $1\emptyset 16$ mm, respectively for lower and upper section reinforcement (see Fig.5). Conversely, the

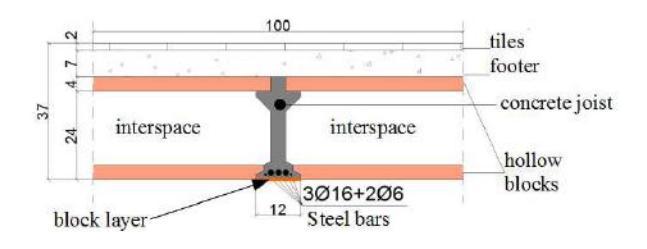
FIG. 2. Roof typical cross-section (dimensions in mm)

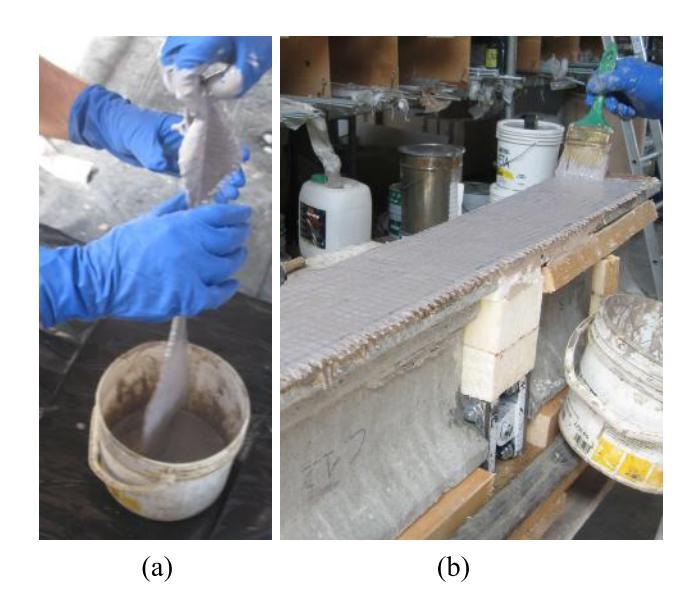
FIG. 3. Application of the liquid impregnation agent to the cut-to-size carbon fabric: (a) impregnation through immersion (Cycle A), (b) application with a brush to the carbon fabric already placed on the mortar bed (Cycle B)

- 1. the substrate (i.e. the clay tile) is wetted and then a water-based liquid inorganic
 adhesion promoter is applied with a brush;
- ⁷³ 2. a first mortar bed, roughly 5 mm thick, is laid;
- cut-to-size pairs of uni-directional carbon fabric reinforcement sheets are impregnated
 by the adhesion promoter through immersion and then squeezed out to eliminate the

excess of impregnating agent (only for Cycle A, see Fig.3);

Alongside this treatment, which is termed Cycle A, a simpler process is considered, named 82 Cycle B, which dispenses with step 3. According to this simpler application cycle, the liquid 83 impregnation agent is applied with a brush directly to the carbon fabric already placed on 84 the mortar bed, both after steps 4 and 5 (Fig.3). The reason for this second option is that the 85 expected performance decay could be weighted against the advantage of a more expedited 86 process and the lower cost it conveys. All materials adopted in the analysis are commercially 87 available and their main properties are gathered in Table 1 for the mortar and in Table 2 88 for the fabric. The mortar (coded B) and the impregnation agent are characterized as single 89 components in Nobili (2016). The main reason for adopting this fairly low-strength mortar is 90 compatibility with the clay tile mechanical properties. Besides, this mortar, in conjunction 91 with the adopted adhesion promoter, has proved very effective in developing a strong bond 92 with the carbon fabric. 93

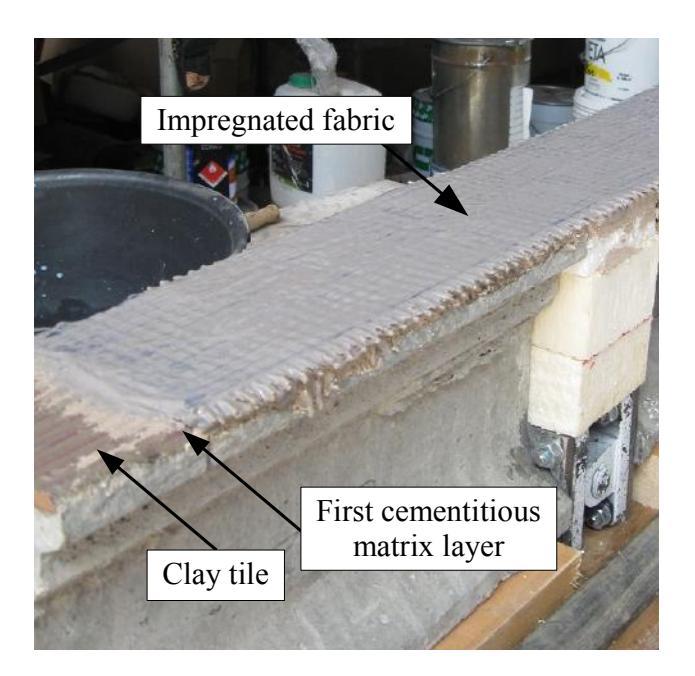
FIG. 4. The roof concrete beam is placed upside down for lamination (clay tile on top, steel hinge for the beam test at the bottom)

- 4. a first sheet of uni-directional carbon fabric reinforcement is placed onto the mortar bed and then rolled to dispense with trapped air bubbles (Fig.4);
- 79

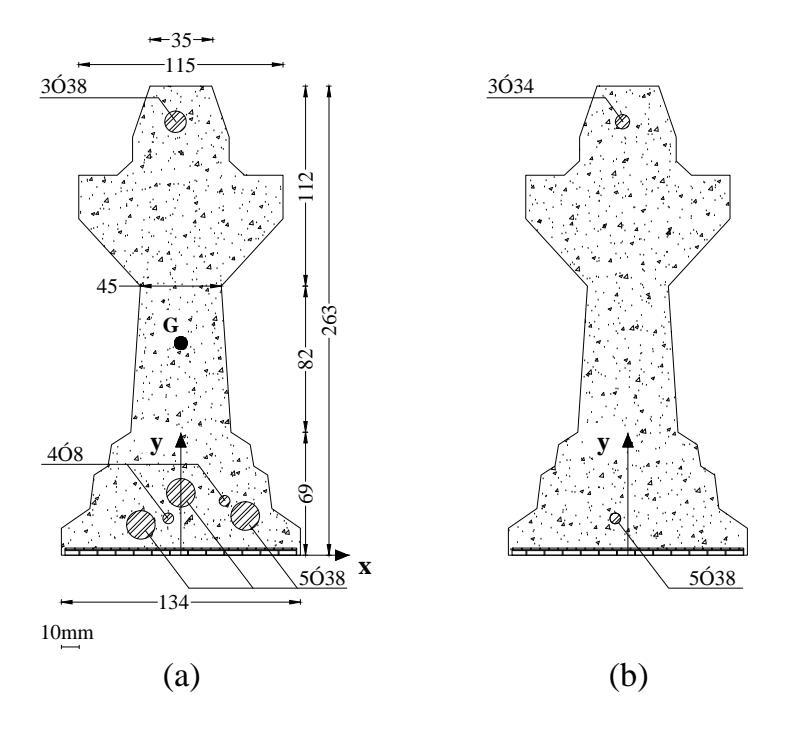
FIG. 5. Concrete beam mid-span (a) and beam end (b) cross-sections (clay tile at the bottom) and reference system

beam end longitudinal reinforcement features $1 \not = 6 \text{ mm}$ (lower) and $1 \not = 12 \text{ mm}$ (upper section). 102 Table 3 gathers the cross-section inertial properties. It should be emphasized that the 103 longitudinal rebar distribution is incompatible with modern seismic design, for no provision 104 is taken against bending moment sign inversion. The beam pieces were further cut into a 105 total of 15 400-mm-long portions, each endowed with a different amount of longitudinal steel 106 rebars according to its location in the original joist. Transverse reinforcement is very weak 107 and only $1 \neq 6/500$ mm steel bar could be detected through pachometer testing. According 108 to the Italian Building Code (2008, §4.1.2.1.3.2), the theoretical ultimate shear strength 109 amounts to 110

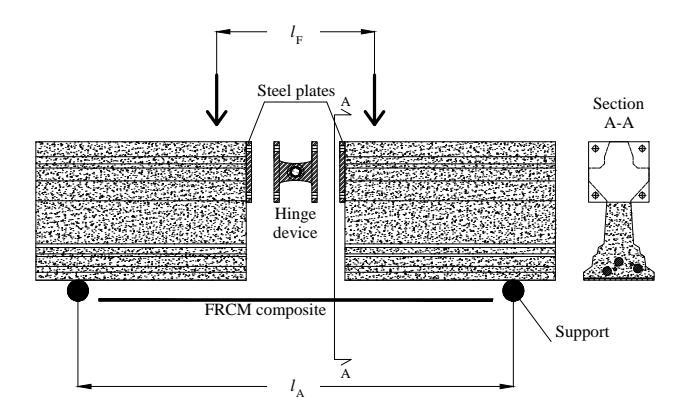
FIG. 6. Schematic of a beam test: $l_F = 300$ mm, $l_A = 900$ mm

In view of the high danger of brittle failure due to shear in a plain bending test, a beam test (alias traction-through-bending test) on pairs of beam portions joined together through a steel hinge was adopted (RILEM 1994). The test schematic is presented in Fig.6.

where $M_u = P(l_A - l_F)/4$ is the ultimate bending moment (Fig.6), d = 210 mm the lever arm and N_u the ultimate normal force conveyed through the hinge and the laminate. Once the normal force N_u is determined, the ultimate average shear stress easily follows

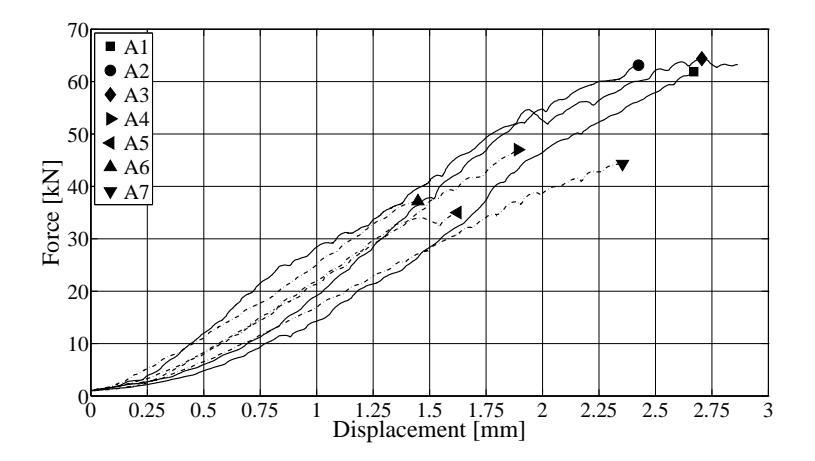
FIG. 7. Beam test results - solid curves belong to Cycle A, dashed curves to Cycle B

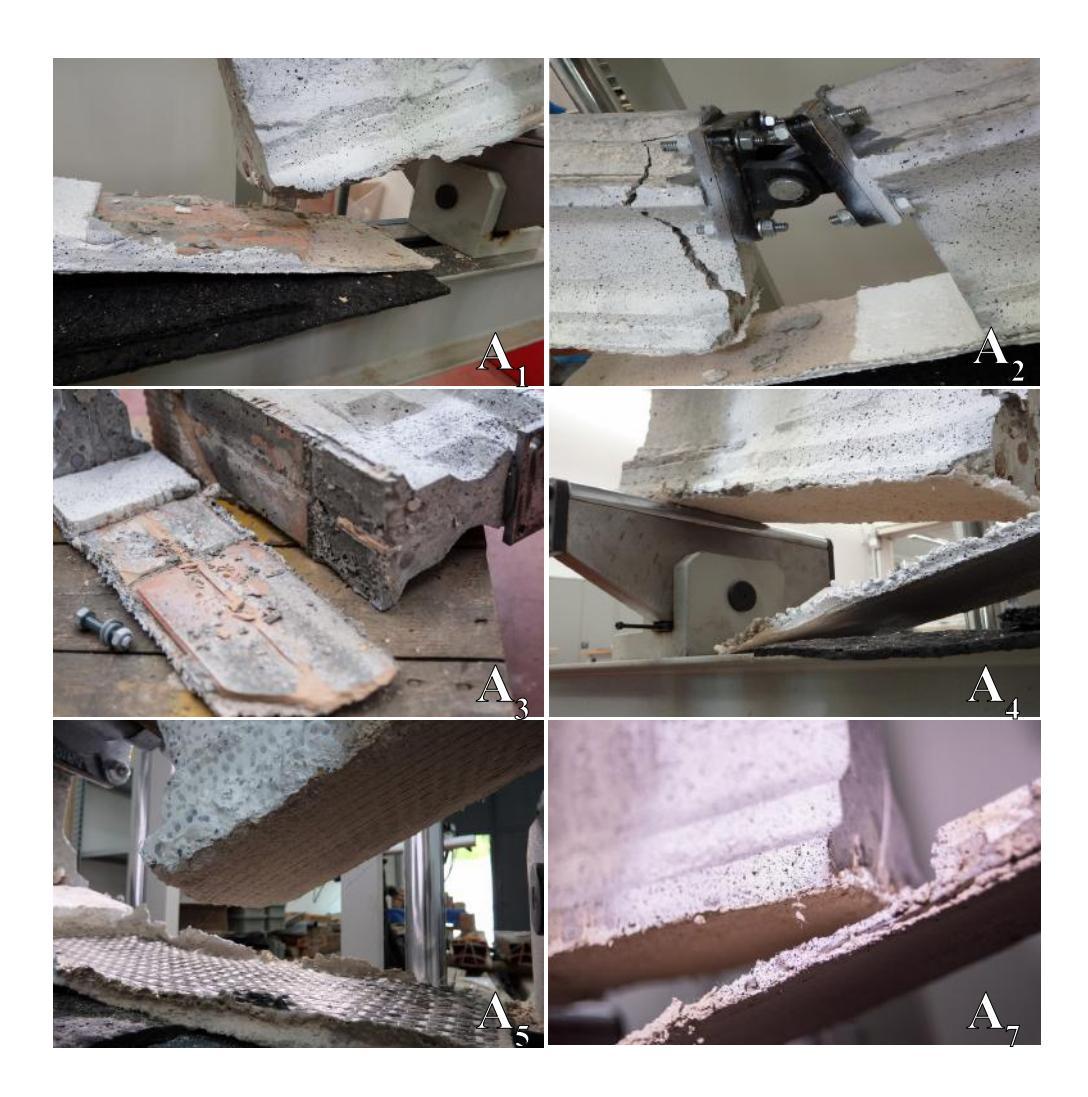
FIG. 8. Failure modes: cohesive fracture (specimen A1 and A3), tensile failure in the concrete (A2), delamination (A4,A5,A7)

where Γ_{fd} is the specific fracture energy which depends on the ultimate slip s_u (see also 134 D'Ambrisi et al. 2013 for a suitable choice of s_u for FRCM materials) and parameters are 135 given in Table 4. Clearly, for maximum performance, the bonded length l_b should exceed 136 l_e . Indeed, a bonded length $l_b = 300$ mm was considered with no special anchoring device 137 U-wrapped fabric, transverse bars, abrasive blasting of the substrate surface etc.). (e.g. 138 The bending test was carried out under displacement control at 1 mm/min knife speed. 139 Fig.7 gathers the results of the beam test while Fig.8 presents the failure mechanism for 140 each specimen. Failure in specimens A1–A3, treated according to Cycle A, is either due 141 to cohesive fracture in the thin tile layer, also known as intermediate debonding, or to 142 tensile failure in the concrete (for a brief description of the different fracture mechanisms see 143 CNR DT200 (2004)). Indeed, specimen A2 displayed clear evidence of tensile failure in the 144 concrete near the hinge, which was accompanied by mixed cohesive fracture at the laminate 145 interface. 146

¹⁴⁷ Conversely, delamination of the fabric with fracture taking place at the fabric/matrix ¹⁴⁸ interface is always met in specimens A4–A7, prepared according to Cycle B. The difference ¹⁴⁹ in the failure mechanism reflects itself in a sharp difference among the ultimate loads, which ¹⁵⁰ exceed 60 kN for Cycle A as opposed to well below 50 kN for Cycle B. It is observed that 151

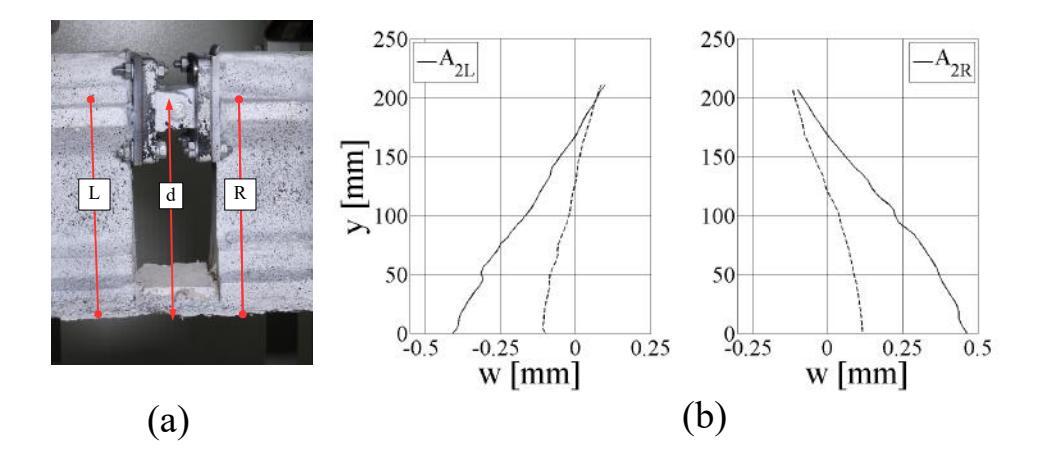
FIG. 9. Location of the reference lines L and R (a) and their axial displacement w vs. cross-sectional height y at 100% (solid) and at 60% (dashed) of the ultimate load for specimen A2 (b). Reference system as in Fig.5

A Q400 Dantec Dynamics Digital Image Correlation system was employed to acquire 153 the displacement field along the beam test through application to the specimen side of a 154 fine coarse speckle array. A preliminary zero-displacement data acquisition allowed assessing 155 a 20 μ m displacement background noise level (resolution). A technical problem prevented 156 recording displacement data of the A6 specimen. Two reference lines, named L and R157 for the left and right element, respectively, are drawn symmetrically about the hinge. The 158 deformation of such lines (i.e. longitudinal displacement with respect to the original position) 159 is displayed in Fig.9 for specimen A2 at 60% of the ultimate load and just prior to failure. 160 The symmetry of the left-right line displacement is remarkable and holds for all specimens. 161

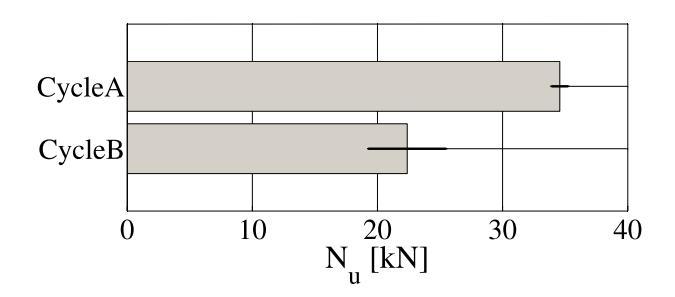
FIG. 10. Ultimate load \boldsymbol{N} and one-standard deviation bar

ultimate loads within Cycle A were remarkably consistent (cfr. error bar in Fig.10).
