Article

Time-Lapse GPR Measurements to Monitor Resin Injection in Fractures of Marble Blocks

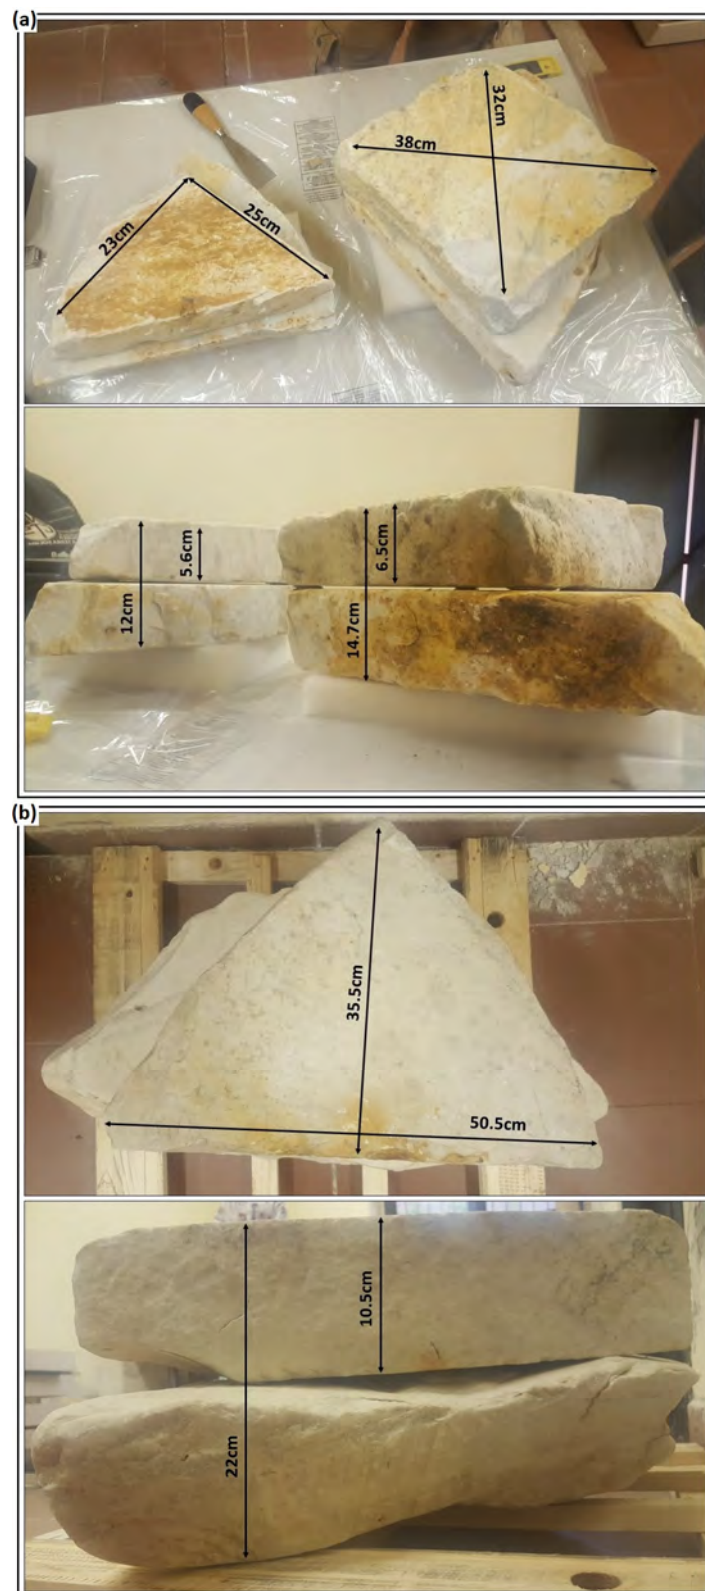
Figure 1. Top and side views of three fractured samples created for laboratory tests using six Carrara marble blocks. (a) Two small blocks (**left**) with the fracture modelled between them at the depth of about 5.6 cm with the average fracture opening of 3 mm. Two medium blocks (**right**) with the fracture modelled between them at the depth of about 6.5 cm with the average fracture opening of 3 mm. (b) Two large blocks with the fracture modelled between them at the depth of about 10.5 cm with the average fracture opening of 8 mm.

For laboratory tests, we used six small marble blocks selected from quarry wastes in Marina di Carrara, Italy. Using these six blocks, we prepared three specimens, shown in Figure 1, with slightly increasing dimensions. We created artificial and irregular fractures by placing the blocks on each other in pairs. To create artificial fractures, small PVC spacers with the height of 2 mm for small blocks (Figure 1a, left), 3.5 mm for medium blocks (Figure 1a, right), and 5 mm for large blocks (Figure 1b) were placed between each pair of blocks. The PVC spacers were positioned as close as possible to the edges in order to prevent their influence on the integrity of the resin after being dried. The inner surfaces of the blocks were not smooth or polished. As a result, the distance between the two blocks, i.e., the thickness of the simulated fracture, was not constant, especially for the large blocks (side view in Figure 1b) where the fracture thickness approximately varied between 1 mm and 15 mm. Based on the surface area of the blocks (Figure 1) and the volume of the resin required for the full injection, we calculated an average fracture opening of 3 mm for small blocks, 3 mm for medium blocks, and 8 mm for large blocks. Considering that the relative permittivity of the epoxy resin was expected to vary in the range 3.5–4.7, a quarter of the wavelength for the 3 GHz antenna used in this study was never less than 15 mm and the simulated fractures can be thus considered as thin layers. All specimens were surveyed with the GPR before and after resin injections in the laboratory.

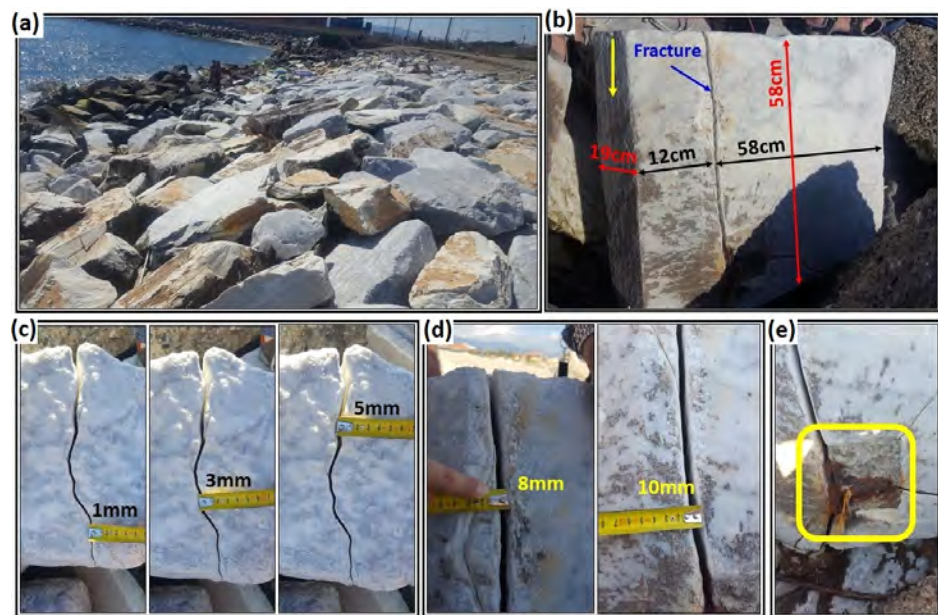
Figure 2. Carrara marble block for field test. (a) A pile of abandoned blocks on the Marina di Carrara coast. (b) The selected block with a vertical, visible natural fracture. The vertical yellow arrow shows the side selected for the GPR measurements. (c) Top view of fracture thickness. (d) Front view of fracture thickness. (e) Detail of a metal target embedded near the fracture in the lower part of the block.

We performed in situ measurements on a fractured marble block in Marina di Carrara where hundreds of irregular marble blocks were deployed on the shore to form a protecting barrier (Figure 2a). The selected block had the advantages of having a clearly visible air-filled fracture and an accessible side parallel to the fracture suitable for radar measurements (Figure 2b–d). Unfortunately, there was a small metal target embedded in the lower part of the block (Figure 2e), maybe related to a previous use of the block or used for block transportation. We performed time-lapse GPR measurements at the same locations before and after resin injections to repair the natural fracture of the selected block. As can be seen, the metal element shown on Figure 2e partially disturbed the radar measurements performed near the base of the block.

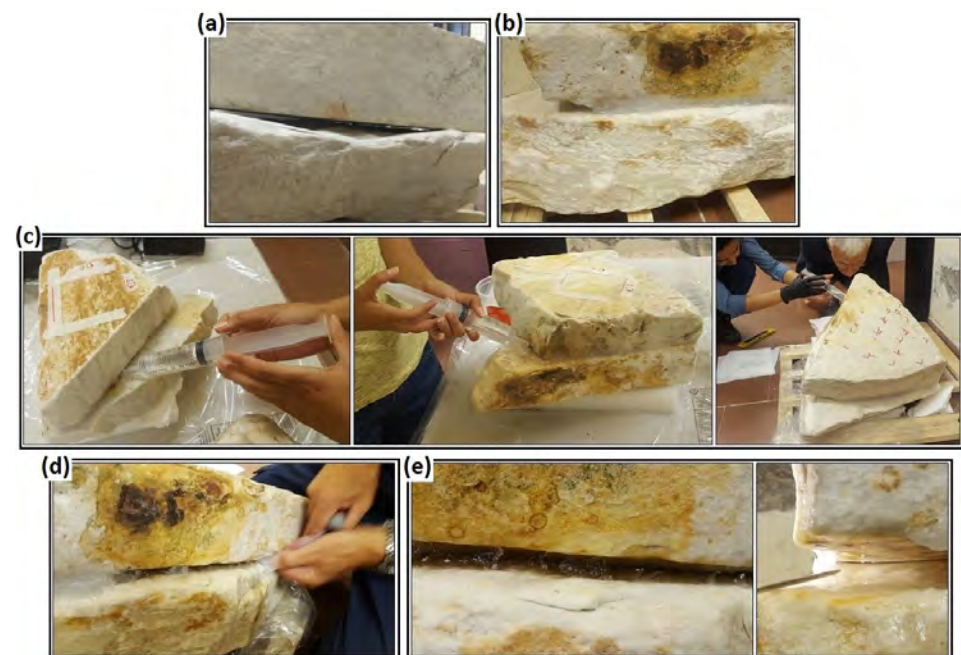
Figure 3. The process of simulating artificial fractures and resin injection in marble specimens. (a) Simulating a fracture by overlapping two blocks. (b) Sealing the fracture perimeter with silicone. (c) Resin injections inside the small blocks (**left**), medium blocks (**middle**) and large blocks (**right**). (d) Removing the dried silicone from around the blocks. (e) Checking that resin arrived at all the peripheral parts of the fracture.

To prevent the dispersion of the resin out of the fractures, both the artificial fractures between the overlapped blocks in the laboratory and the natural fracture in Marina di Carrara were properly sealed with silicone along their external perimeter with the exception of a small injection point (Figure 3).

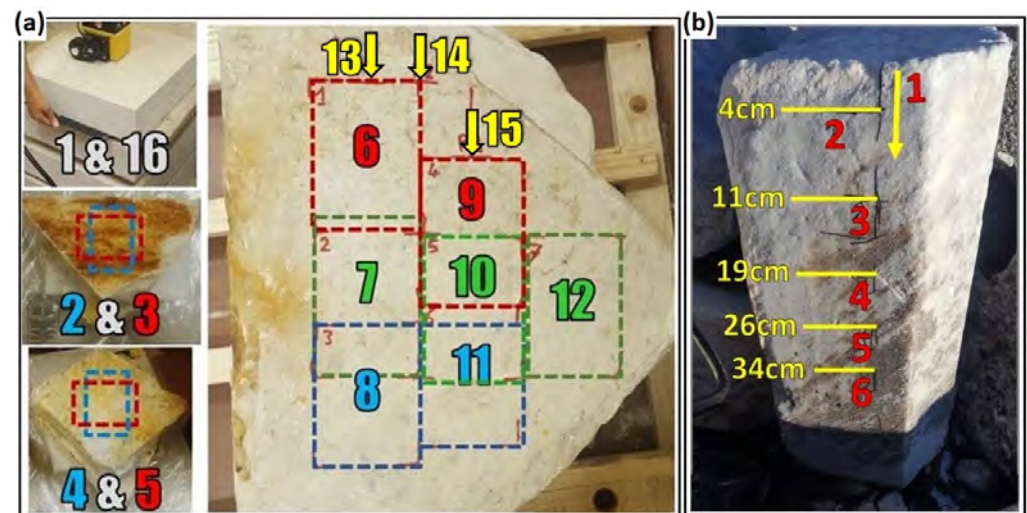
Figure 4. (a) The positions of the GPR antenna for different measurements performed in the laboratory. Records 1 and 16 were surveyed on marble blocks of Botticino for amplitude calibration at the beginning and end of each experiment. Records 2 and 3 were surveyed from the central position of the small blocks of Carrara (see Figure 1a, left). The antenna was rotated 90 degrees from record 2 to record 3. Similarly, records 4 and 5 were surveyed from the central position of the medium blocks of Carrara (see Figure 1a, right). Records 6 to 12 were surveyed on the large blocks of Carrara (see Figure 1b) by deploying the antenna at the fixed positions from 6 to 12. Profiles 13, 14 and 15 were recorded as continuous profiles parallel to the longer side of the blocks by moving the antenna from the positions 13, 14, and 15. (b) Measurements on the Carrara marble block with natural fracture used for field test (see Figure 2b). Profile 1 was recorded as a continuous profile from top to down. Records 2 to 6 were surveyed by placing the antenna at the positions 2 to 6, and yellow numbers are the distances of the antenna's positions from the top of the block.

GPR measurements were performed on the laboratory specimens for eleven days. In addition, measurements on the Botticino blocks were performed every day for amplitude calibration. Each set of measurements consisted of 16 records. Two records (n. 1 and n. 16) were surveyed on Botticino marble blocks at the beginning and the end of the measurements of each day to control the amplitude drift of the radar system. The reference signal used to control the antenna amplitude drift was the reflection from a metal shield inserted between the first and the second blocks measured by the antenna from the central position of the first block. The remaining fourteen records were surveyed at the positions shown in Figure 4a. All GPR measurements were performed as time-triggered surveys without moving the antenna from the fixed position, except for records 13, 14, and 15 that were surveyed as wheel-driven profiles by moving the antenna on the large blocks along short trajectories. Profiles 13 and 14 were about 18 cm and 22 cm long, respectively, while profile 15 was about 12–14 cm long.

the third day. The fracture created between the large blocks was progressively saturated with four injections. The large blocks were slightly dipping in such a way that the resin, injected from the block corner closer to position 6 (Figure 4a), was gently flowing by gravity towards the block side opposite to the injection point.

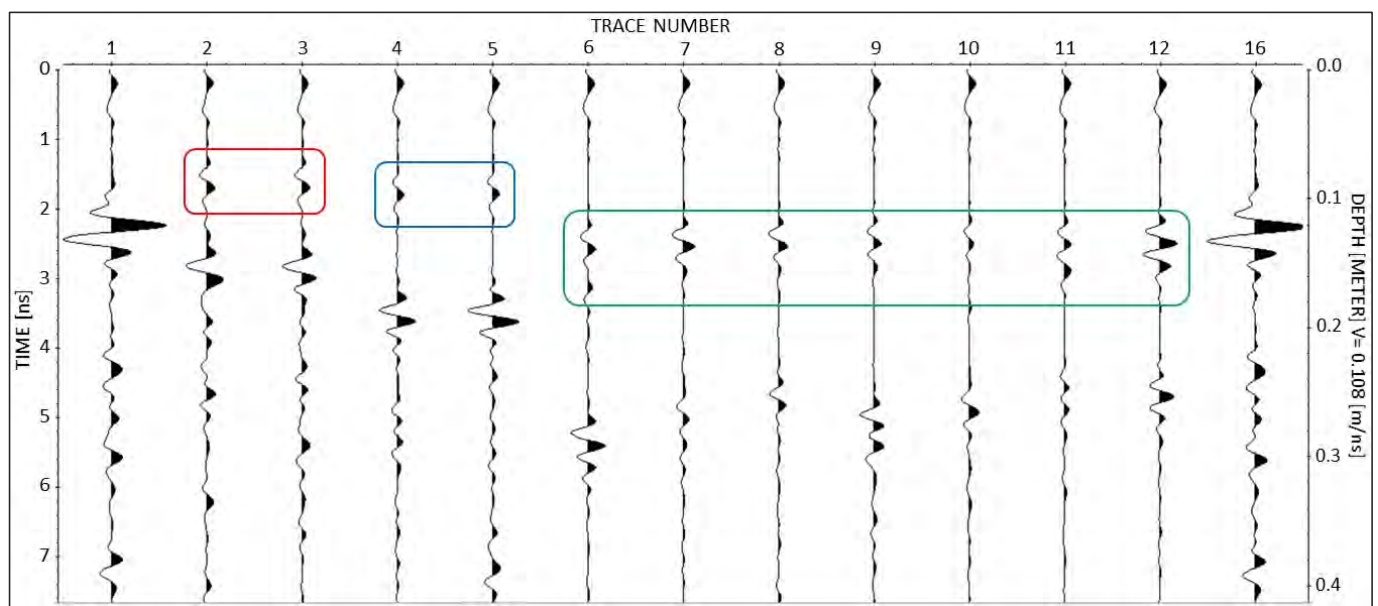
Figure 5. An example of a complete session of the laboratory time-triggered data after data processing and stacking. Traces 1 and 16 are the calibration records measured on the Botticino blocks. Traces 2 and 3 belong to the small blocks of Carrara. Traces 4 and 5 belong to the medium blocks. Traces 6–12 belong to the large blocks. The reflections of the artificial fractures are highlighted by three rectangles.

After stacking, all the time-triggered data of a measurement session, i.e., measurements related to the positions from 2 to 12 plus the calibration tests 1 and 16 (Figure 4a), were merged and compared on a single plot as shown in the example of Figure 5. The first and last traces relate to the Botticino blocks that were used for the calibration process. Trace numbers 2 and 3 showing a reflection at 1.2 ns (depth of about 6 cm) belong to the records of the small blocks of Carrara. Trace numbers 4 and 5 showing a reflection at 1.4 ns (depth of about 7 cm) belong to the records of the medium blocks. These pairs of records were measured in the same positions on the small and medium blocks using two orthogonal orientations of the antenna. Since the reflection came from the same reflecting point for each pair, the thin bed reflection was expected to show the same amplitude. On the contrary, for the records from 6 to 12 that belong to the large blocks and show a reflection at 2.2 ns (depth of about 11 cm), the reflecting position was changing, and this affected the amplitude of the reflection, as is clearly visible in Figure 5.

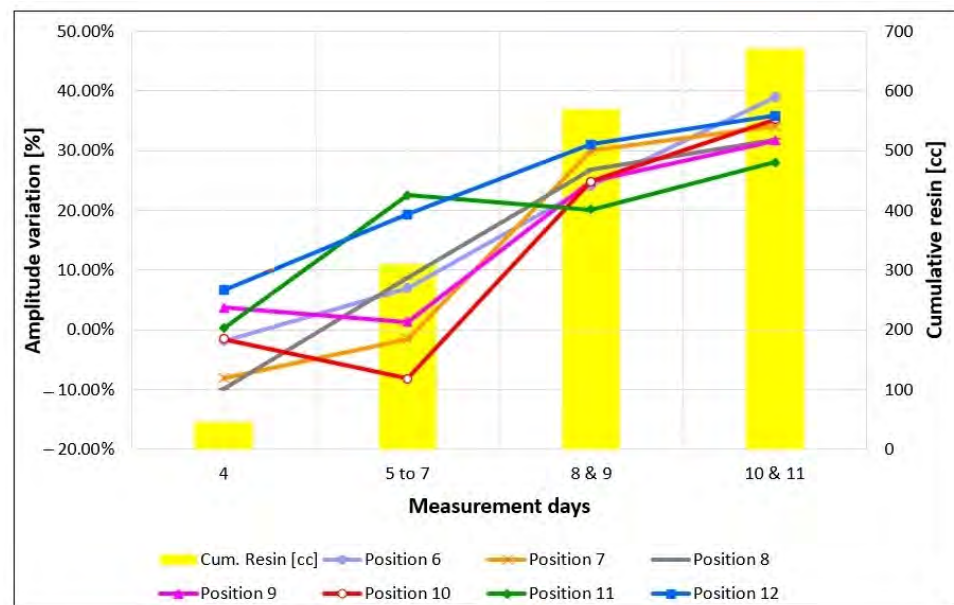
Figure 6. Amplitude percentage variations of the artificial fracture reflections measured on the large block at the selected positions after each injection phase. Positive numbers indicate amplitude decrease. Yellow bars indicate the cumulative amount of the resin injected after each phase.

Figure 6 shows the percentage variations measured after each injection phase on the seven different positions tested on the large blocks (positions 6–12 shown in Figure 4a). Except for the data points measured on the fourth day after the first injection of only 45 cc of resin, other data points are the average values of the measurements repeated on successive days, i.e., three times after the second injection, and two times after the third and the fourth injections. The yellow bars indicate the cumulative resin amount resulting after each injection phase.

By observing the graph in Figure 6, we understand that the first initial injection was so minimal (only 45 cc) that was not able to fill the fracture in any position, as proved by the GPR amplitude variations that are negative or close to 0% with a maximum positive value of 6.65% in position 12. Note that negative variations are obviously not attributable to the presence of the resin because resin injections cannot produce an amplification of the reflected wave. Thus, negative variations are the result of noise and residual drift effects. On the contrary, positive variations could be attributed to resin injections, but the values are too far from the theoretical expectations (about 38%) associated with a filled fracture. Moreover, positive variations never exceed 7% which is almost the standard deviation observed on the medium block test. Therefore, the positive variations are very likely attributable to noise and residual drift effects as well. After the second injection, resulting in a cumulative resin volume of 310 cc, the situation does not change for most positions except for positions 11 and 12 in which the amplitude variations rise to values close to, or a little larger than 20%, suggesting that the resin was mostly flowing towards these two positions. This is consistent with the expectations based on the inclination given to the specimen. A 20% variation cannot be confused with amplitude variations produced by noise or residual drift effects. Thus, it must be caused by resin injections; however, there might be the probability that the fracture was still not totally filled. After another injection, resulting in a cumulative resin volume of 570 cc, all amplitude variations approached values between 20% and 31%. This proves that resin has reached all the tested positions; however, in some points where the variations are still less than 25%, we might think that the filling is not complete. It is interesting to note that the amplitude variation at position 12 jumps up from about 19% to 31%, the highest value measured at this stage. This seems to confirm that the inclination of the specimen produces a preferential flow directed towards that position, which seems to be the first zone to be totally filled. After the last injection, resulting in a cumulative resin volume of 670 cc, all amplitude variations show further small increases, with all values in the range 28–39%. According to GPR, we conclude that the injections were successful at all positions. This is consistent with the fact that at this stage, no more resin could be injected inside the fracture, and we are mostly sure that the fracture was completely filled everywhere. It is interesting to note that the amplitude variation at position 6 moves from 24% to 39% at the final stage. This is the highest increase observed between stage three and stage four. Considering that the injection point was close to position 6, and that the specimen was gently inclined to favor the resin flow towards the opposite side of the block, it is quite reasonable that position 6 was not totally filled after stage three and was completely filled only after the final injection.

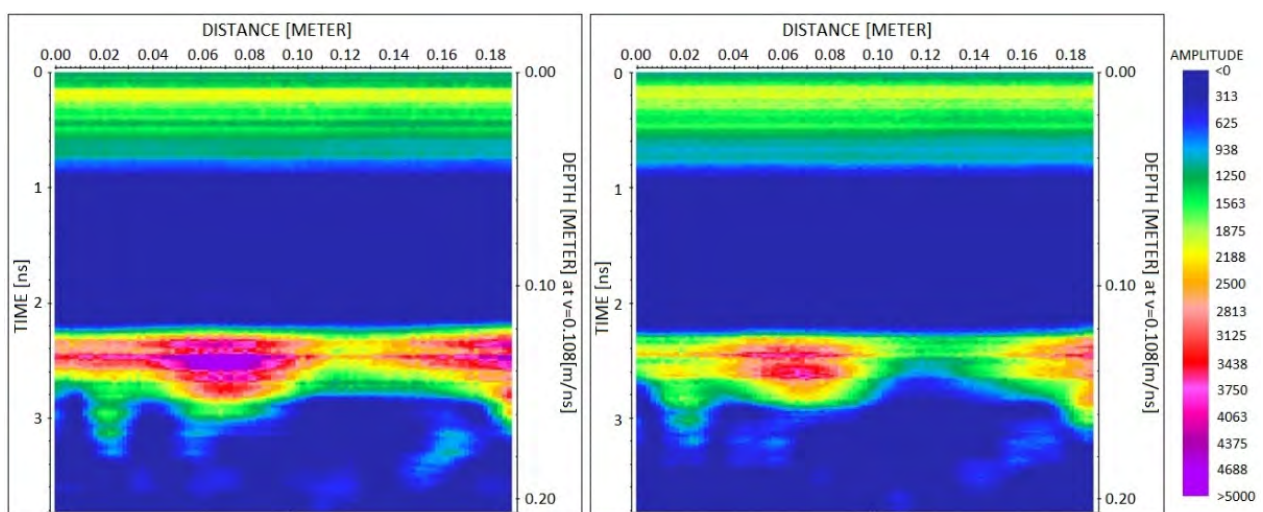
Figure 7. Comparison of profile 14 measured on the large specimen before and after injections on the third day (left) and on the last day (right), respectively. Data are plotted after time and amplitude calibration, dewow filter, and envelope extraction.

To illustrate the results obtained with the profiles 13, 14 and 15 measured by moving the antenna on the large specimen, Figure 7 shows the comparison of profile 14 measured on the third day, i.e., before injections (left image), with profile 14 measured on the last day, i.e., after full injection of the fracture (right image). Data are presented after applying the dewow filter and after time and amplitude calibration, by plotting the radar trace envelope with the same color scale to facilitate the amplitude comparison of the reflection from the fracture arriving at about 2.2 ns. For a more detailed comparison of the reflected amplitudes, a selection of the same data (one trace every eight traces), is compared in Figure 8 by overlapping the trace envelope before and after injections. Very similar images were also observed by analyzing profiles 13 and 15 measured before and after injections.

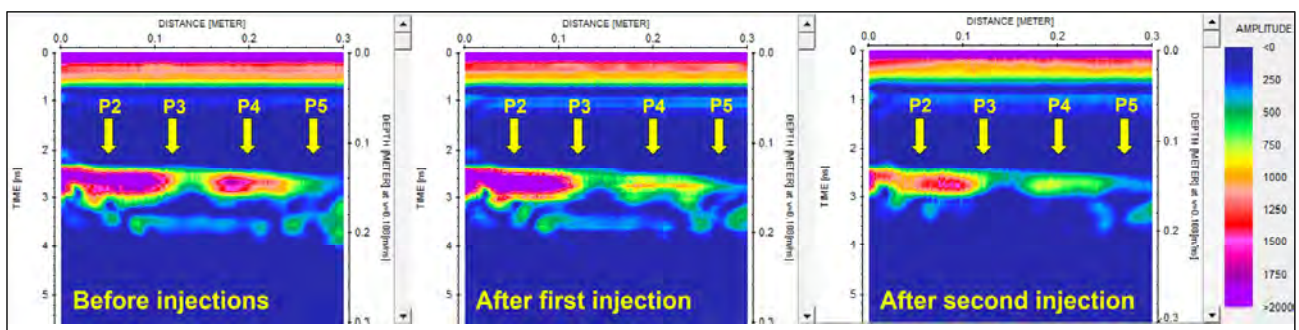
Figure 9. The radar profile measured on the fractured block on the Marina di Carrara before and after the two injection phases. Data are plotted after time and amplitude calibration, dewow filter, and envelope extraction. The arrows indicate the approximate positions of the point measurements reported in Figure 10.

Field data measured on the selected block in Marina di Carrara were processed using the same processing steps applied to the laboratory data. The vertical wheel-driven profile is shown in Figure 9 to compare the envelope amplitudes of the reflection before injections, after the first injection phase, and finally, after the concluding injection phase. The arrival time of the fracture reflection was 2.2 ns (about 12 cm) at the beginning of the profile (i.e., at the top of the block) and gently increased as the antenna moved down along the block face. At 30 cm from the initial position, the apparent depth of the fracture was about 14 cm. The profile was cut at 30 cm because the last part was disturbed by the diffraction produced by the metal target embedded in the block (Figure 2e). For the same reason, we analyzed the point data measured in positions 2 to 5 (Figure 4b), while we ignored position 6 which was too close to the metal element. The percentage amplitude reductions measured at these positions after the first and the second injections are illustrated in Figure 10. To compare the profile amplitude variations with the point measurements, Figure 9 shows the approximate positions of the selected points.

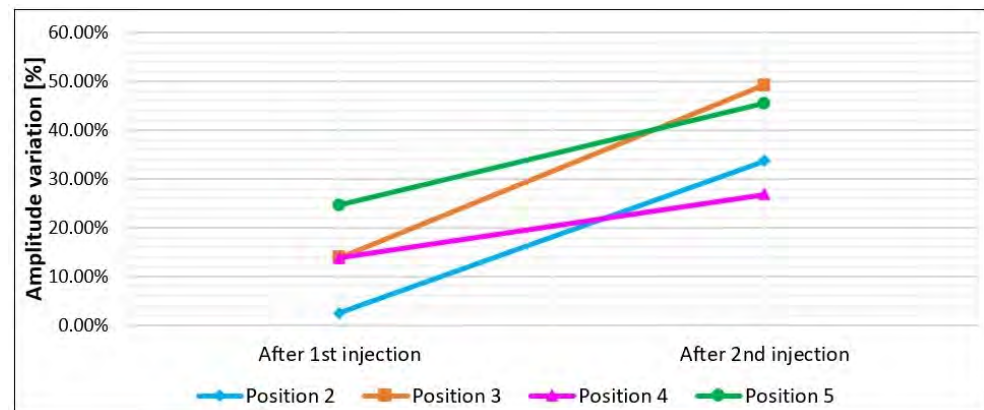
Figure 10. Amplitude percentage reductions of the natural fracture reflection measured at the selected positions after the first and the second injection phases. Position 6 is not reported because the fracture reflection was interfering with a strong diffraction generated by the metal element embedded in the block.

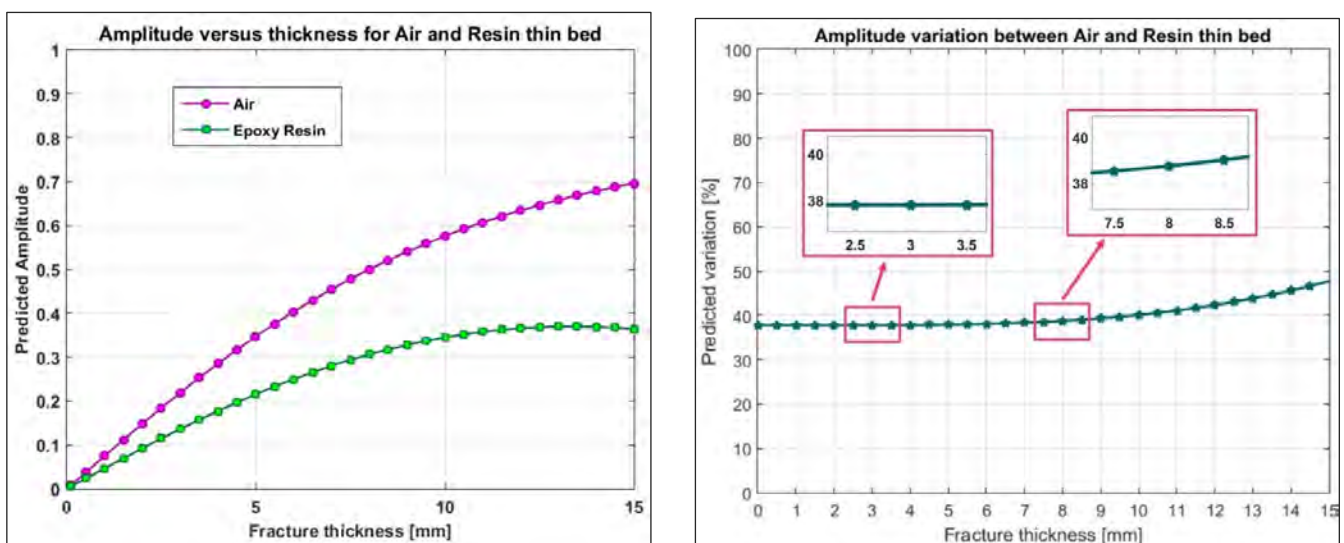
Figure 11. Comparison of the predicted amplitudes for the air-filled fractures (purple circles) versus the resin-filled fractures (green squares) for a 3 GHz antenna. Marble relative permittivity: 7.7. Resin relative permittivity: 3.5. The right plot shows the percentage amplitude reduction expected when the resin substitutes the air within the fracture.

Numerical simulations and analytical models can predict the difference between the air-filled and resin-filled fractures [18,21]. Figure 11 indicates the predicted theoretical difference between the air-filled and the resin-filled fractures obtained by tuning the analytical models to the actual marble velocity measured on the Carrara blocks (10.8 cm/ns). We assumed the relative permittivity of 3.5 for the resin. This is the minimum value of the expected range for resin (3.5 to 4.7) and thus, the results will illustrate the minimum theoretical differences that we can predict before and after injections. Based on Figure 11, if GPR detects an air-filled fracture, a minimum of 38% amplitude reduction is expected after the fracture is filled with the resin. In our laboratory tests, the predicted variation is about 38% for the 3 mm-thick fractures (the average fracture thickness for the small and medium blocks), and 39% for the 8 mm-thick fracture (the average fracture thickness for the large block). This percentage variation will increase to about 48% for thicker fractures (15 mm).
