Virtual reconstruction of damaged archaeological sites based on Unmanned Aerial Vehicle Photogrammetry and 3D modelling. Study case of a southeastern Iberia production area in the Bronze Age / Carvajal-Ramírez, F.; Navarro-Ortega, A. D.; Agüera-Vega, F.; Martínez-Carricondo, P.; Mancini, F.. - In: MEASUREMENT. - ISSN 0263-2241. - 136:(2019), pp. 225-236. [10.1016/j.measurement.2018.12.092]

# Virtual Reconstruction of Damaged Archaeological Sites based on Unmanned Aerial Vehicle Photogrammetry and 3D Modelling. Study Case of a Southeastern Iberia Production Area in the Bronze Age

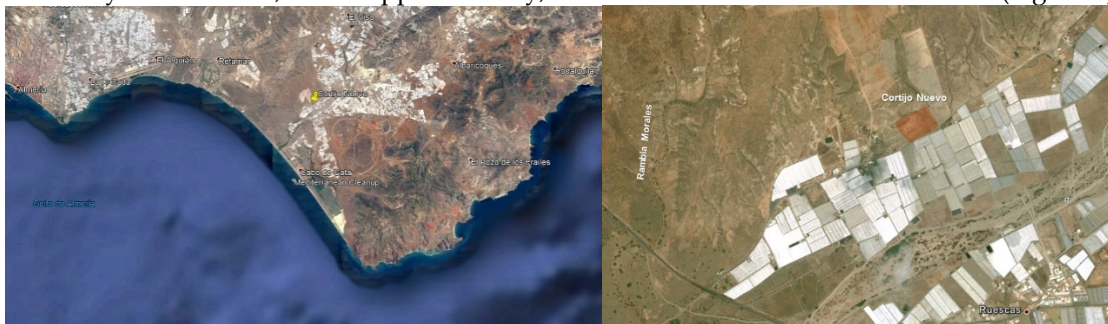
**Figure 1.** Study area. The location of Cortijo Nuevo is now in a greenhouse intensive agriculture zone.

The studied archeological site is located in Almería province, southeastern Spain, with geographic coordinates 36°49'24.5"N latitude, 2°13'59"W longitude. Almería province has evidences of ancient societies including remains of Roman establishment, salt extraction mines and coastal infrastructures, an Islamic city with necropolis, defensive walls and fortress [23]. Cortijo Nuevo is delimited by an area of 22,360 m<sup>2</sup> approximately, close to Rambla Morales and Ruescas (Figure 1).

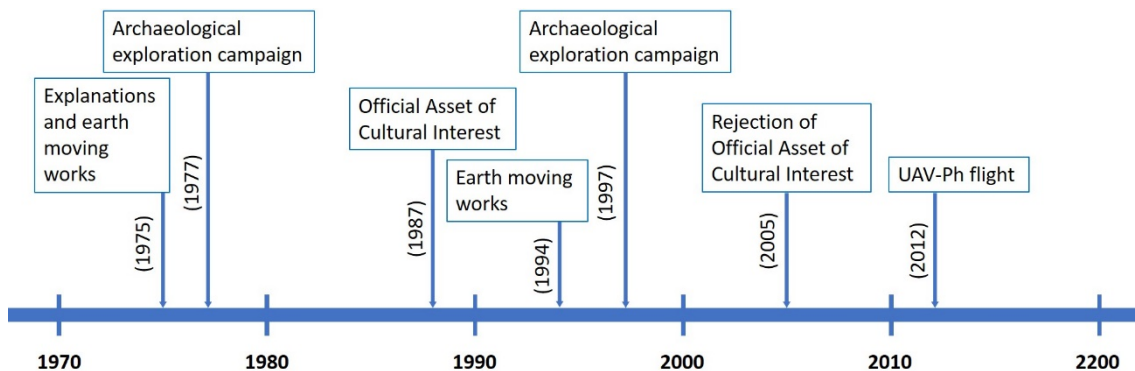
**Figure 3.** Timeline of Cortijo Nuevo archaeological site.

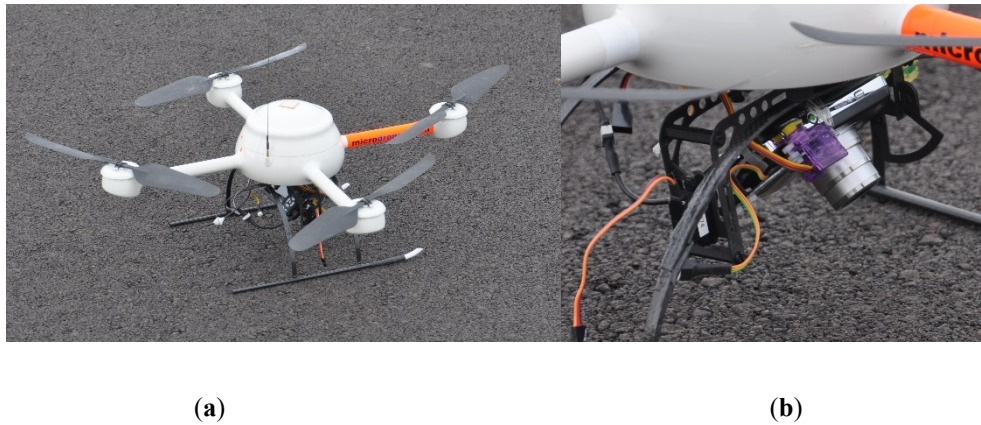
**Figure 6.** (a) Microdrones md4-200. (b) Detail of digital camera Pentax Optio A40 and gimbal on board.

A rotary-wing quadcopter UAV was used, model Microdrones md4-200 [30], with programmable capabilities for flight routes and actions at each waypoint on the flight. The payload is a maximum of 200 g, enough for carrying a compact digital camera, model Pentax Optio A40, with 12 megapixels, and the gimbal that stabilises the camera (Figure 6).

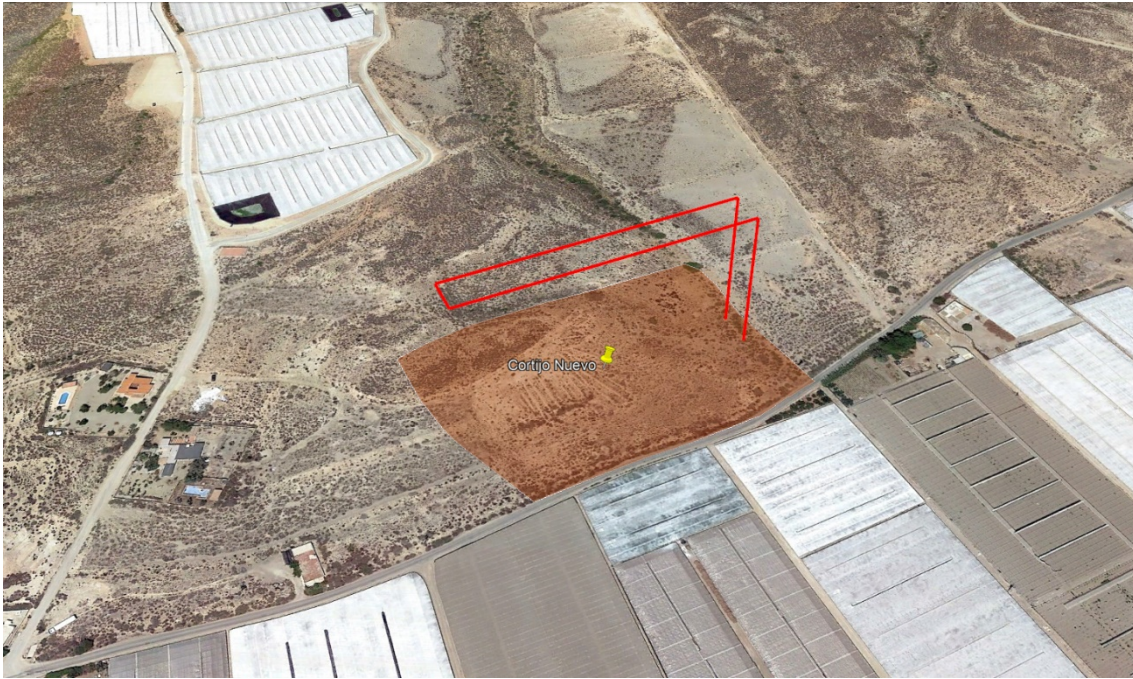
**Figure 7.** Target area to be covered by the photogrammetric flight and the two central paths of flight.

The target area to be covered by the photogrammetric flight was close to 2.2 ha and is located at the main damage to the architectural complex. Figure 7 shows the evidence of the cutting, drilling marks and the unaltered terrain surface in the northwest of the site. The limits of the flight area were the dividing line of the natural slope at the north, the road at the south, the watercourse axis at the east and the terraced plot at the west.

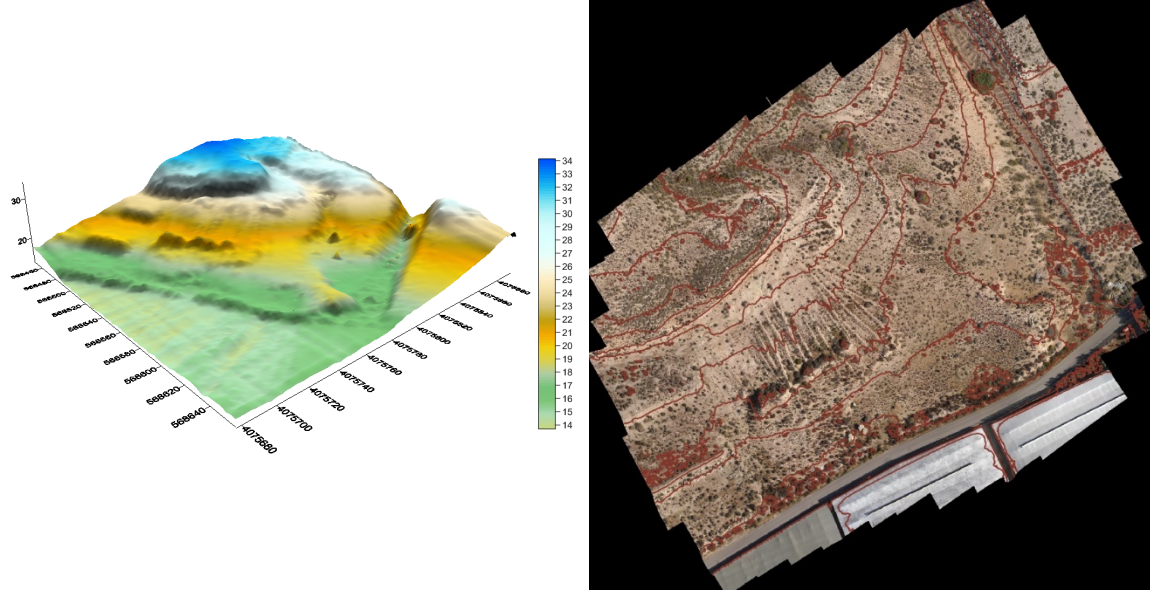
**Figure 12.** (a) DMS of the archaeological site with elevation referring to height above sea level, in m. (b) Orthoimage with overlapped contours, each 2 m.

The orthoimage was the result of both a orthogonal projection of the photogrammetric model over the sea level surface based on the topography of the DSM, and an interpolation process by the nearest neighbour method [44] for deriving missing data between projected information, with a resulting ground sample distance of 0.02 m. Figure 12 shows a hypsometric DSM representation and the orthoimage with overlapped 2 m contours.

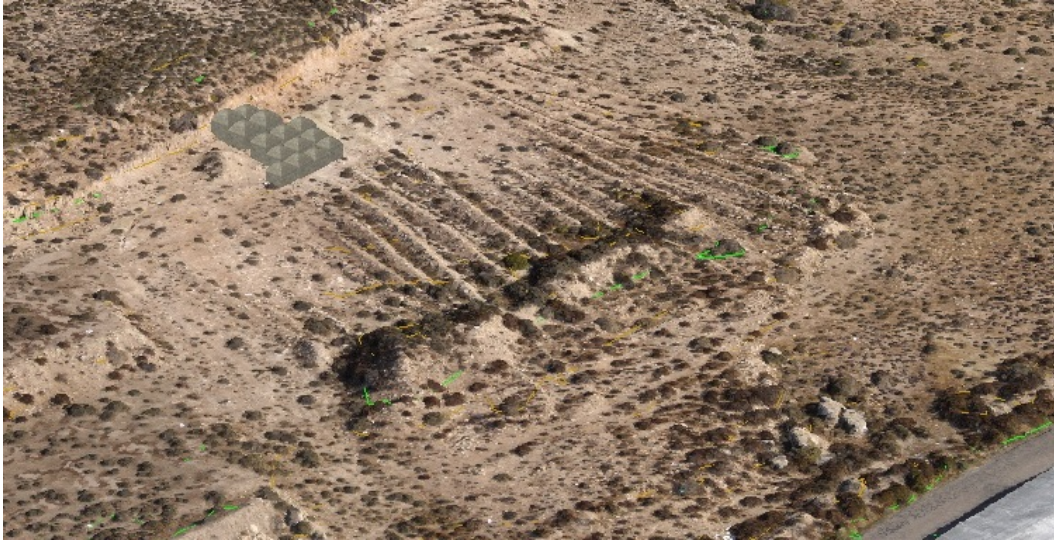
**Figure 13.** (a) Architectural structure model overlapped with point cloud obtained from UAV-Photogrammetric representation the current altered surface. (b) New TIN surface interpolated representing the original terrain morphology, with 1-m contours. Vaults can be observed over the slope level.

The architectural of the complex including structures, vaults and interconnection channels was represented according to descriptions registered in both archaeological campaigns [23,29] and based on the evidence obtained by UAV-Photogrammetry about current and past terrain morphology of the archaeological site. The surface of the bases and the depth of the structures used for the 3D model were measured in the excavation works. A total of 13 structures well-adapted to the geologic slope were distributed in five levels, containing 4, 3, 3, 2 and 2 structures respectively, from the lower to higher elevations (Figure 13). The bases of all the structures over the geological terrain were represented by the point cloud obtained by UAV-Photogrammetry, while tops of the structures were based on the unaltered level terrain, represented by the interpolated TIN. The vaults appear above the the ground level where the site is unaltered, and the interconnections between bottoms of structures at the same level are aligned with the contours. All the virtual structures were covered with a texture of limestones engaged with mud.
