Unusual becoming Usual: recent persistent-rainstorm events and their implications for debris flow risk management in the northern Apennines of Italy / Corsini, Alessandro; Ciccarese, Giuseppe; Truffelli, Giovanni. - (2019). (Intervento presentato al convegno 4th Regional Symposium on Landslides in the Adriatic Balkan Region tenutosi a Sarajevo, Bosnia and Herzegovina nel 23-25 October 2019) [10.35123/ReSyLAB_2019].

Unusual becoming Usual: recent persistent-rainstorm events and their implications for debris flow risk management in the northern Apennines of Italy

Alessandro Corsini ⁽¹⁾, Giuseppe Ciccacese ⁽¹⁾, Giovanni Truffelli ⁽²⁾

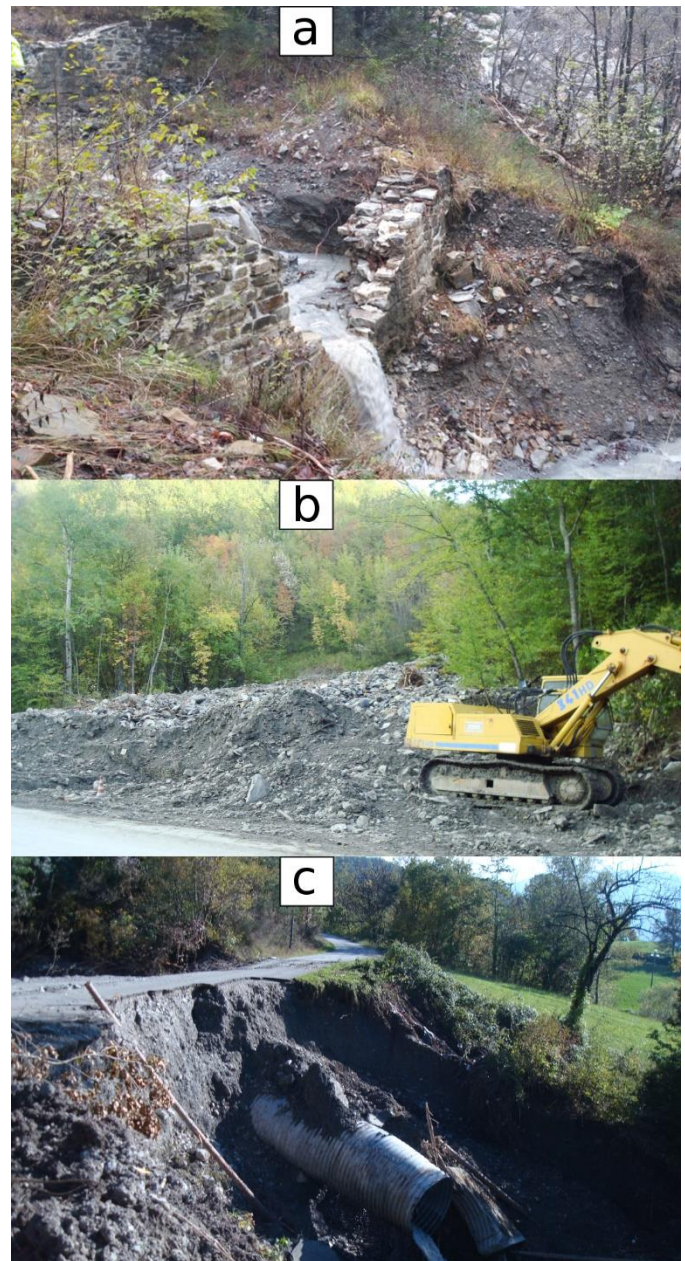
Fig. 5 – Example of effects on infrastructures in Parma province: a) check-dams cut-through by debris flows; b) road overrun by debris; c) erosion and cut-through of the road track.

During the Parma province alluvial event, several check dams along the torrents affected by debris flows were destroyed or buried by debris (Fig. 5a). Consequently, large amounts of debris previously trapped upstream of the check-dams, have been mobilized along the channel. Severe damages have affected many local roads crossing the debris flow tracks (Fig.5b), mostly where the torrents have been previously channeled into 1 m diameter pipes under the roads. In these cases, the flow-pipes have been rapidly obstructed by the debris flows, causing the overflow of debris and the erosion and cut-through of the road track (Fig. 5c).
