Experimental study on K-joints of Concrete-Filled Steel Tubular truss structures

Abstract

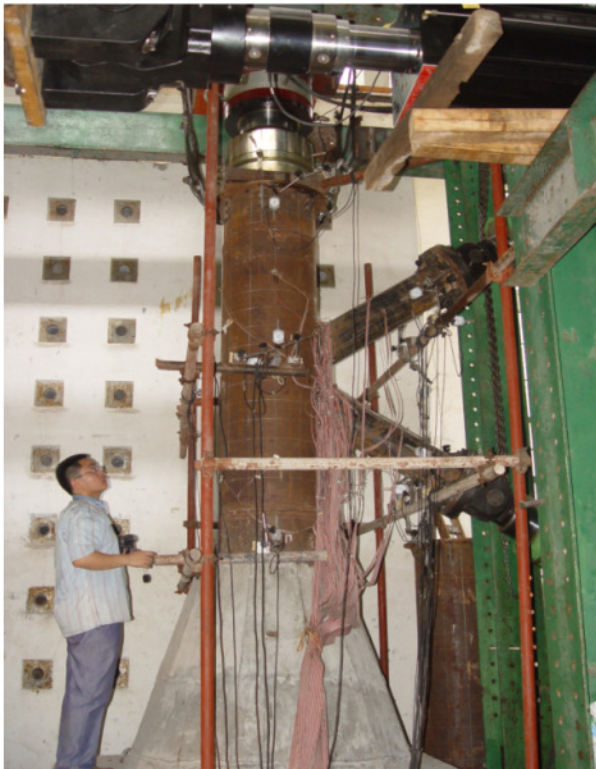
Fig.1: View of a K-joint specimen and of the test set-up

In this work, CHS and CFST K-joint specimens were tested (Fig.1). These joints (together with the KT joints that function similarly to K-joints and are considered as K-joints by certain codes [33,34]) are the most common type of joint used in tubular girders and in the arch trusses of bridges.

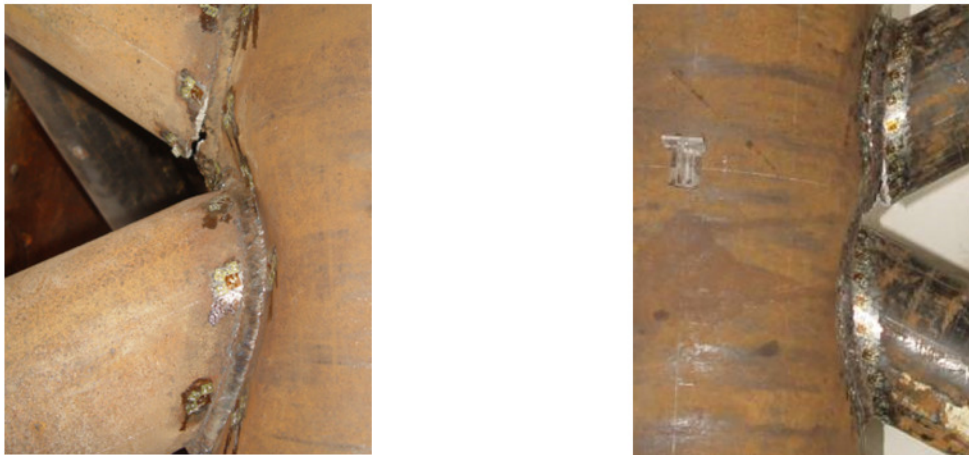
Fig. 6. Chord face failure mode of the CHS K-joint specimens CHS-6 (a) and CHS-8 (b)

The experimental tests showed that the chord face failure mode occurred in both CHS K-joint specimens (Fig. 6), in accordance with the fact that using the above formulations, the joint resistance to punching shear was much higher than that for the chord face failure mode (Table 3).

Moreover, when in both the CHS-6 and CHS-8 specimens the joint resistance for chord face failure was attained (717 kN and 719 kN, respectively, see Table 3) with high plastic deformations (Fig. 7), the typical peak of strain in the tension brace at the crown toe (for 180° =gap in Fig. 4-a1) caused the formation of a crack (see the upper brace of Fig. 6) whose rapid propagation led the joint to fail suddenly.

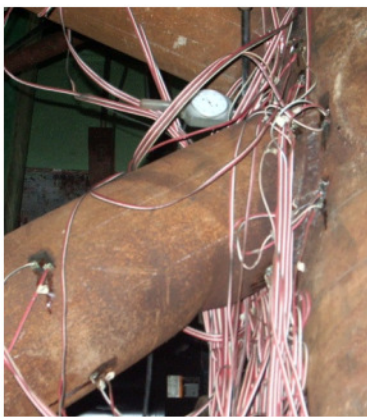
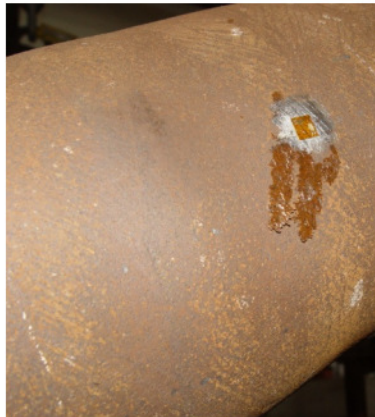
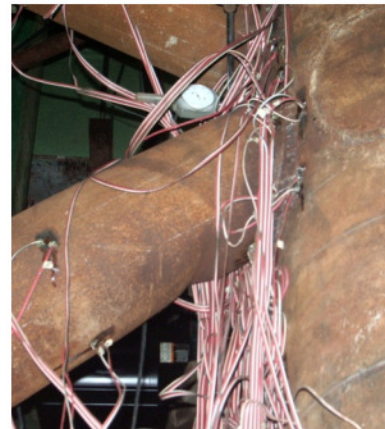
(a) Bulge at the end of the compression brace of specimen CFST-6

(b) Shear lines on the surface of the compression brace of specimen CFST-6

(c) Bulge at the end of the compression brace of specimen CFST-6s

Fig. 8. Member failure mode for yielding of the compression brace of the K-joint specimens CFST-6 and CFST-6s with wall thickness $t = 6$ mm.

1 by yielding at the joint location, with an outward bulge that formed close to the joint (Fig. 8). The
2 compression force at failure was 1115 kN (Table 4 and Fig. 9), which was less than the brace yield
3 strength of 1325 kN. *Yielding at the brace end was favoured by the extremes in the strain*
4 *distribution (as expected in a tubular joint) along the welded connection between chord and*
5 *compression brace (Fig.4-a2).*

7 All three CFST K-joint specimens with studs failed in the same failure modes of the corresponding
8 specimens without studs (Figures 8c, 10c and 10d), but the resistance and ultimate deformation of
9 the former specimens were always greater than those of the latter.

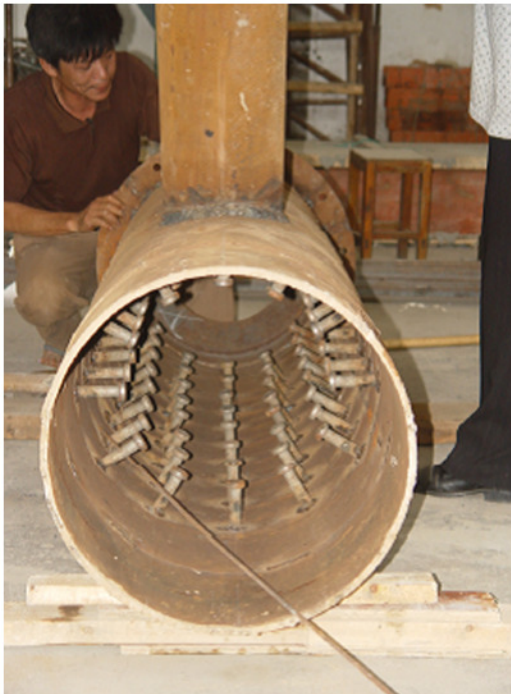
Fig. 12. View of the interior surface of the chord tube of a CFST joint with studs

Finally, three CFST K-joint specimens with studs welded to the interior surface of the chord across the joint region were tested (Fig. 12). The three specimens (CFST-6s, CFST-8s, CFST-10s) differed from each other only in the brace wall thicknesses of 6 mm, 8 mm and 10 mm, respectively, and studs with a height of 80 mm were used (shank diameter = 19 mm, head diameter = 32 mm, head thickness = 12 mm). The stud spacing in the direction of the chord tube was 150 mm, and spacing
