Recognition of ancient fires in archaeological sites containing gypsum rocks / Lugli, S. - In: VI International Conference of the Association for the Study of Marble and Other Stones in Antiquity / Lazzarini L.. - STAMPA. - Padova : AAGEP, 2002. - pp. 545-548

# RECOGNITION OF ANCIENT FIRES IN ARCHAEOLOGICAL SITES CONTAINING GYPSUM ROCKS

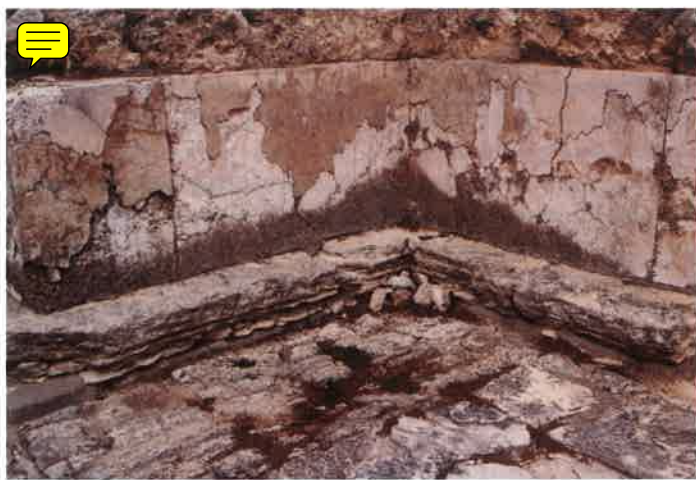
*Fig. 1* – Partially dehydrated gypsum block (white, center) located in a wall structure at Eraclea Minoa (Sicily). The other gypsum block immediately on the right is unaltered, whereas the thickness of the white surface decreases toward the right, suggesting that a fire burned the left side of the wall decreasing in intensity and effectiveness to the right. Note that the other adjacent rocks, arenite (deeply altered, at bottom) and limestone (left), do not show traces of burning. The gypsum blocks are about 30 cm high.

Gypsum blocks and slabs in archaeological sites can be used as indicator of ancient fires because relatively low temperatures, leaving no visible traces on bricks and other stones, may affect calcium sulfate in a permanent and recognisable way (*fig. 1*). A white, thin, layer forms on the surface of blocks exposed

- 1) develop only on the exposed faces of the blocks (figs. 1 and 2),
- 2) are a few centimeters thick and thin away from burned zones (figs. 1 and 2),
- 3) may contain anhydrite in amounts which are decreasing away from burned zones,
- 4) are correlable across adjacent blocks made of different gypsum facies together with their «shield shadows» (figs. 1 and 2).

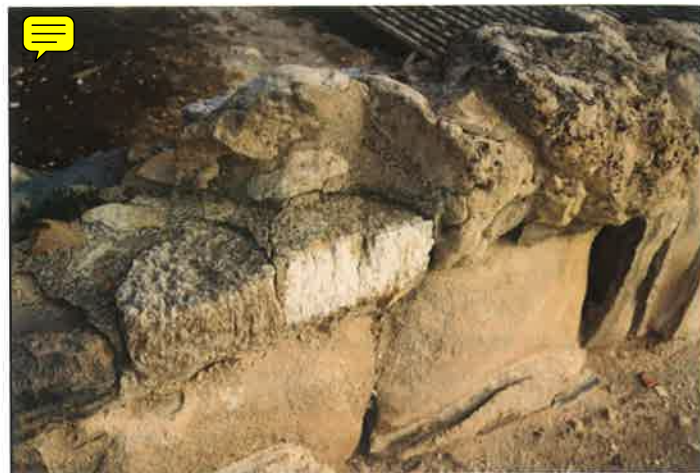
Fig. 2 – Top view of a partially dehydrated gypsum block in the Palace of Minos at Knossos (Crete). Note the white surface running parallel to the vertical face of the block (left). The maximum thickness of the white surface is about 4 cm.

The white surfaces are planar, generally less than 5 mm-thick (fig. 2) and affect totally or in part exposed faces of the blocks, which normally show a gray color (selenite, gypsarenite and gypsrudite). The boundary of the dehydrated surfaces commonly match across adjacent blocks of different shape and size showing different crystal orientation (3 and 4). These characteristic clearly indicate that the whitening should have occurred after the emplacement of the blocks. Moreover, the white surface commonly affect, and thus postdates, remnants of scratched lines produced by carving tools.

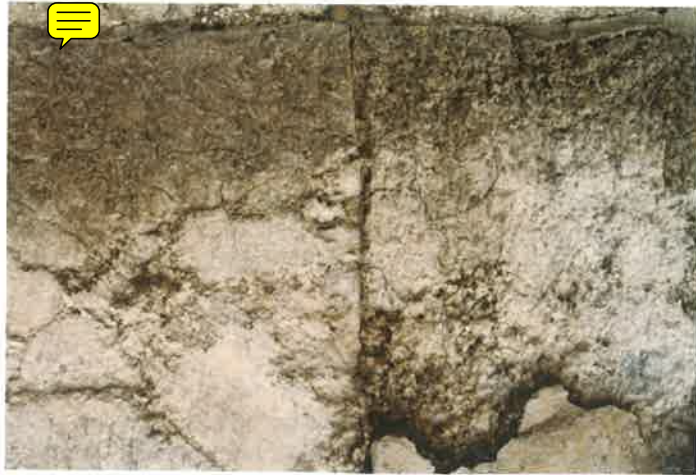
Fig. 3 – Partially dehydrated gypsum blocks (white) in the western façade of the Palace of Minos at Knossos (Crete). Note that the boundary of the white surface correlates across different blocks, indicating that the blocks were dehydrated after their emplacement. The lower portion of the gypsum blocks are unaltered (dark gray), suggesting that the socle may have acted as a sort of shield against the fire («shield shadow»). This interpretation is supported by the observation that the gypsum blocks are completely affected by the white surface in those tracts where socle is missing (not visible on picture). The gray areas on gypsum blocks are concrete restorations. Vertical blocks are about 60 cm high.

Most of the gypsum blocks in the studied sites are affected by white surfaces totally or in part. The unaffected areas are commonly in the lower part of the blocks and correlate across the walls (figs. 3 and 4). The presence of sharp unaffected surfaces in the white blocks could be interpreted as the shield effect to direct heat by fallen blocks, bricks, roofing-tiles, beams or other objects. In some examples in the Minoan Palace of Cnossos the shield against fire may have been the socle (fig. 1). This interpretation is supported by the observation that gypsum blocks are completely affected by white surfaces in those tracts where socle is missing.

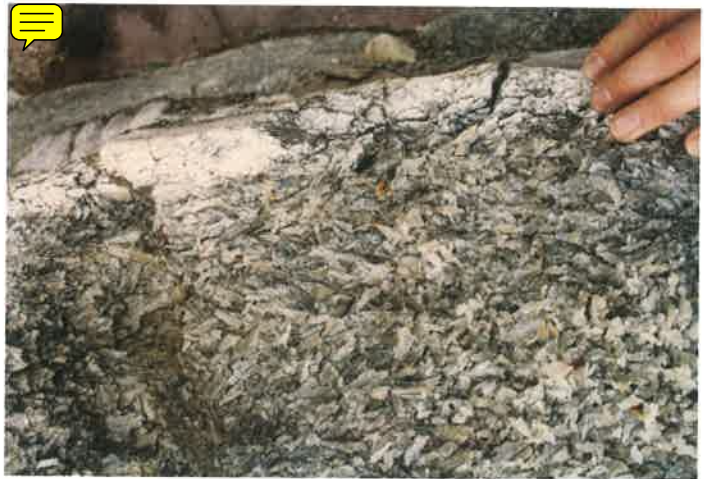
Fig. 4 – Close-up of the wall structure of fig. 3 (Palace of Minos, Knossos, Crete). Note that the white surface cut through blocks with different crystal orientations, indicating that dehydration occurred after emplacement of the blocks.
