# Lessons learnt from the disasters of Sgorigrad (Bulgaria) and Stava Valley (Italy)

*by Graziano Lucchi\* and Giovanni Tosatti\*\**

## IV INTERNAT. GEOMECHANICS CONFERENCE SECOND PLENARY SESSION – TOPIC 8

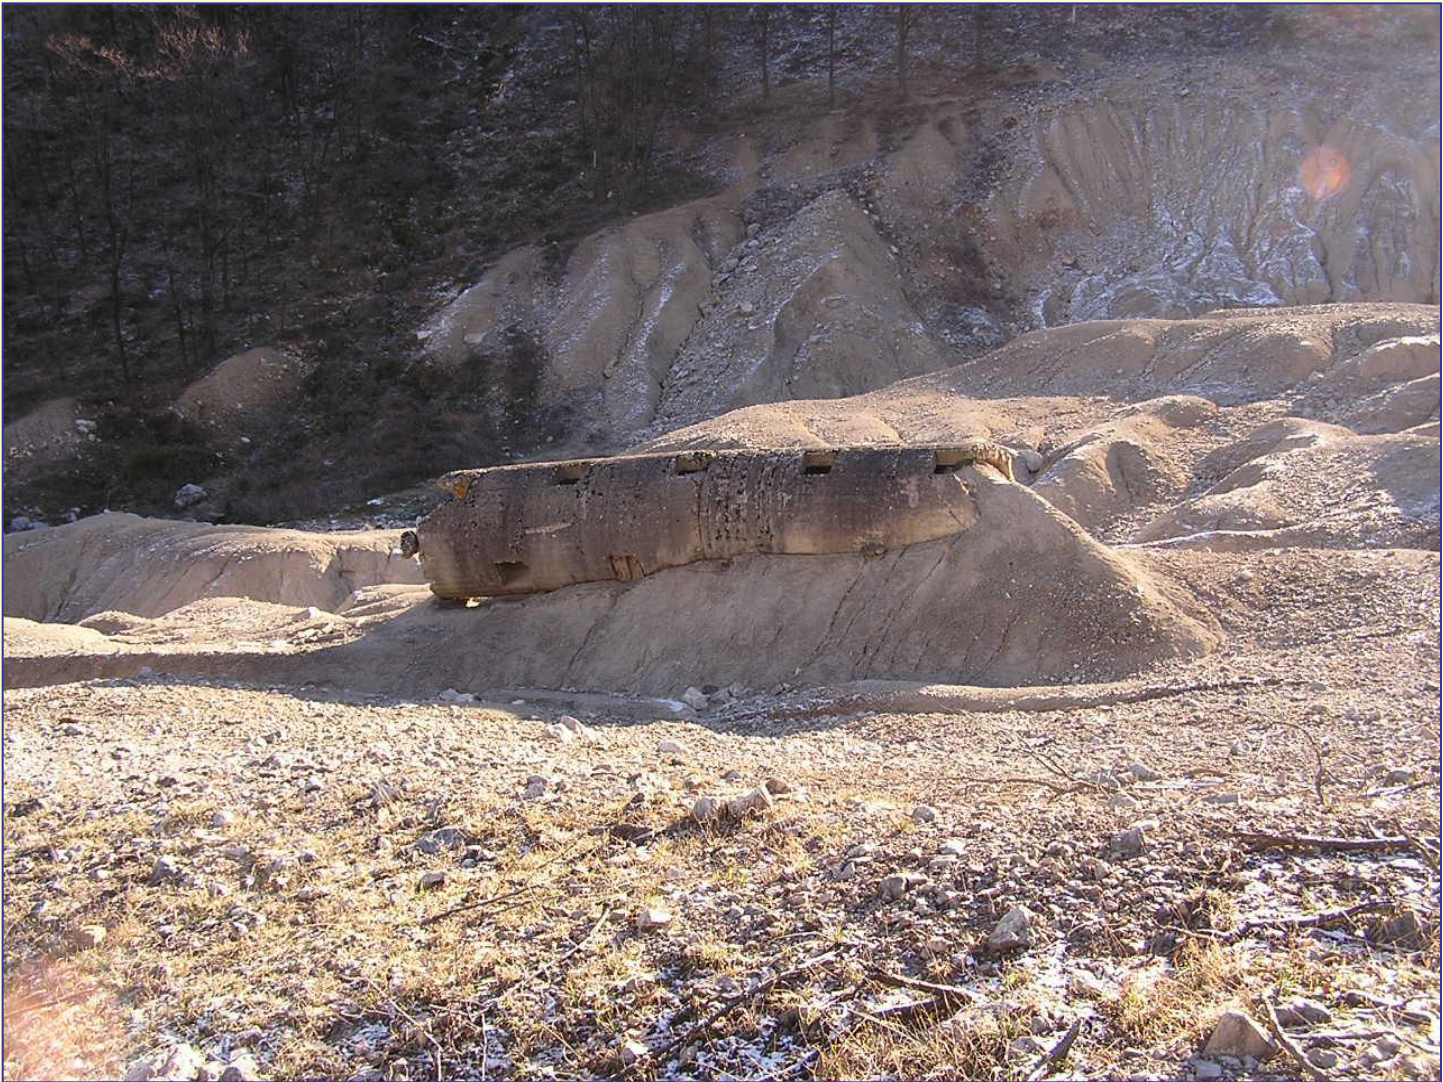
The retaining embankment for damming the torrent, the overflow towers and segments of the pipes are still visible today, together with small amounts of decanted mud, which remained in place.

The remains of the Sgorigrad tailings dam with a fallen overflow tower.

The failure of the Sgorigrad tailings dam occurred after days of heavy rains. The basin was in “high pond” conditions and the tailings were saturated. Since the decant towers had a low spillway capacity, the pond water level had risen dangerously and caused the submersion of the beach.

Hydrogeological investigations on the tailings dam area had not been adequate since they did not detect the presence of a water spring located inside the basin.

The dam failed suddenly and a large mass of tailings and water went down like a fast-moving wave of mud. According to eye-witnesses, the dam did not overflow. This was recorded also by aerial photographs. The ultimate cause of failure was the sudden loss of stability and the ensuing liquefaction of the tailings, that is the complete loss of shear strength of saturated soils under static loading. If it had been overtopped, erosion would have taken some time and the failure wave would not have been so vast and fast.

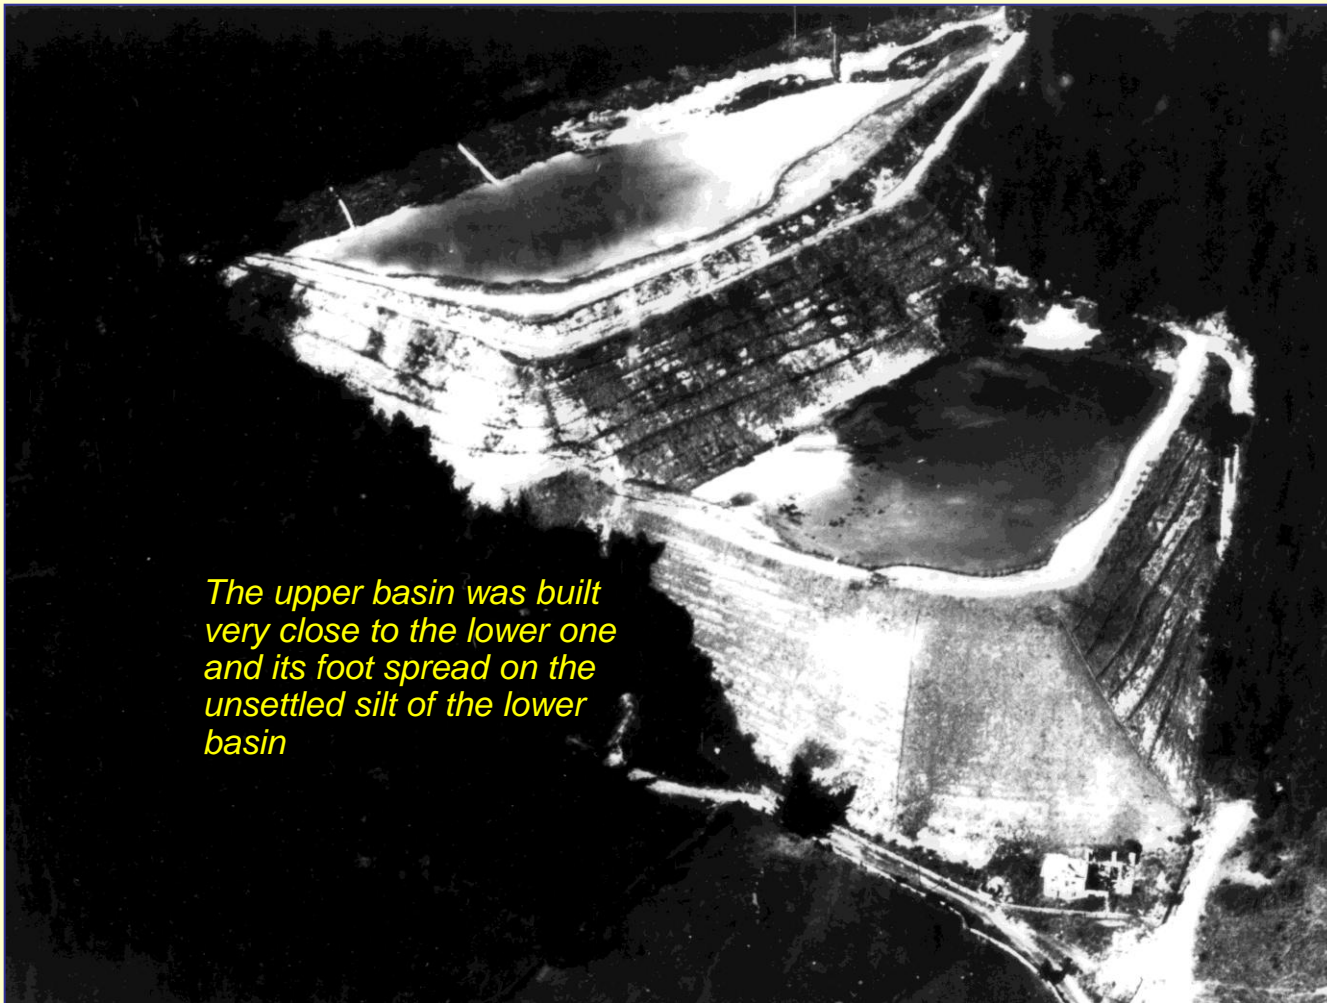
*The upper basin was built very close to the lower one and its foot spread on the unsettled silt of the lower basin*

The tailings dams of the fluorite mine in the Stava Valley in 1981

- i) the marshy nature of the foundation ground, which hindered the consolidation of the sediments;
- ii) the erroneous construction of the upper basin's dam, which did not allow adequate drainage at its foot;
- iii) the position of the upper basin just uphill of the lower one: as it grew in width the dam came to rest partially on the silts of the lower basin, thus worsening drainage and stability conditions.

As a consequence, there was considerable build-up of pore water pressure inside the upper basin's dam. Therefore, water fluctuations led to a high piezometric surface that eventually caused the failure of the dam and the liquefaction of the silts therein contained.

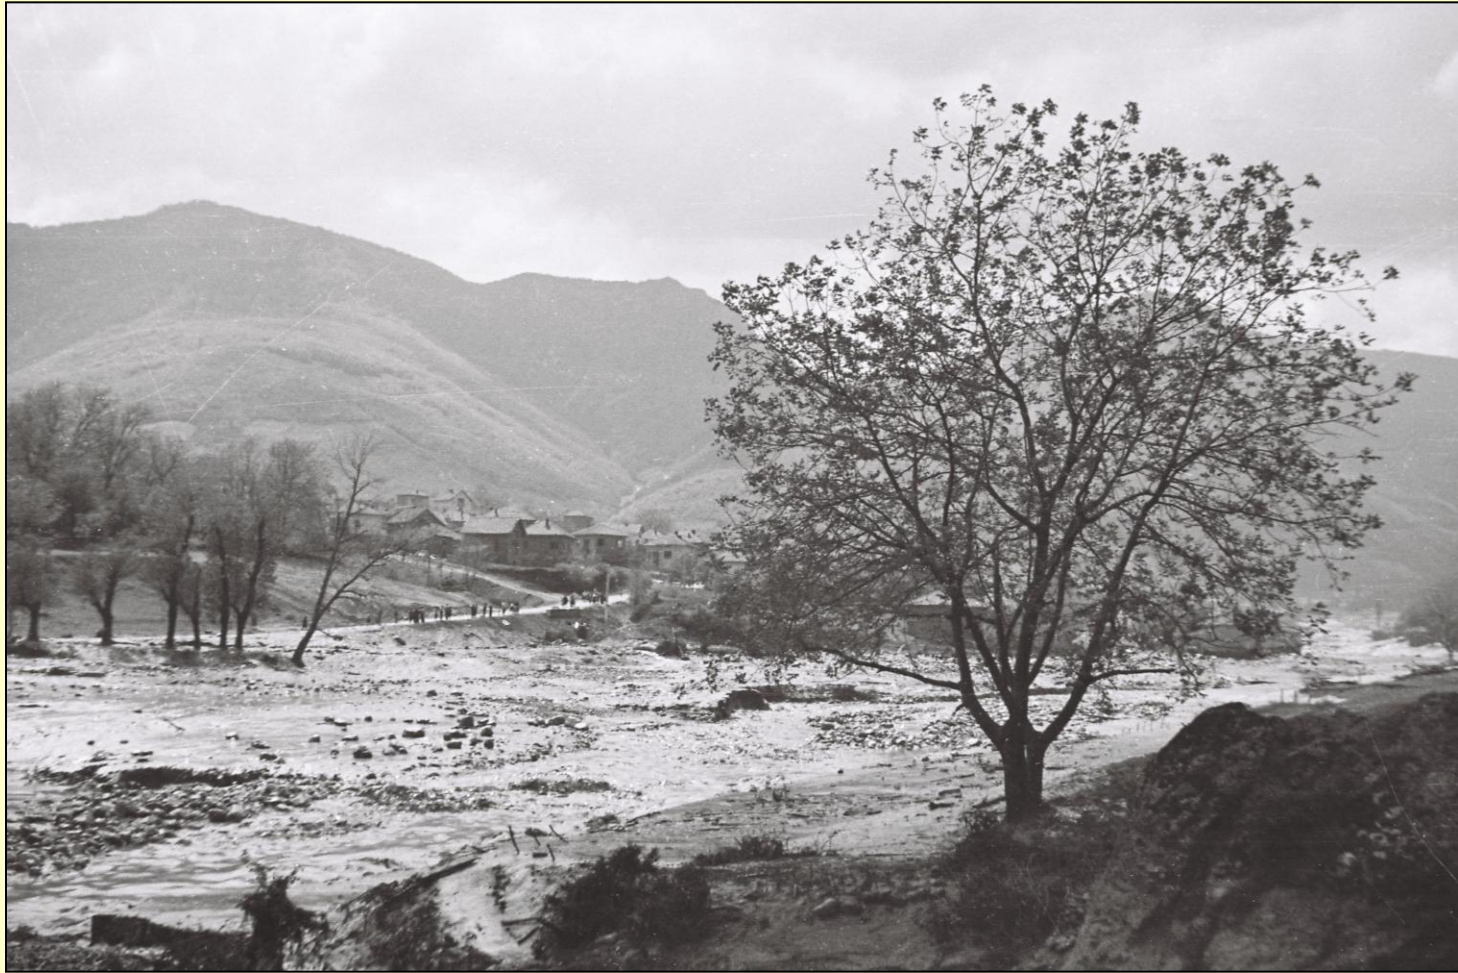
The Sgorigrad area soon after the collapse of the tailings dam (May 1966)

- Failure took place on 1<sup>st</sup> May at 11:15 hours. A 220,000 m<sup>3</sup> flowslide, in some places over 3 m high, ran a distance exceeding 6 km.
- The mudflow destroyed most of the village of Sgorigrad, and eventually reached the town of Vratza.
- The number of casualties in Sgorigrad was rather high as most of the inhabitants were in the town centre taking part in the celebrations of Workers' Day. The corpses of the victims were then taken to Vratza's stadium but their identification was a particularly difficult task. Officially, the number of lives lost was declared as 107. Over 2,000 persons were injured, 576 families were affected, over 150 houses were destroyed together with Vratza's Zoological Garden.

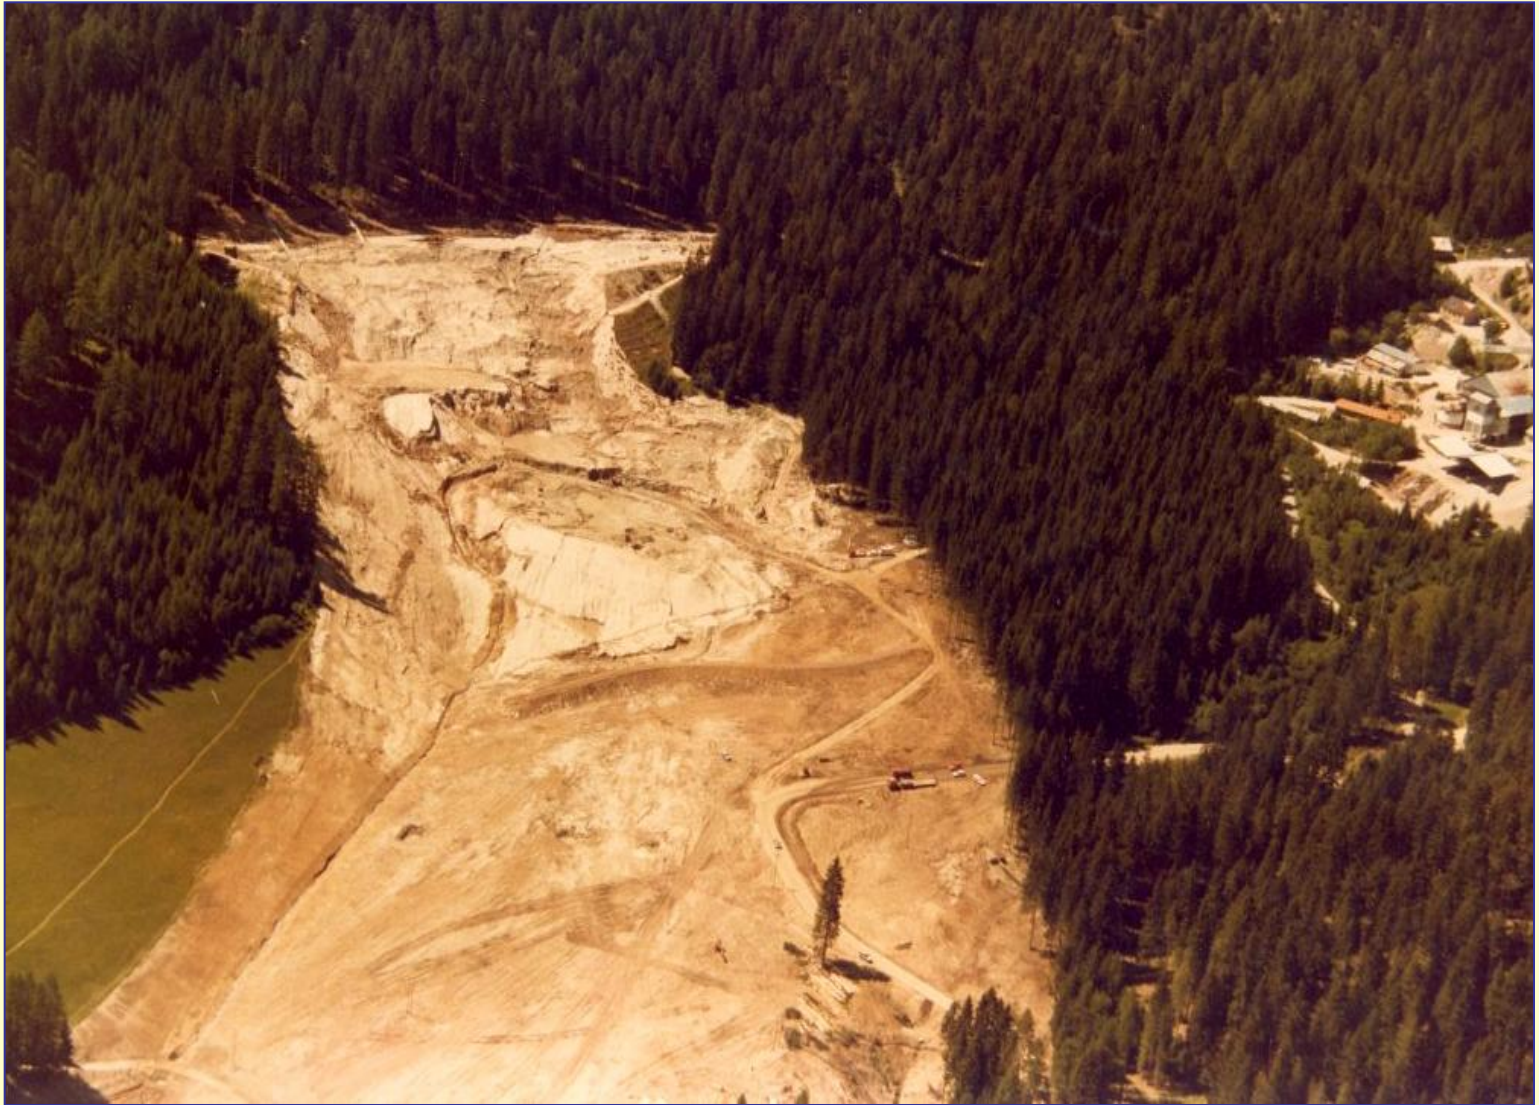
The upper Stava Valley soon after the tailings dams failure (July 1985)

- At 12:23 hours of 19<sup>th</sup> July 1985 the dam of the upper basin failed and collapsed onto the lower basin, which also failed. The flowslide composed of water, sand and silt descended downstream at a velocity of nearly 90 km/h, sweeping away whatever it met in its path as far as the main valley floor over a distance of 4.2 km.
- 268 people were killed and many houses and bridges destroyed.
- The area where the dams stood and the path of the mud flow were completely reclaimed some years after failure.

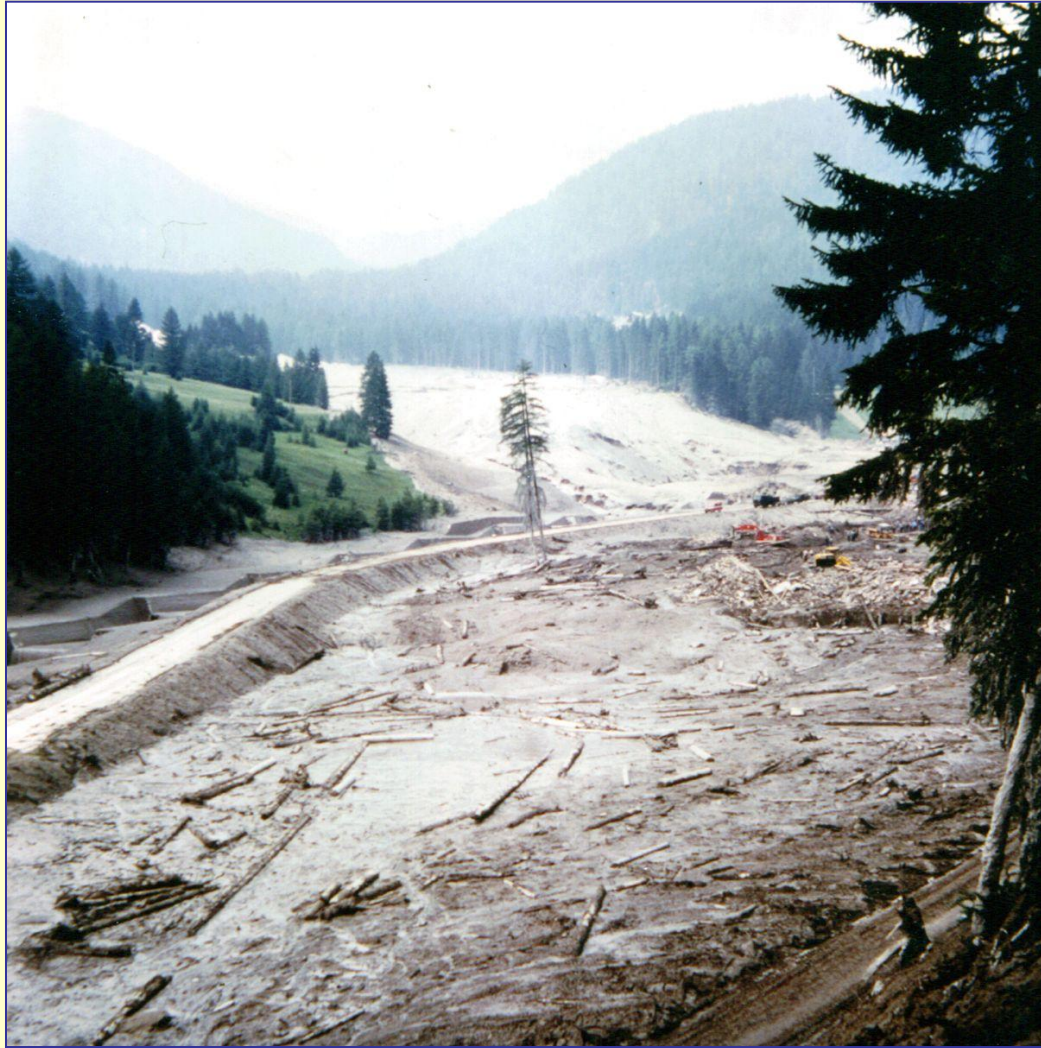
The devastating effect of the flowslide on the Stava Valley (July 1985)
