# Virtual Reconstruction of Damaged Archaeological Sites based on Unmanned Aerial Vehicle Photogrammetry and 3D Modelling. Study Case of a Southeastern Iberia Production Area in the Bronze Age

**Abstract:** Knowledge about cultural and archaeological heritage can dissolve or even disappear with the passage of time, especially when the protection level of the archaeological site is weak.

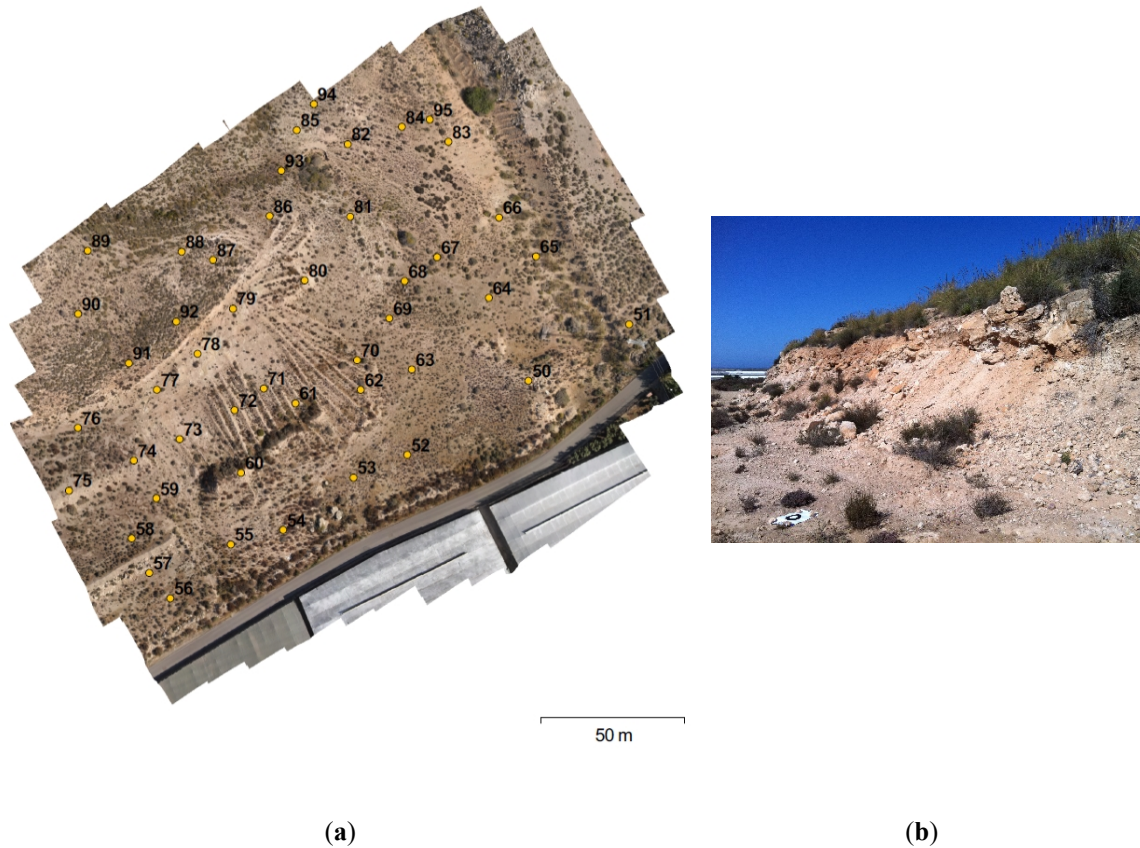
**Figure 8.** (a) Distribution of target points of the survey campaign. (b) Northern profile at Cortijo Nuevo archaeological site. Details of one of the target points.

The survey campaign consisted of the measurement of a total amount of 46 targeted points (Figure 8a), 13 of which were used in the orientation process (Ground Control Points, GCPs) and 33 for statistical characterisation of errors included in point clouds, DSM, and orthoimage (Check Points, CPs) according to the criteria established by [36], [25], and [9]. The targeted points were A4 in size.
