MICROPILES TRIPODS SHIELDS (MTS) AS UNCONVENTIONAL BREAKERS FOR THE CONTROL OF MODERATELY RAPID EARTHFLAWS (SASSI NERI LANDSLIDE, NORTHERN APENNINES)

The paper deals with the idea, design and implementation of unconventional one-of-a-kind Micropiles Tripods Shields (MTS) intended to break and decelerate moderately rapid earthflows surges in the track zone of the Sassi Neri landslide (Nure Valley, Northern Apennines, Province of Piacenza, Italy). The MTS are inspired to floating anchors and “chevaux de fries” used in wartime. The basic elements are tripods of 193 mm diameter steel micropiles laid out at triangle, driven into the stable bedrock and emerging some meters aboveground. Each tripod consists of a vertical upslope central pile and two lateral oblique piles, linked by two transversal beams and connection plates aboveground. Multiple tripods are spaced along transversal rows to form Micropiles Tripods Shields (MTS) to advancing earthflows. The design of MTS has been based on field investigations such as boreholes and geophysics, that indicated a limited thickness of landslide deposits in the track zone where MTS have been installed. The forces resulting from active earthflow

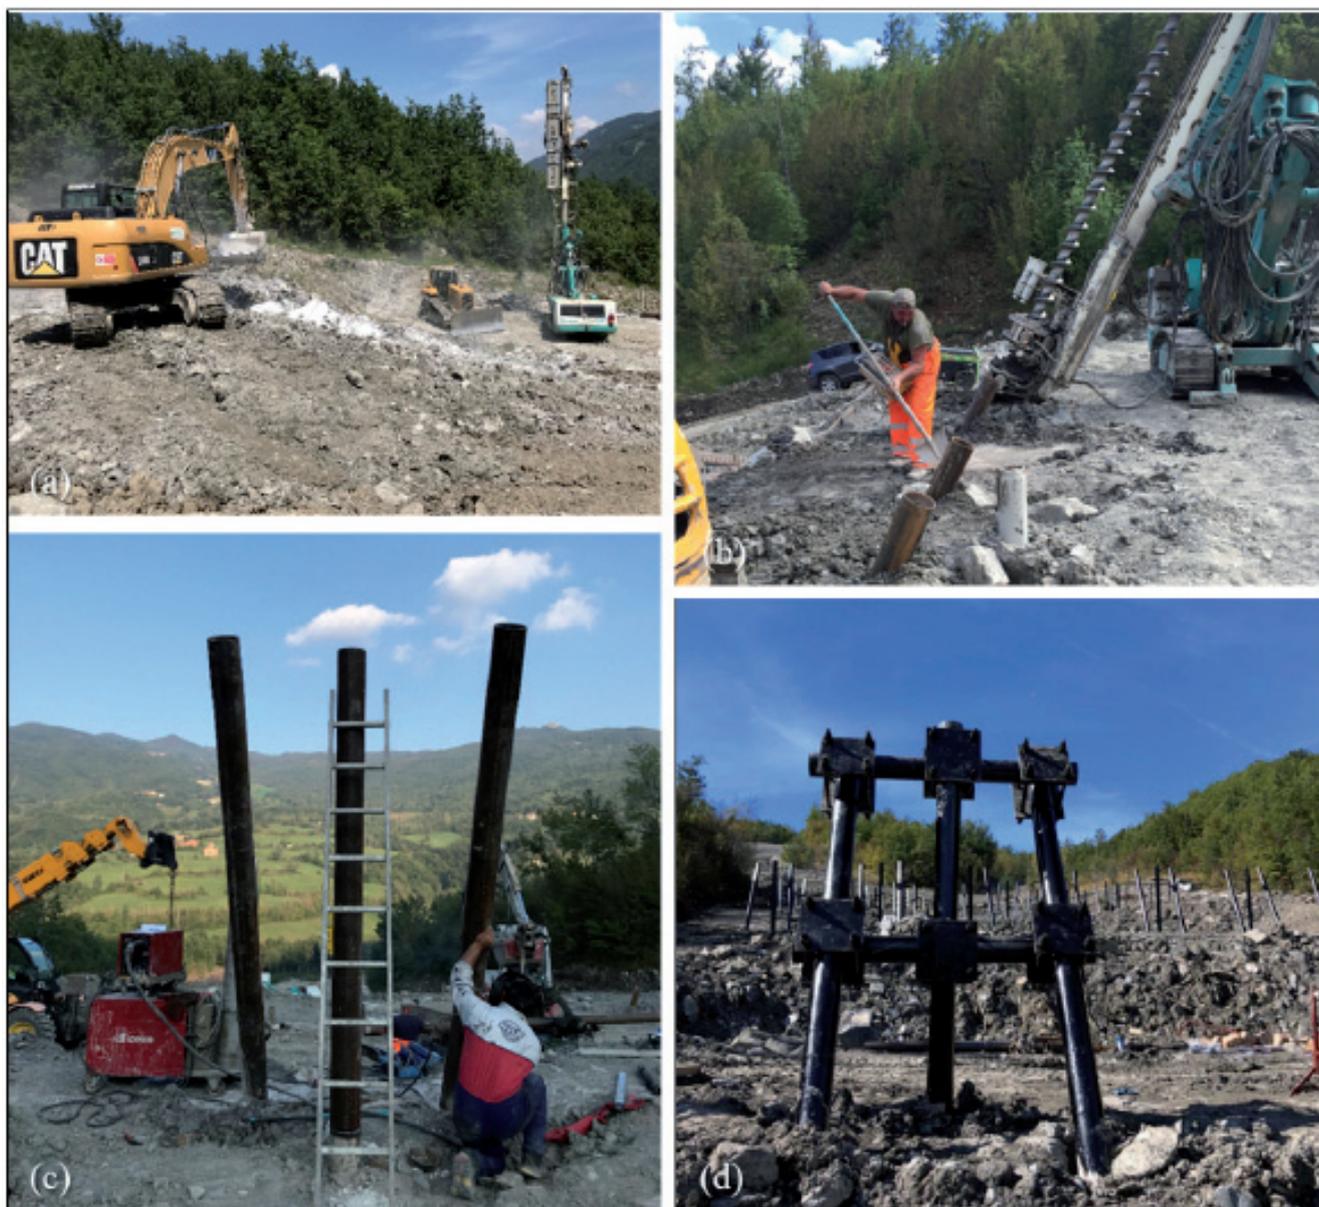
Fig. 5 – Field views of the main MTS construction phases. LEGEND: (a) working site preparation with lime-treatment of the surficial layer of the embankments; (b) underground micropiles drilling and installation; (c) aboveground micropiles welding; (d) tripods completed with connection beams and plates

layer of embankments (Fig. 5a) Finally, at the drilling points, large limestone blocks selected from the earthflow deposit have been rolled out. The underground micropiles drilling and installation phase started in early August 2018, by first drilling and installing all vertical piles and then all the oblique piles (Fig. 5b). Due to the additional deposit left by the earthflows of May to June 2018, bedrock was reached by the piles at depths varying between 8 to 12 m, hence slightly deeper than considered in the design phase. In order to increase the strength of the micropiles, the standard threaded coupling junction system was substituted by a one meter long inner pipe for bayonet coupling between casings and micropiles have been fully grouted. This phase was completed by late September 2018. The aboveground micropiles

tripods completion phase was carried out throughout October 2018. Bayonet coupling between micropiles casings was used and reinforced by welding of all the junctions (Fig. 5c). Once the micropiles were completed, they were connected by using, for each tripod, two transversal pile elements and twelve opposing steel plates (2 cm thick and 40x40 cm large) connected, two by two, with four M32 thread bars (Fig. 5d). By early November 2018, all the 30 micropiles tripods making up the 4 Micropile Tripods Shields were fully assembled, coated with anti-rust paint and completed (Fig. 6a and 6b). Due to practical constrains during construction, the downslope spacing between MTS rows resulted higher and more irregular than designed, i.e. 20 m between the 1st-2nd MTS rows (numbered from upslope) and 40 m between the

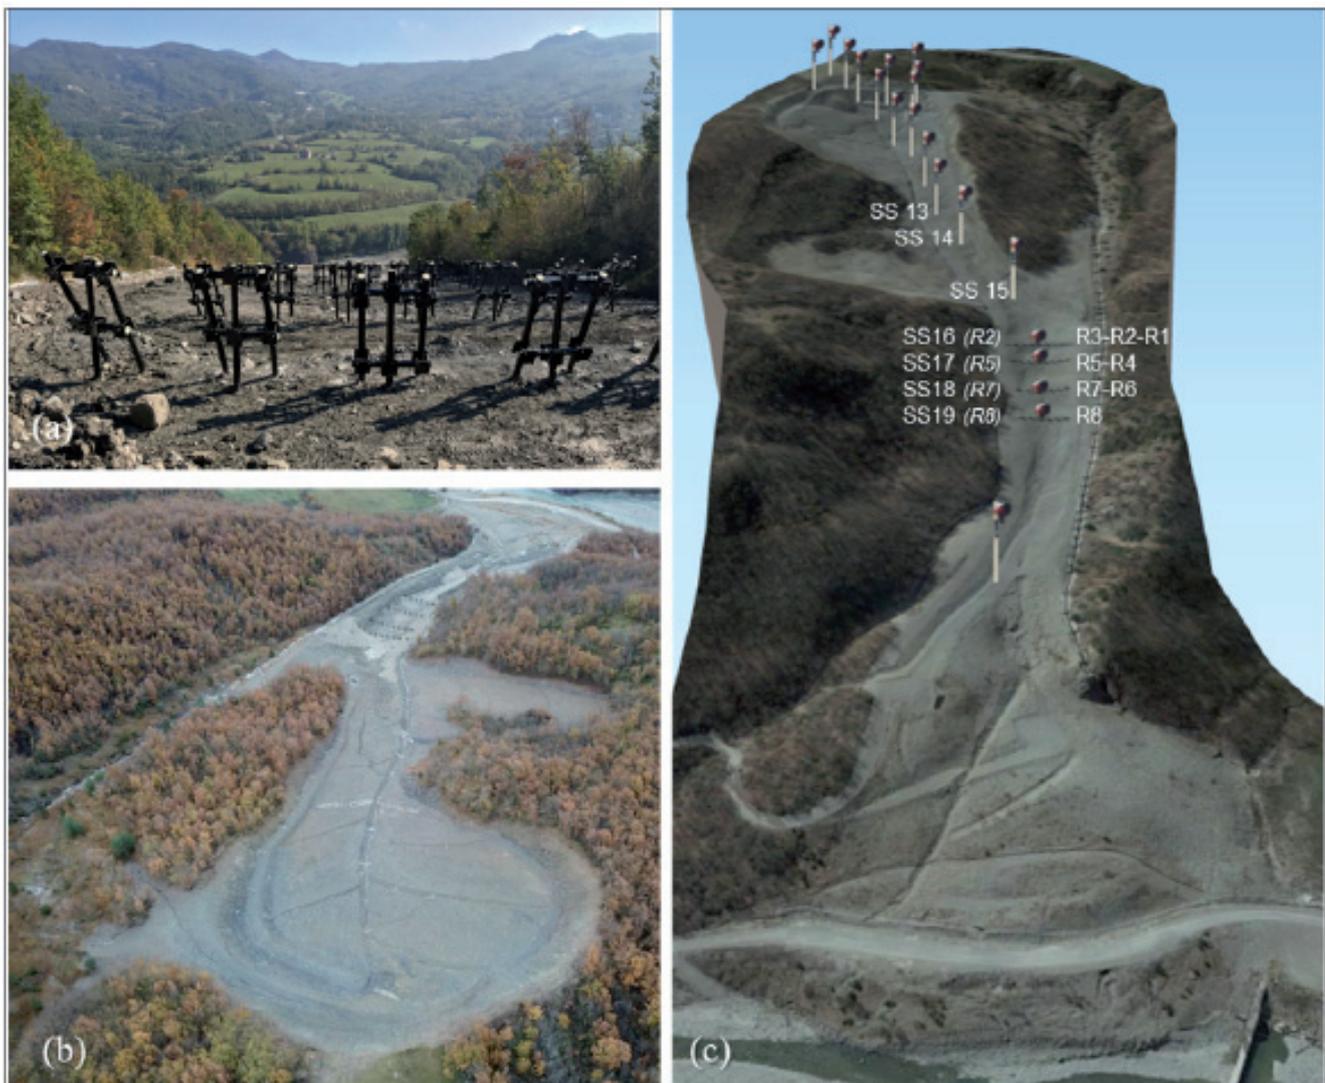
Fig. 6 – Field and aerial views of ground reshaping and MTS finalization as integral part of all other slope consolidation intervention. LEGEND: (a) Upslope to downslope field view. (b) Upslope to downslope aerial view. (c) Downslope to upslope aerial view with labels and relative position of monitored tripods (R1 to R8) and topographic monitoring prisms (SN13 to SN19)

2nd-3rd and 3rd-4th. MTS rows. The final ground reshaping phase took the whole month of November 2018 to be completed. In practice, was the finalization of the slope grading and reshaping activities conducted in the upper part of the slope, during the previous months, in parallel to the MTS construction (Fig. 6c). Ground reshaping in the MTS zone has allowed a general gentle concavity to be created, so that advancing future earthflows would point to the center of MTS rather than divert laterally. Finally, side levees and surface water discharge ditches, integrating the drainage system in the source area, were created to finalize the job together with hydroseeding.

After construction, 8 tripods have also been instrumented for monitoring in an automated wireless sensor network (see location in Fig. 4a and Fig.6c). In each tripod, the following sensors are installed (Fig. 7): 1 load-cell one and half meter underground (meant to measure earth pressure on existing landslide deposits in the range 0-2000 kg, loaded via a 25×15 cm contrast plate); 1 load cell one meter aboveground (meant to measure earth pressure from future earthflow surges in the range 0-2000 kg, loaded via a 25×15 cm contrast plate); 1 pore pressure transducer in a sand pocket two meters underground (meant to measure groundwater pressure in the range 0-100 kPa.); 1 biaxial tiltmeter in the upper part of the tripod (meant to measure longitudinal and transversal
